METALLURGICAL INVESTIGATION OF
CRACKING IN A REACTOR VESSEL NOZZLE SAFE-END

SWRI PROJECT 02-5389-001

INTERIM REPORT

Iowa Electric Power
Cedar Rapids

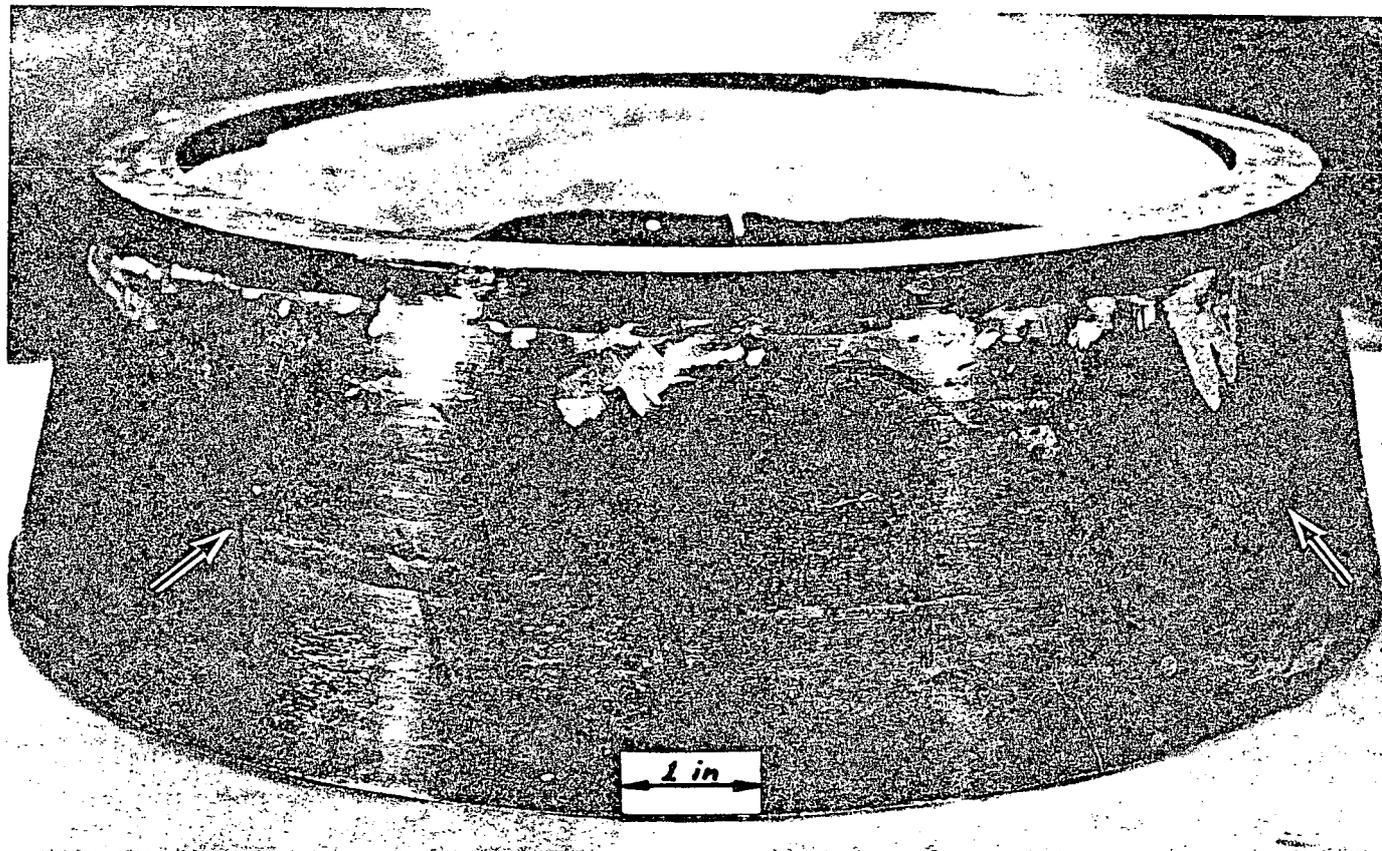
FIGURE 1-2. SAFE-END SAMPLE. Arrows mark the ends of the through-wall-crack.

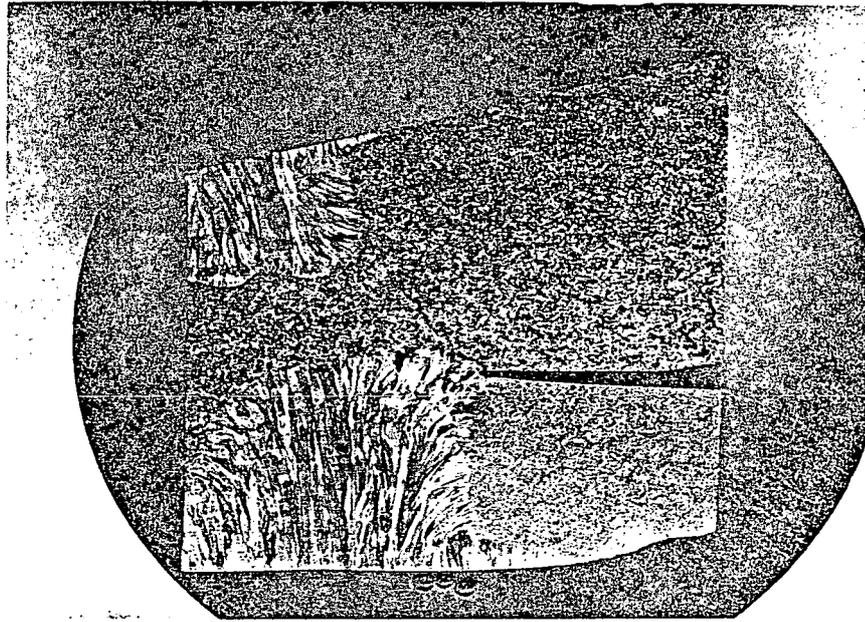
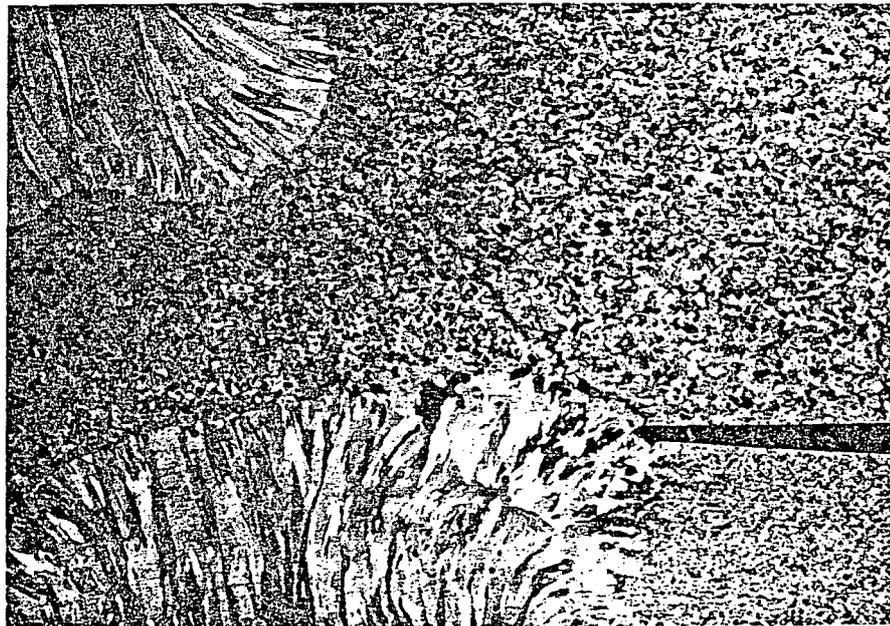
propagated through the repair weld, see Figures 2-2 and B-1 and Figure 1-3(a). In the zone from approximately 75° to 125° crack propagation occurred completely within the safe-end base metal and penetrated the outside surface adjacent to the fusion line of the repair weld, see Figures 2-3 and 1-3(b).

FIGURE 2-2. LONGITUDINAL SECTION AT THERMAL SLEEVE ATTACHMENT.
Section 1-1, Figure 1-4. Lapito's etch.

In each section the crack path was observed to be completely intergranular and crack initiation occurred within the HAZ of the root pass of the thermal sleeve attachment weld, see Figures 4-1, 4-4 and 4-6. The initial portion of the cracking followed a path parallel to the contour of the root pass fusion line. The cracks did not initiate exactly at the tip of the crevice where the highest stresses would be expected. This factor indicates that the weld metal is less susceptible than the base metal to the particular cracking mechanism.

In Section 1-1, crack initiation and early crack propagation occurred within the re-solution treated zones. The re-solution treated material adjacent to the crack path and the transition to the sensitized base metal structure are shown in Figures 4-2 and 4-3. In Section 4-4 the first portion of the crack path lies within the zone of material exhibiting the most pronounced sensitization (see Figure 4-4) while in Section 5-5 the crack path lies at the outer edge of the HAZ (Figures 4-6 and 4-7). These observations indicate that the degree of sensitization in the vicinity of the thermal sleeve attachment weld did not influence crack initiation or propagation.

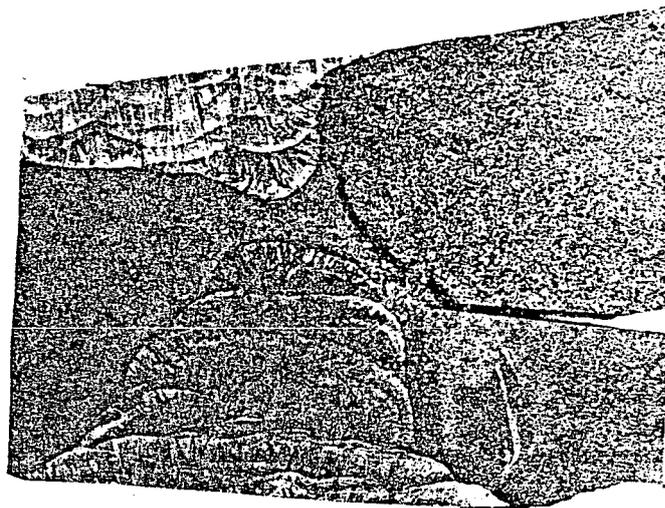
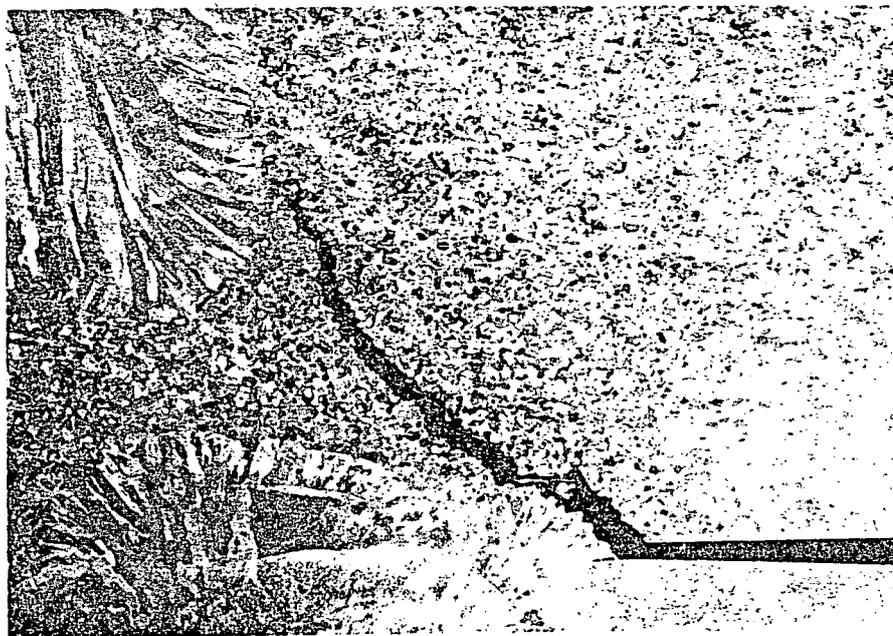
FIGURE 2-3. LONGITUDINAL SECTION AT THERMAL SLEEVE ATTACHMENT.
Section 4-4, Figure 1-4. Lapito's etch.

Micrographs at the tip of the crack in Section 4-4 where the crack approaches the repair weld are shown in Figure 4-5. At this location, crack propagation has continued within unaffected base metal in spite of the proximity of the more heavily sensitized HAZ.

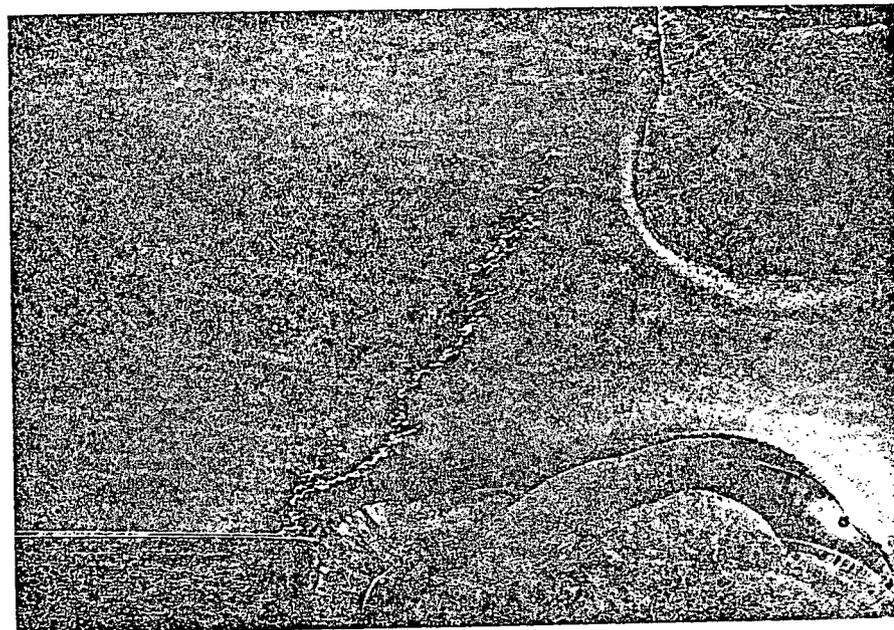
FIGURE 2-4. LONGITUDINAL SECTION AT THERMAL SLEEVE ATTACHMENT.
Section 5-5, Figure 1-4.

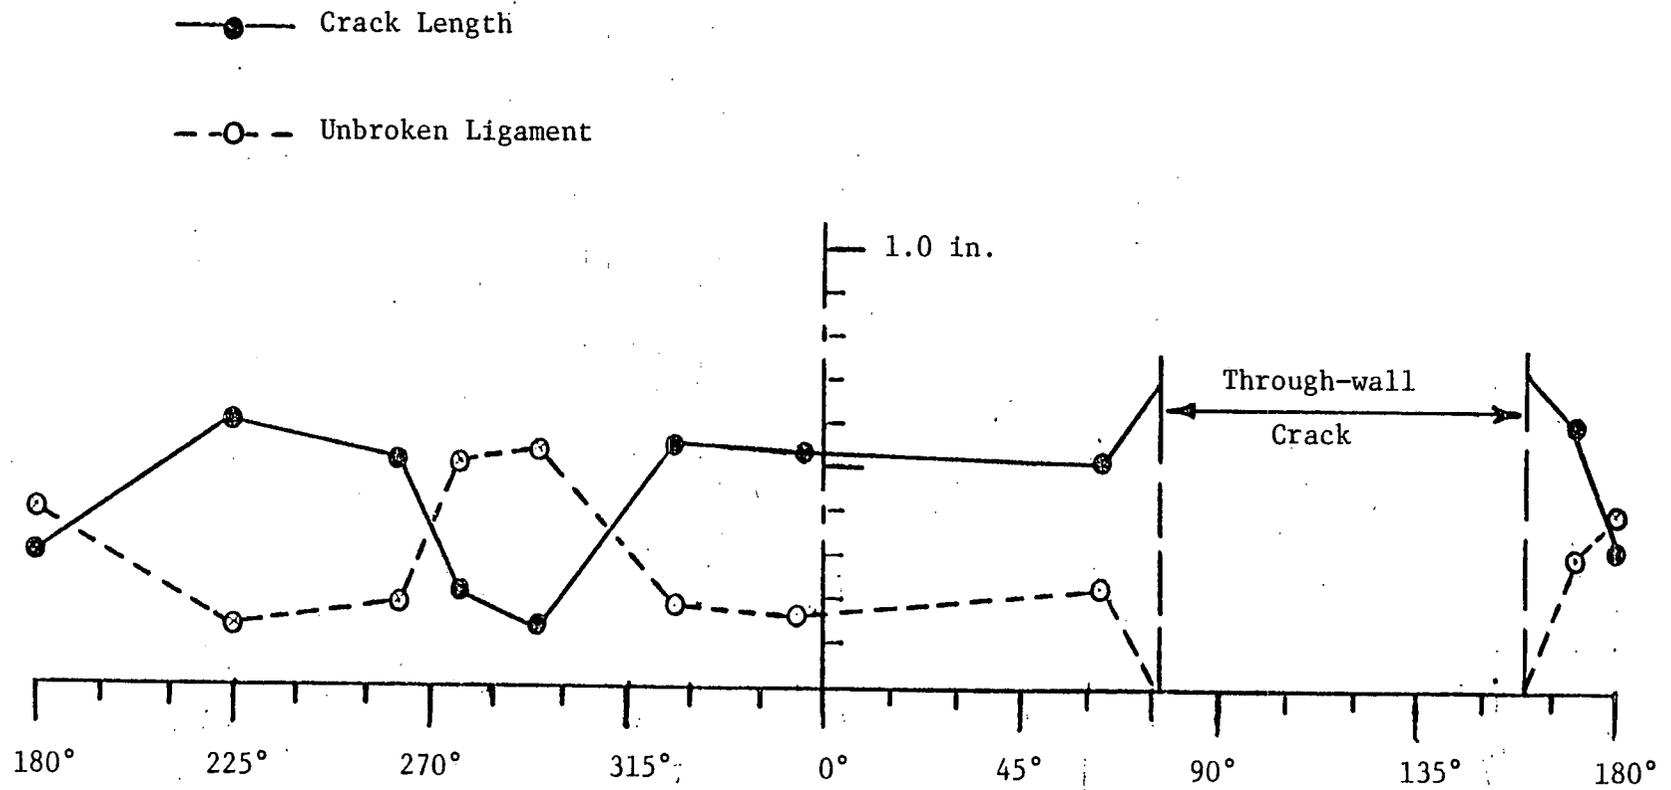
The crack length and remaining ligament (radial distance from the crack tip to the outside surface) were measured in all 11 sections. The results are plotted in Figure 2-5. Examination of sections 5-5, 8-8, 9-9, 10-10 and 11-11 verified the existence of major cracking in the zone from 270° to 330° . The radiographic inspection of this area did not reveal definite crack indications.

FIGURE 2-5. CRACK LENGTH AND UNBROKEN LIGAMENT VS ANGULAR POSITION

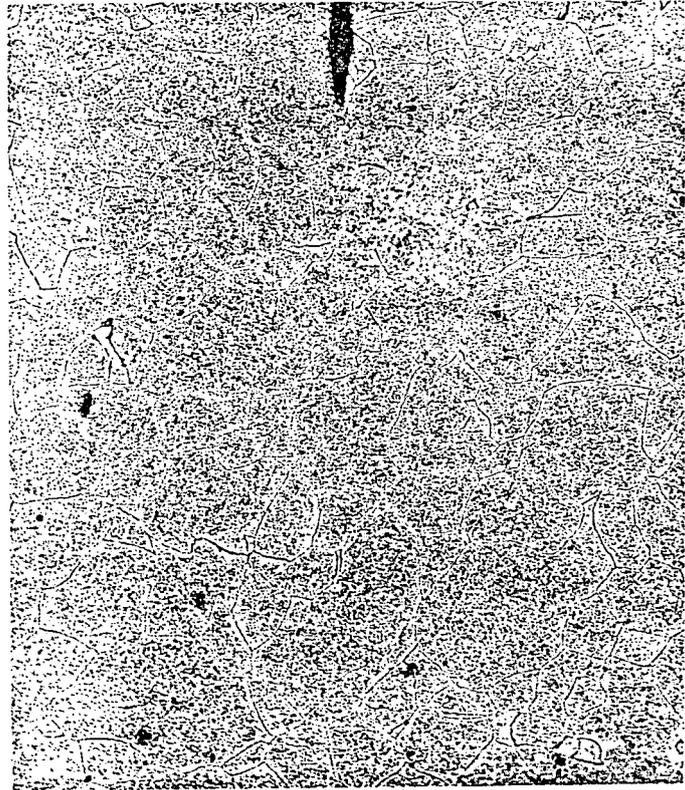
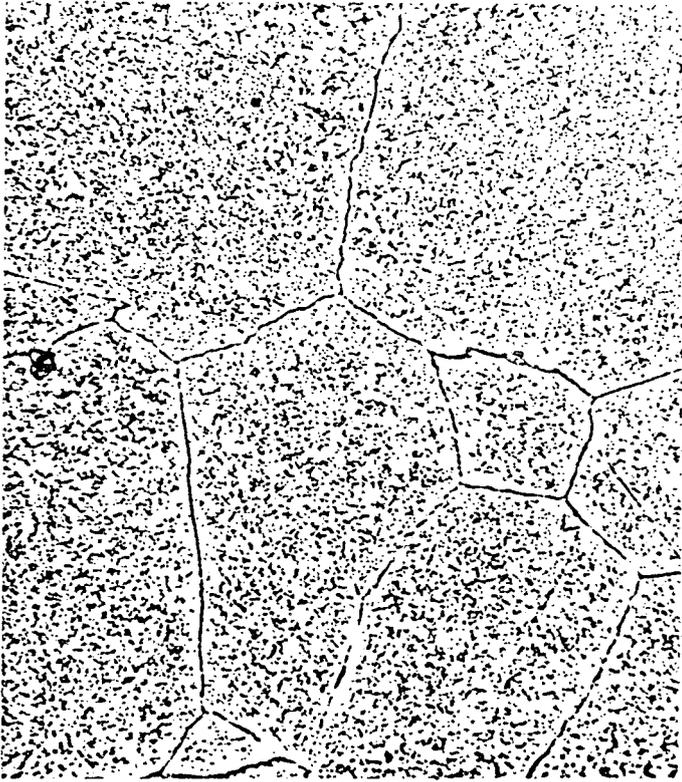
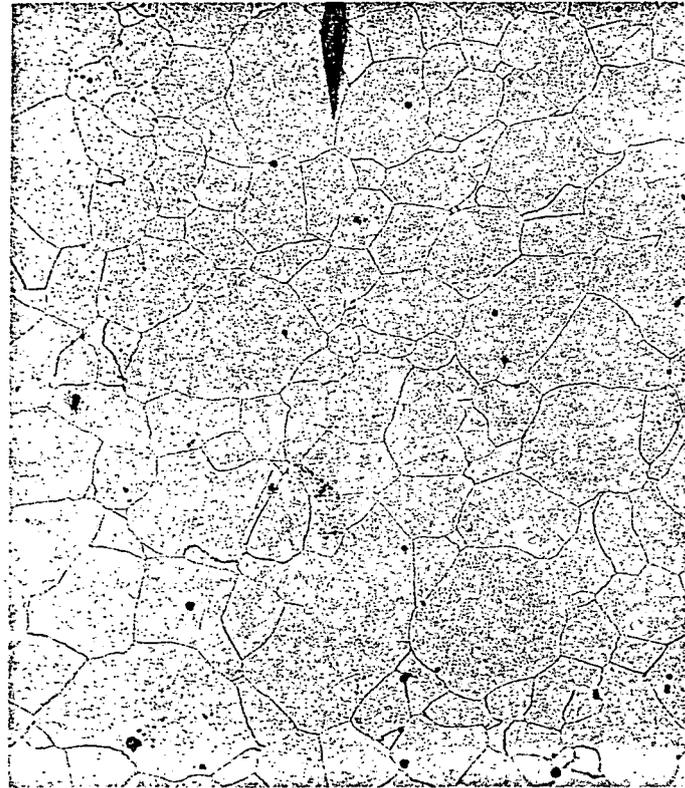
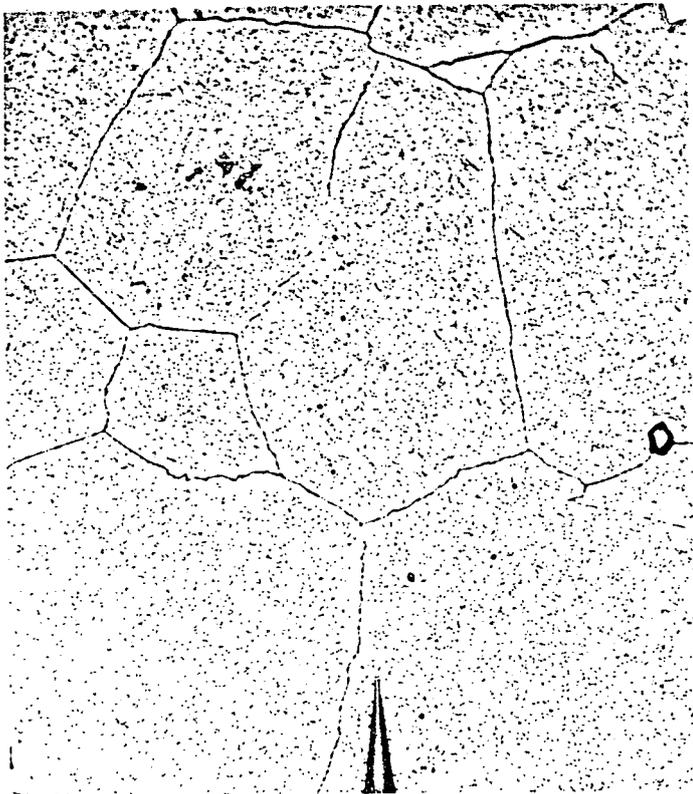
The safe-end material exhibits clearly delineated grain boundaries after the phosphoric etch, (See Figure 3-1). At some grain boundary locations, relatively large, discrete carbide particles are evident. Extensive matrix carbides are also resolved after the phosphoric acid etch. This

observed condition is consistent with the fact that the safe-end was subjected to two 1100^o-1175^oF stress relieving operations with a total time at temperature of approximately 16 hours.

FIGURE 3-1. MICROSTRUCTURE OF SAFE-END.
Location 1, Figure 3-3.

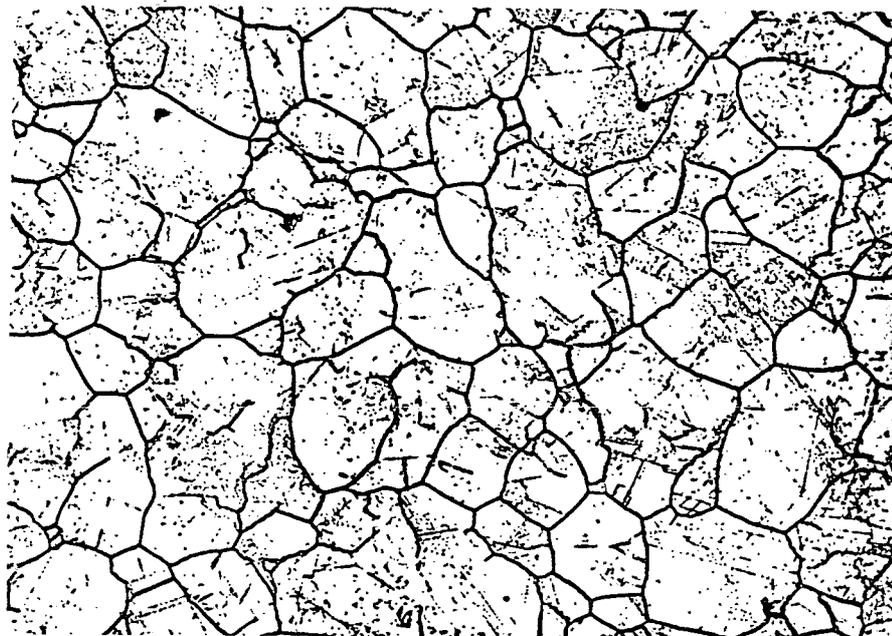
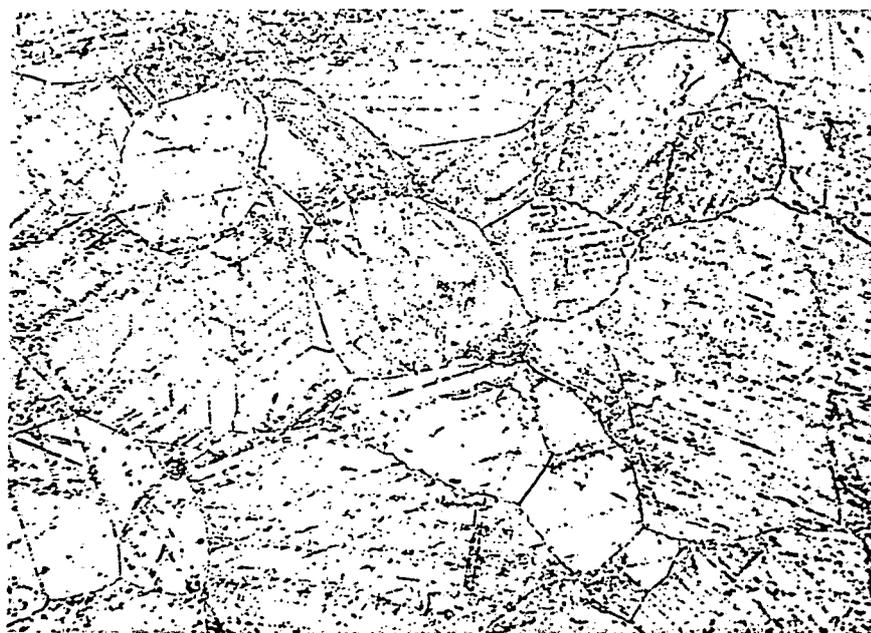
The microstructure of the thermal sleeve is shown in Figure 3-2. It is evident from the features shown in these micrographs that the thermal sleeve is sensitized (carbides precipitated at grain boundaries). Apparently the material was furnished in the sensitized condition since no stress relief treatments were performed after installation of the thermal sleeve.

FIGURE 3-2. MICROSTRUCTURE OF THERMAL SLEEVE.
Location 2, Figure 3-3.

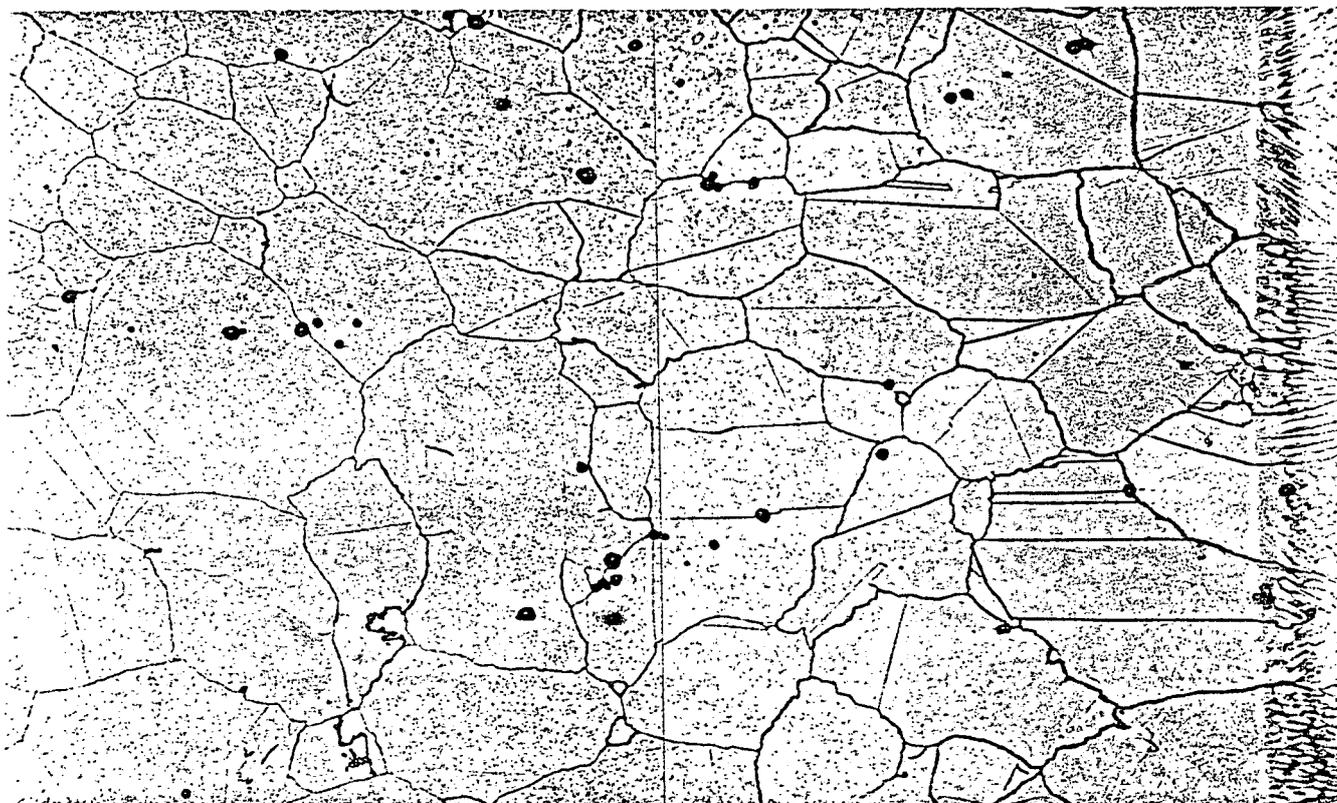
Micrographs illustrating the microstructure of the heat-affected-zones (HAZ) associated with the repair weld are shown in Figures 3-4 and 3-5. In each case, a zone of more pronounced grain boundary sensitization is apparent immediately adjacent to the fusion line. This feature is normal for the fabrication sequence employed, since sensitization in the HAZ is inherent in any welding of Inconel 600 and subsequent stress relieving would serve to enhance any earlier sensitization. The microstructure at locations 0.003 in. from the fusion line and beyond is comparable to that observed at locations remote from the weld [compare Figures 3-1(b) and 304]. The microstructural features within the HAZ are consistent with normal welding procedures and techniques.

FIGURE 3-4. MICROSTRUCTURE OF HAZ AT REPAIR WELD.
Location 3, Figure 3-3.
Etchant: 10% Nital, electrolytic. 200X

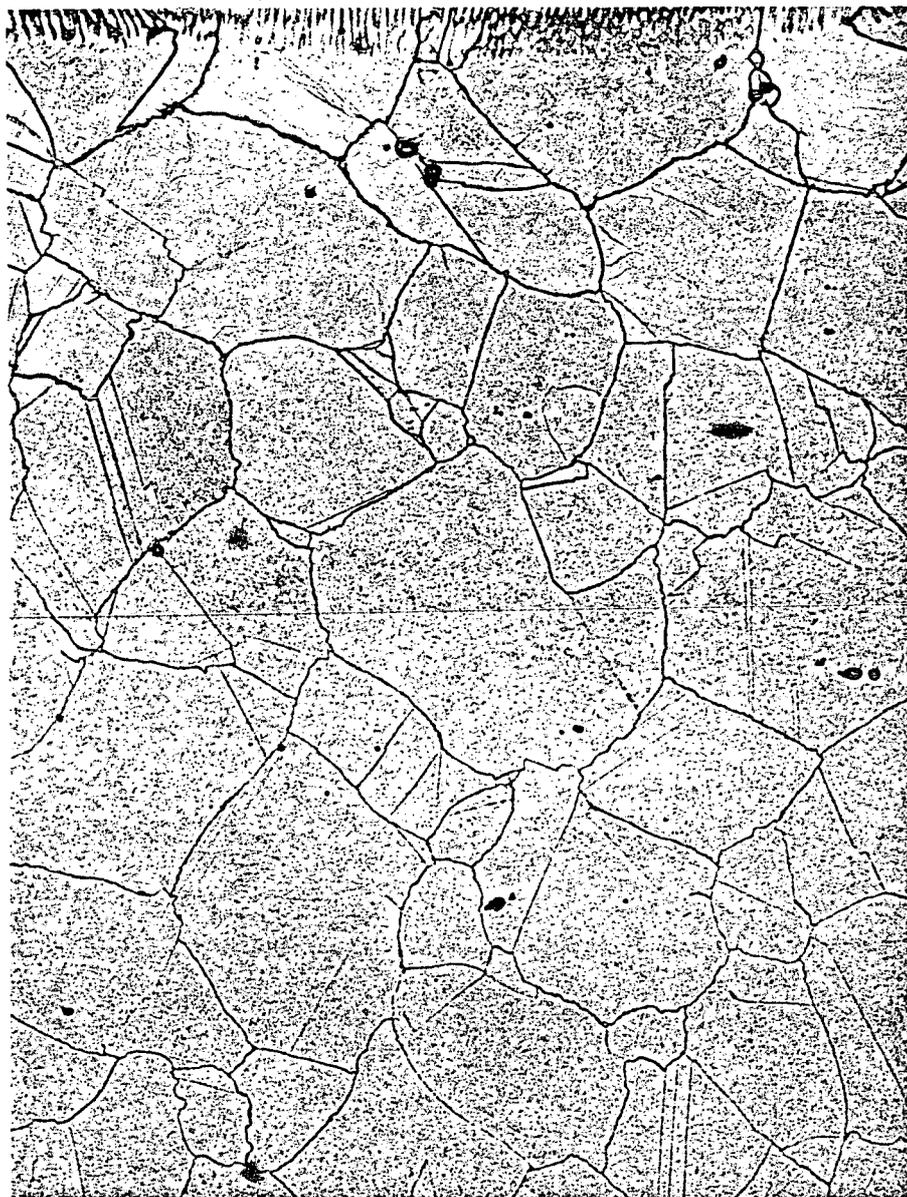
FIGURE 3-5. MICROSTRUCTURE OF HAZ AT REPAIR WELD.
Location 4, Figure 3-3.
Etchant: 10% Nital, electrolytic. 200X

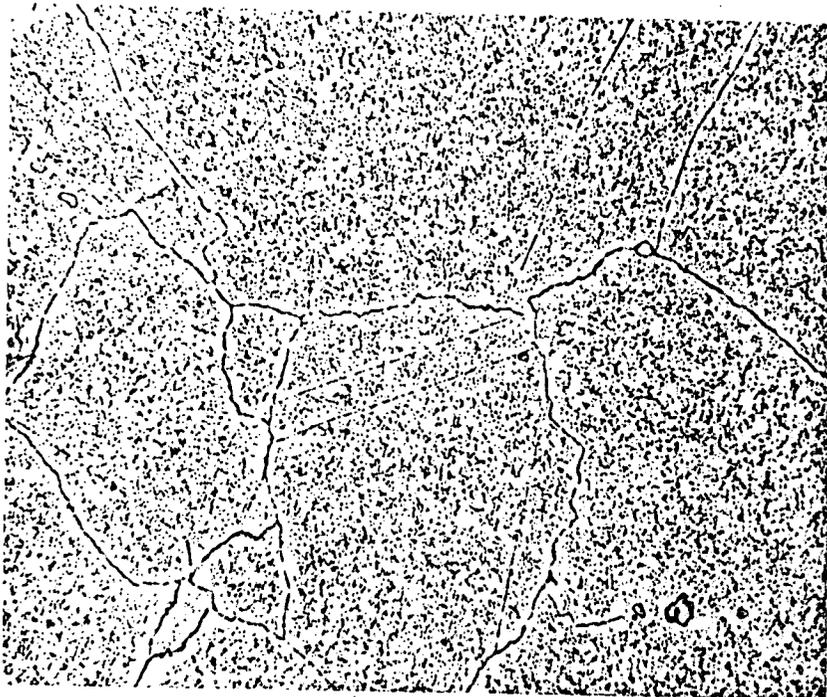
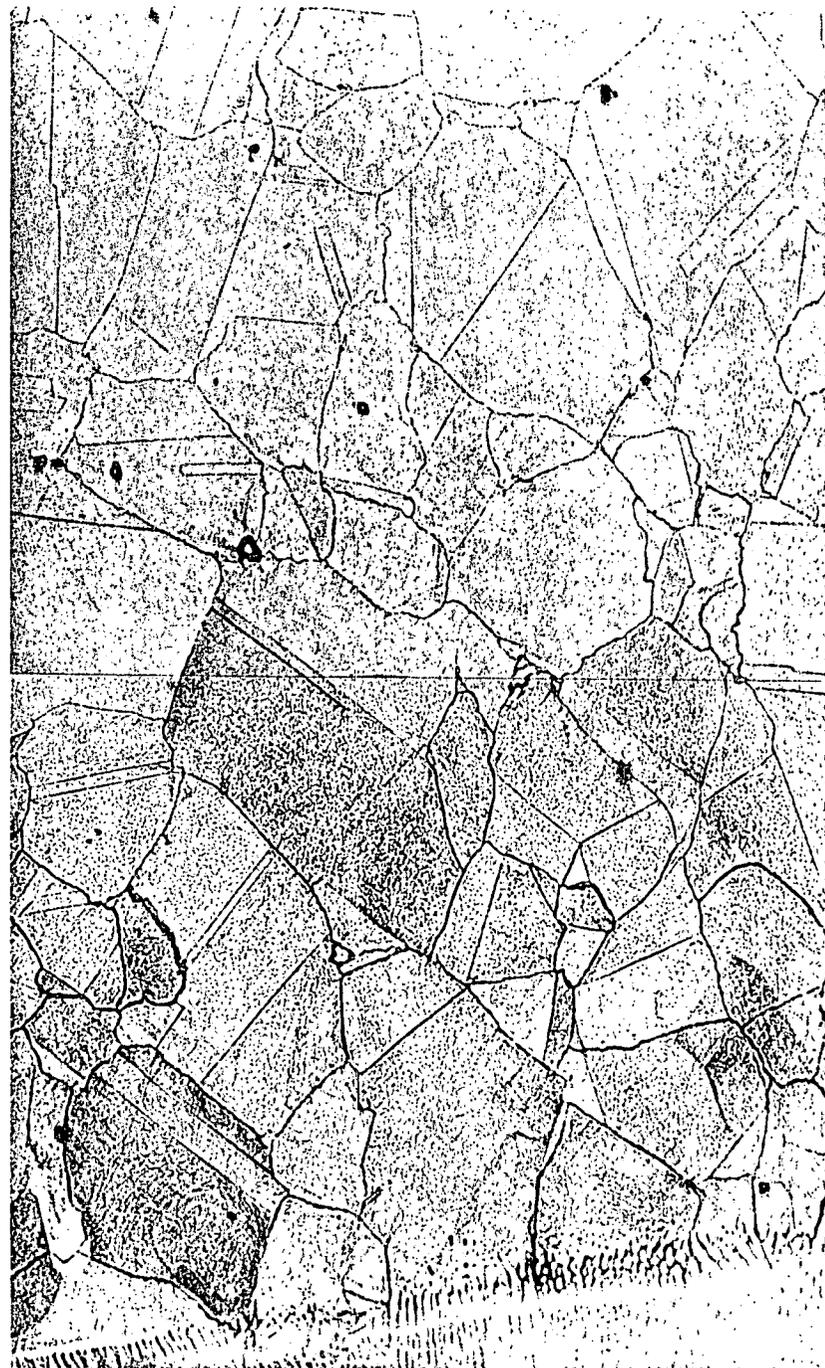
The microstructure midway along the line of closest approach of the repair weld and the thermal sleeve attachment weld is shown in Figure 306(a). This structure is comparable to that at remote locations [compare with Figure 301(b)] indicating that the repair welding operation did not alter the microstructure in the vicinity of the thermal sleeve attachment.

The HAZ at the thermal sleeve attachment weld is shown in Figure 3-6(b). The microstructural features are similar to those of the repair weld HAZ and are normal for this situation. This zone was not involved in the cracking but the normal microstructure serves to indicate normal welding practice.

FIGURE 3-6. MICROSTRUCTURE OF HAZ AND BASE METAL
AT THERMAL SLEEVE ATTACHMENT WELD.
See Figure 3-3 for locations.

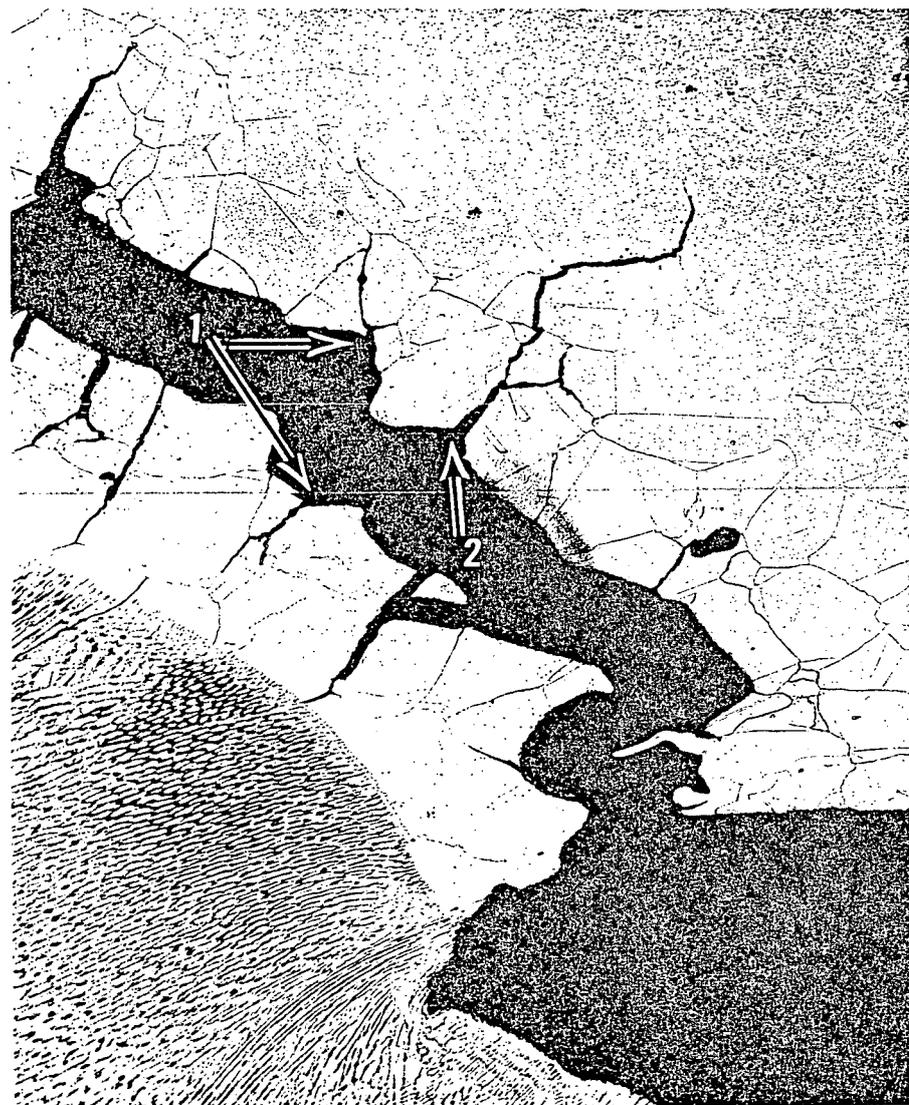
FIGURE 4-1. MICROSTRUCTURE AT TIP OF CREVICE. Section 1-1,
Figure 1-4, Etchant: 8:1 Phosphoric acid. 100X

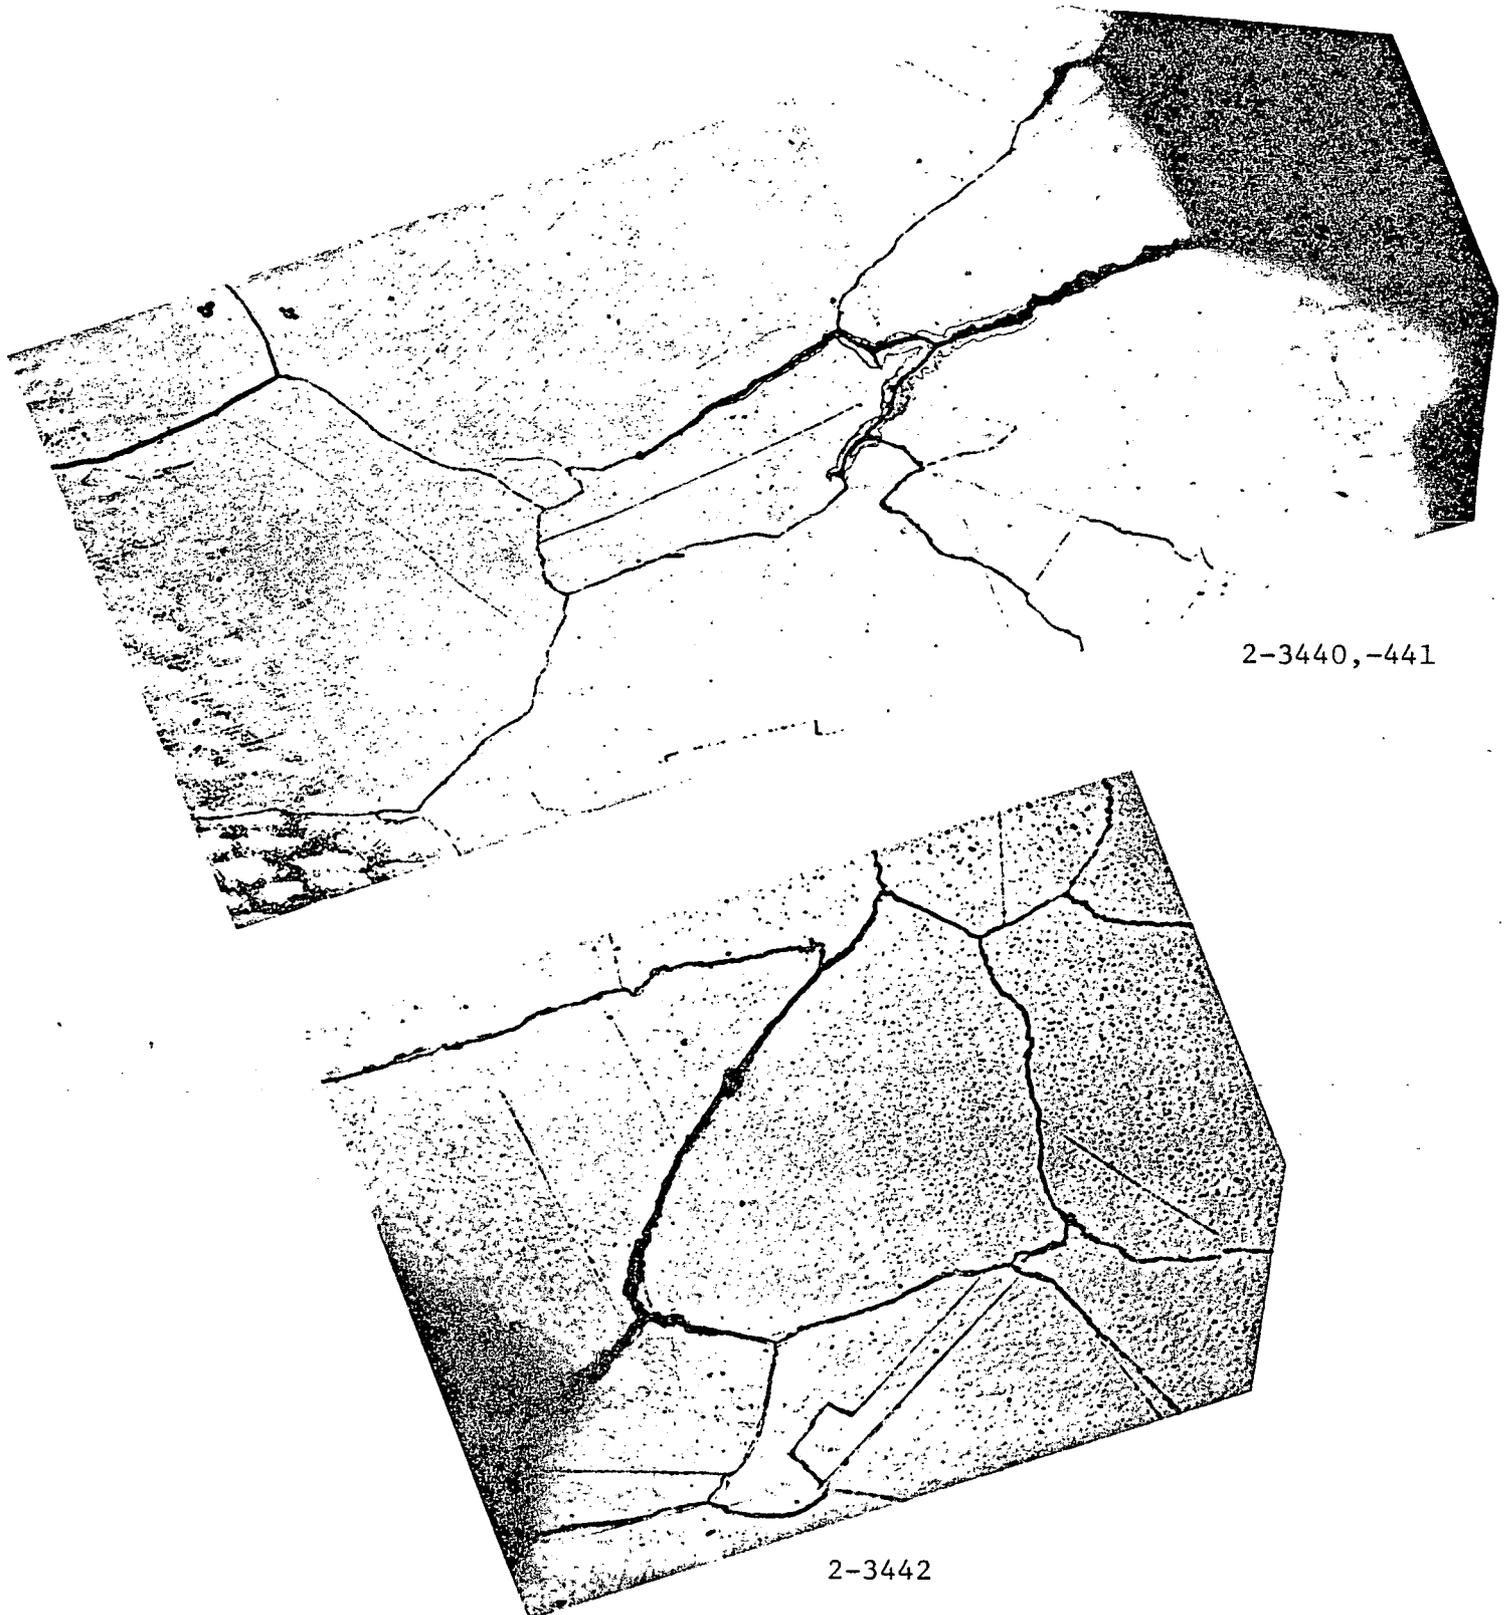
FIGURE 4-2. MICROSTRUCTURE AT POINTS ON OPPOSITE SIDES OF CRACK. Section 1-1, Location 1, Figure 4-1. Etchant: 8:1 Phosphoric acid. 500X

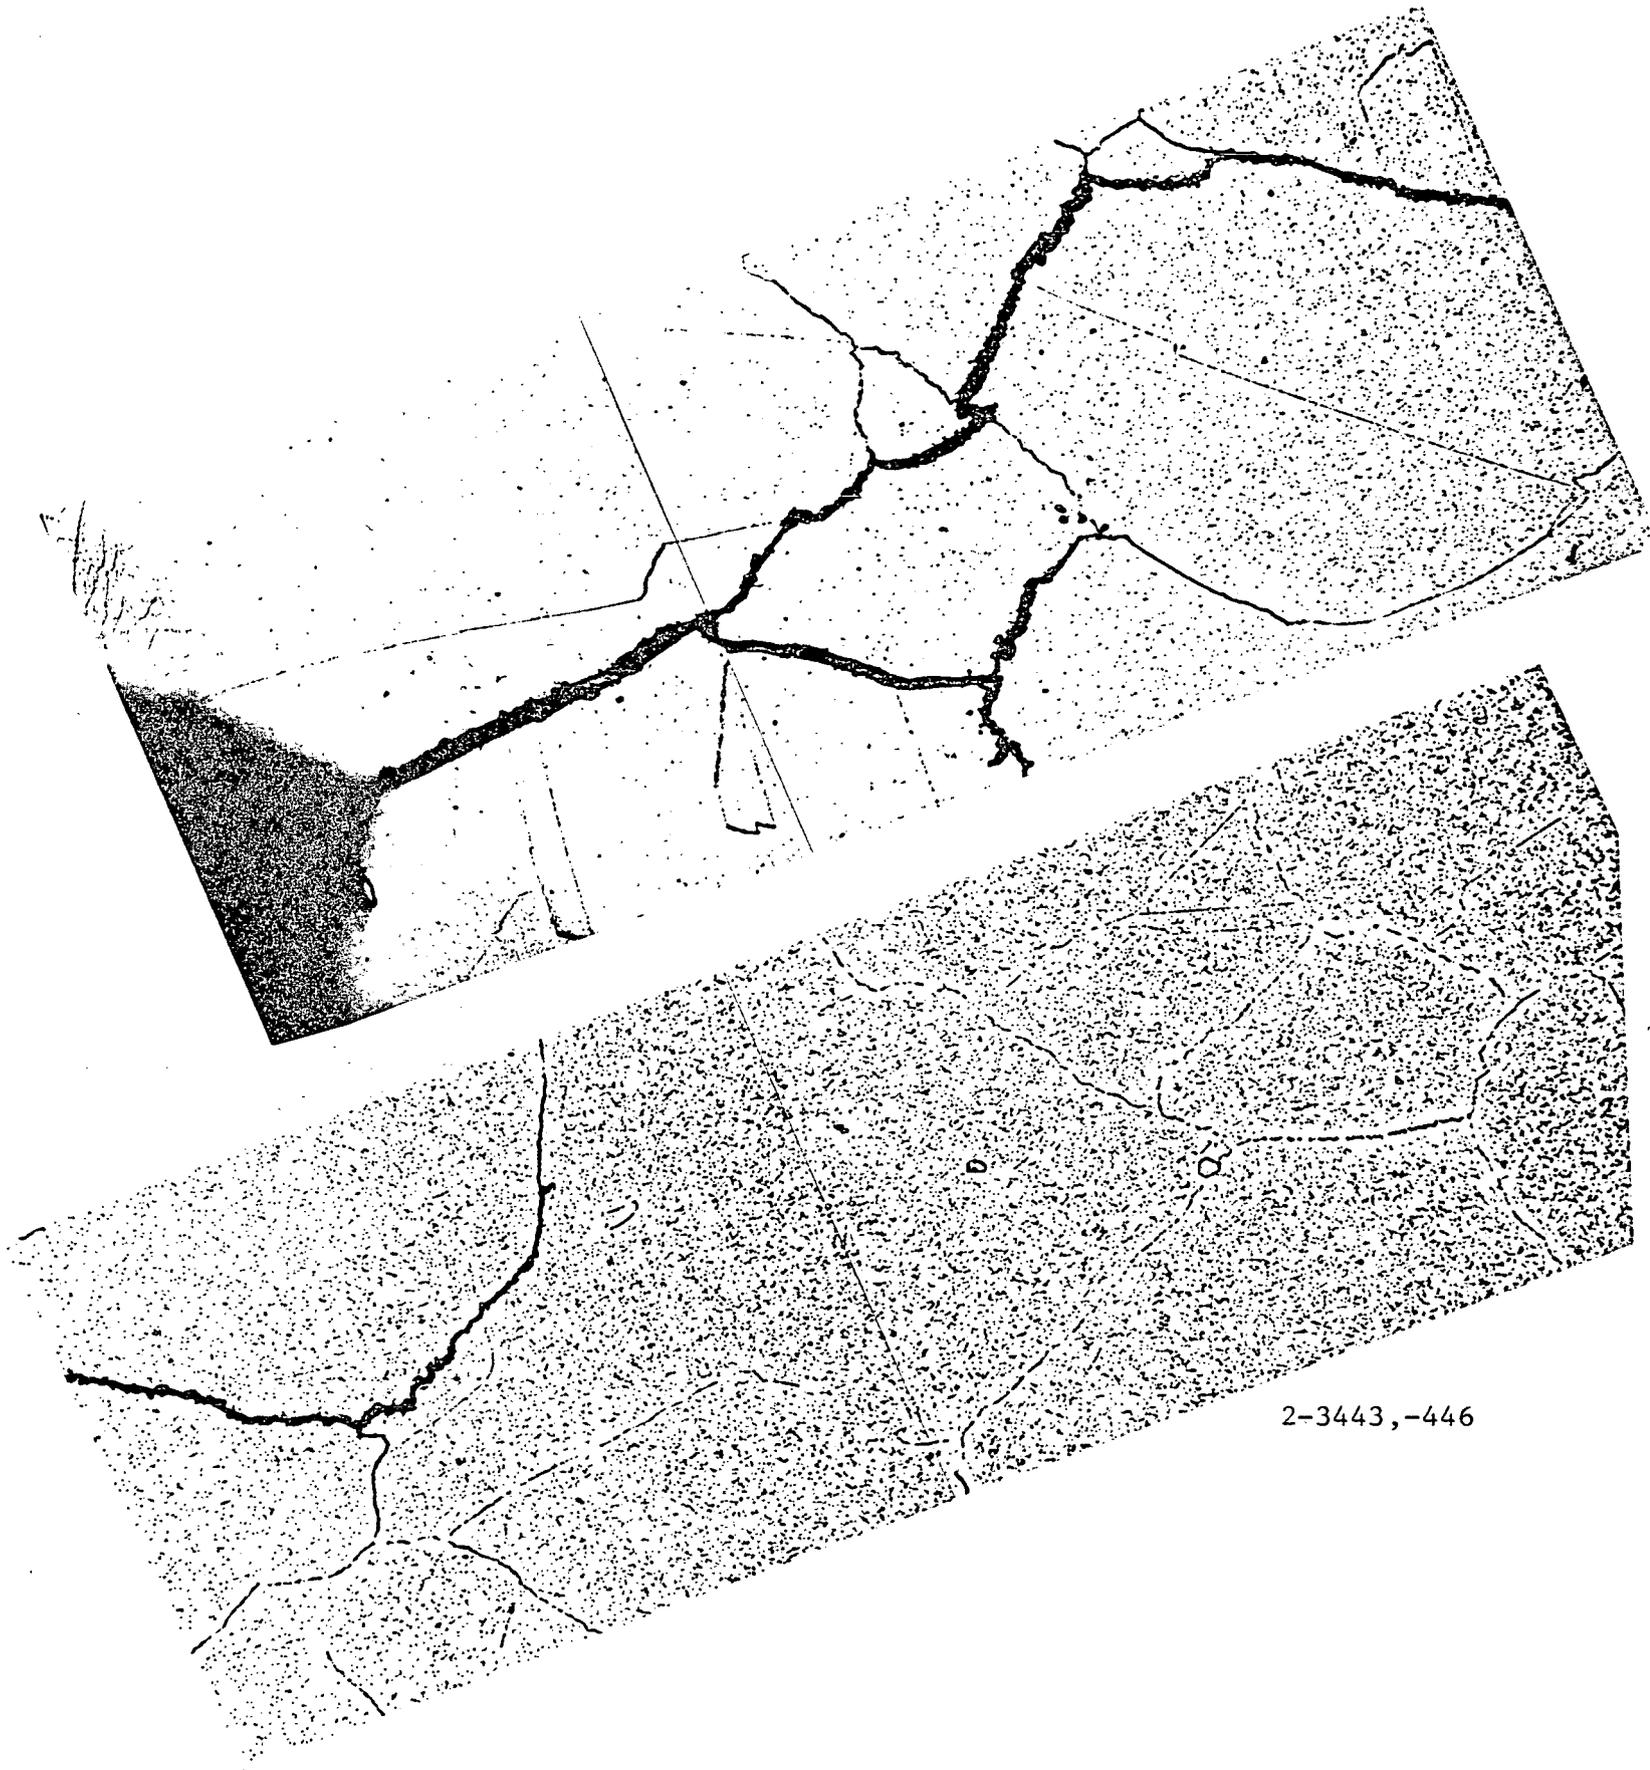
FIGURE 4-3. MICROSTRUCTURE AT MAIN CRACK. Section 1-1, Location 2, Figure 4-1. Arrows indicate match points. Etchant: 8:1 Phosphoric acid. 500X

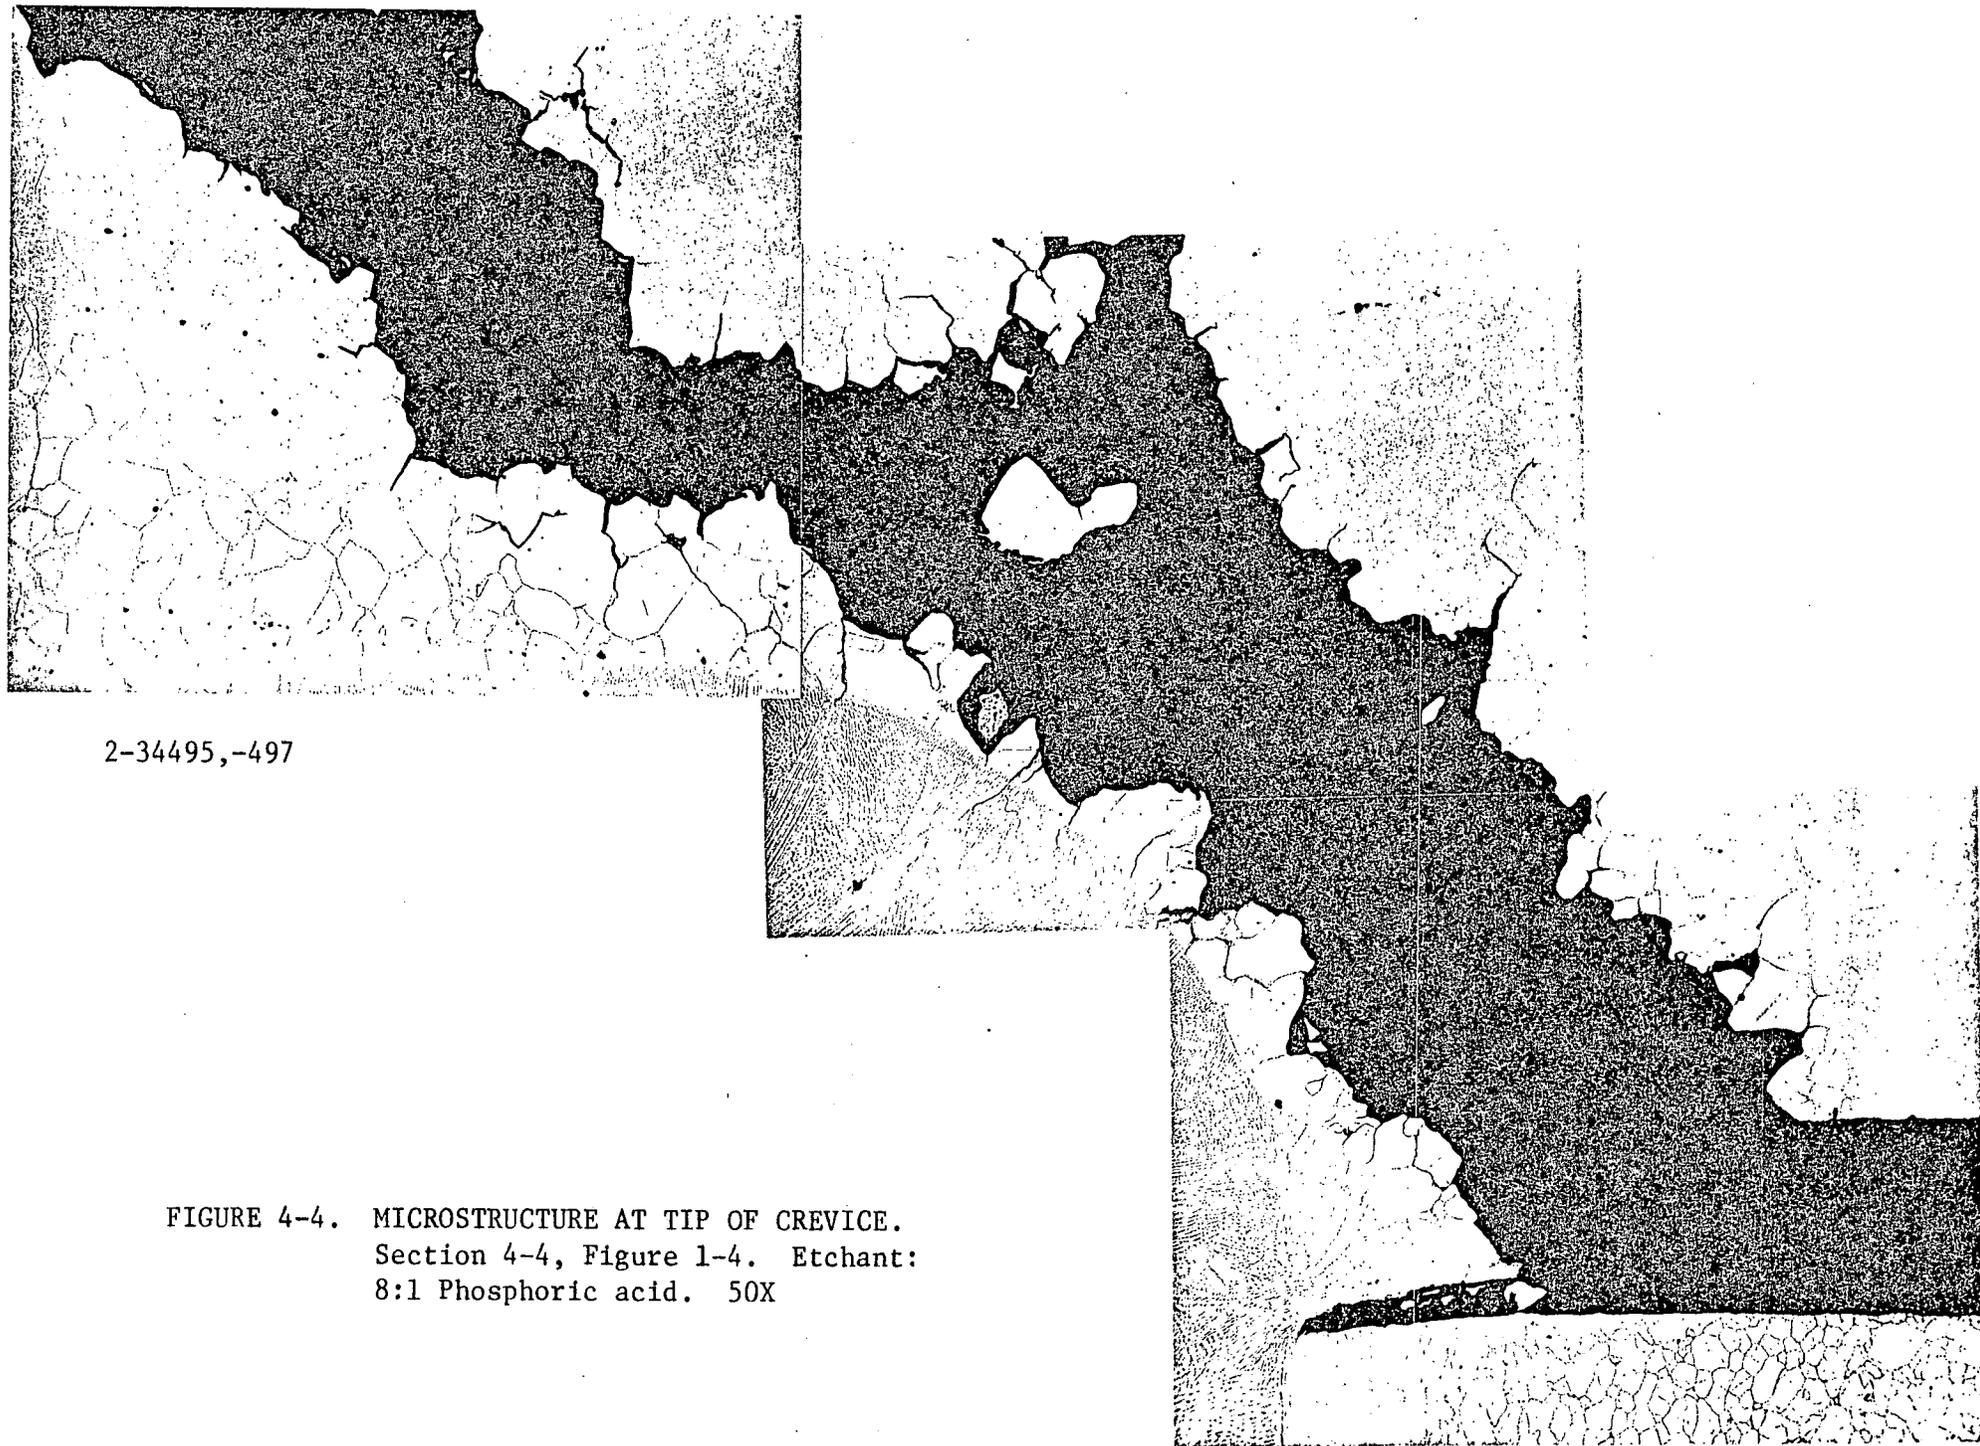
FIGURE 4-4. MICROSTRUCTURE AT TIP OF CREVICE.
Section 4-4, Figure 1-4. Etchant:
8:1 Phosphoric acid. 50X
