METALLURGICAL INVESTIGATION OF
CRACKING IN A REACTOR VESSEL NOZZLE SAFE-END

SWRI PROJECT 02-5389-001

INTERIM REPORT

Iowa Electric Power
Cedar Rapids

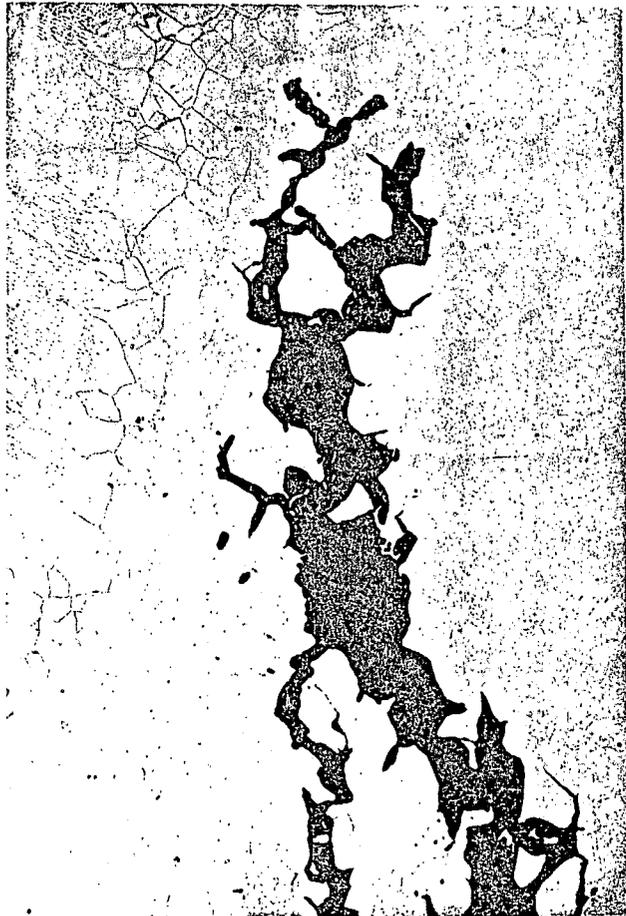
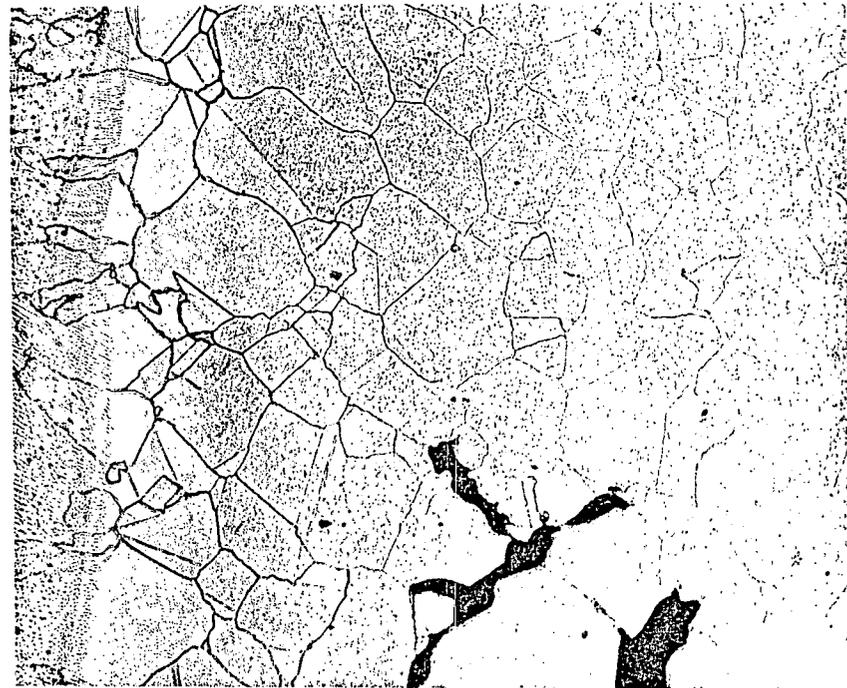
Micrographs at the tip of the crack in Section 4-4 where the crack approaches the repair weld are shown in Figure 4-5. At this location, crack propagation has continued within unaffected base metal in spite of the proximity of the more heavily sensitized HAZ.

FIGURE 4-5. MICROSTRUCTURE AT CRACK TIP. Section 4-4.
See Figures 2-3 and 4-4. Etchant: 8:1
Phosphoric acid.

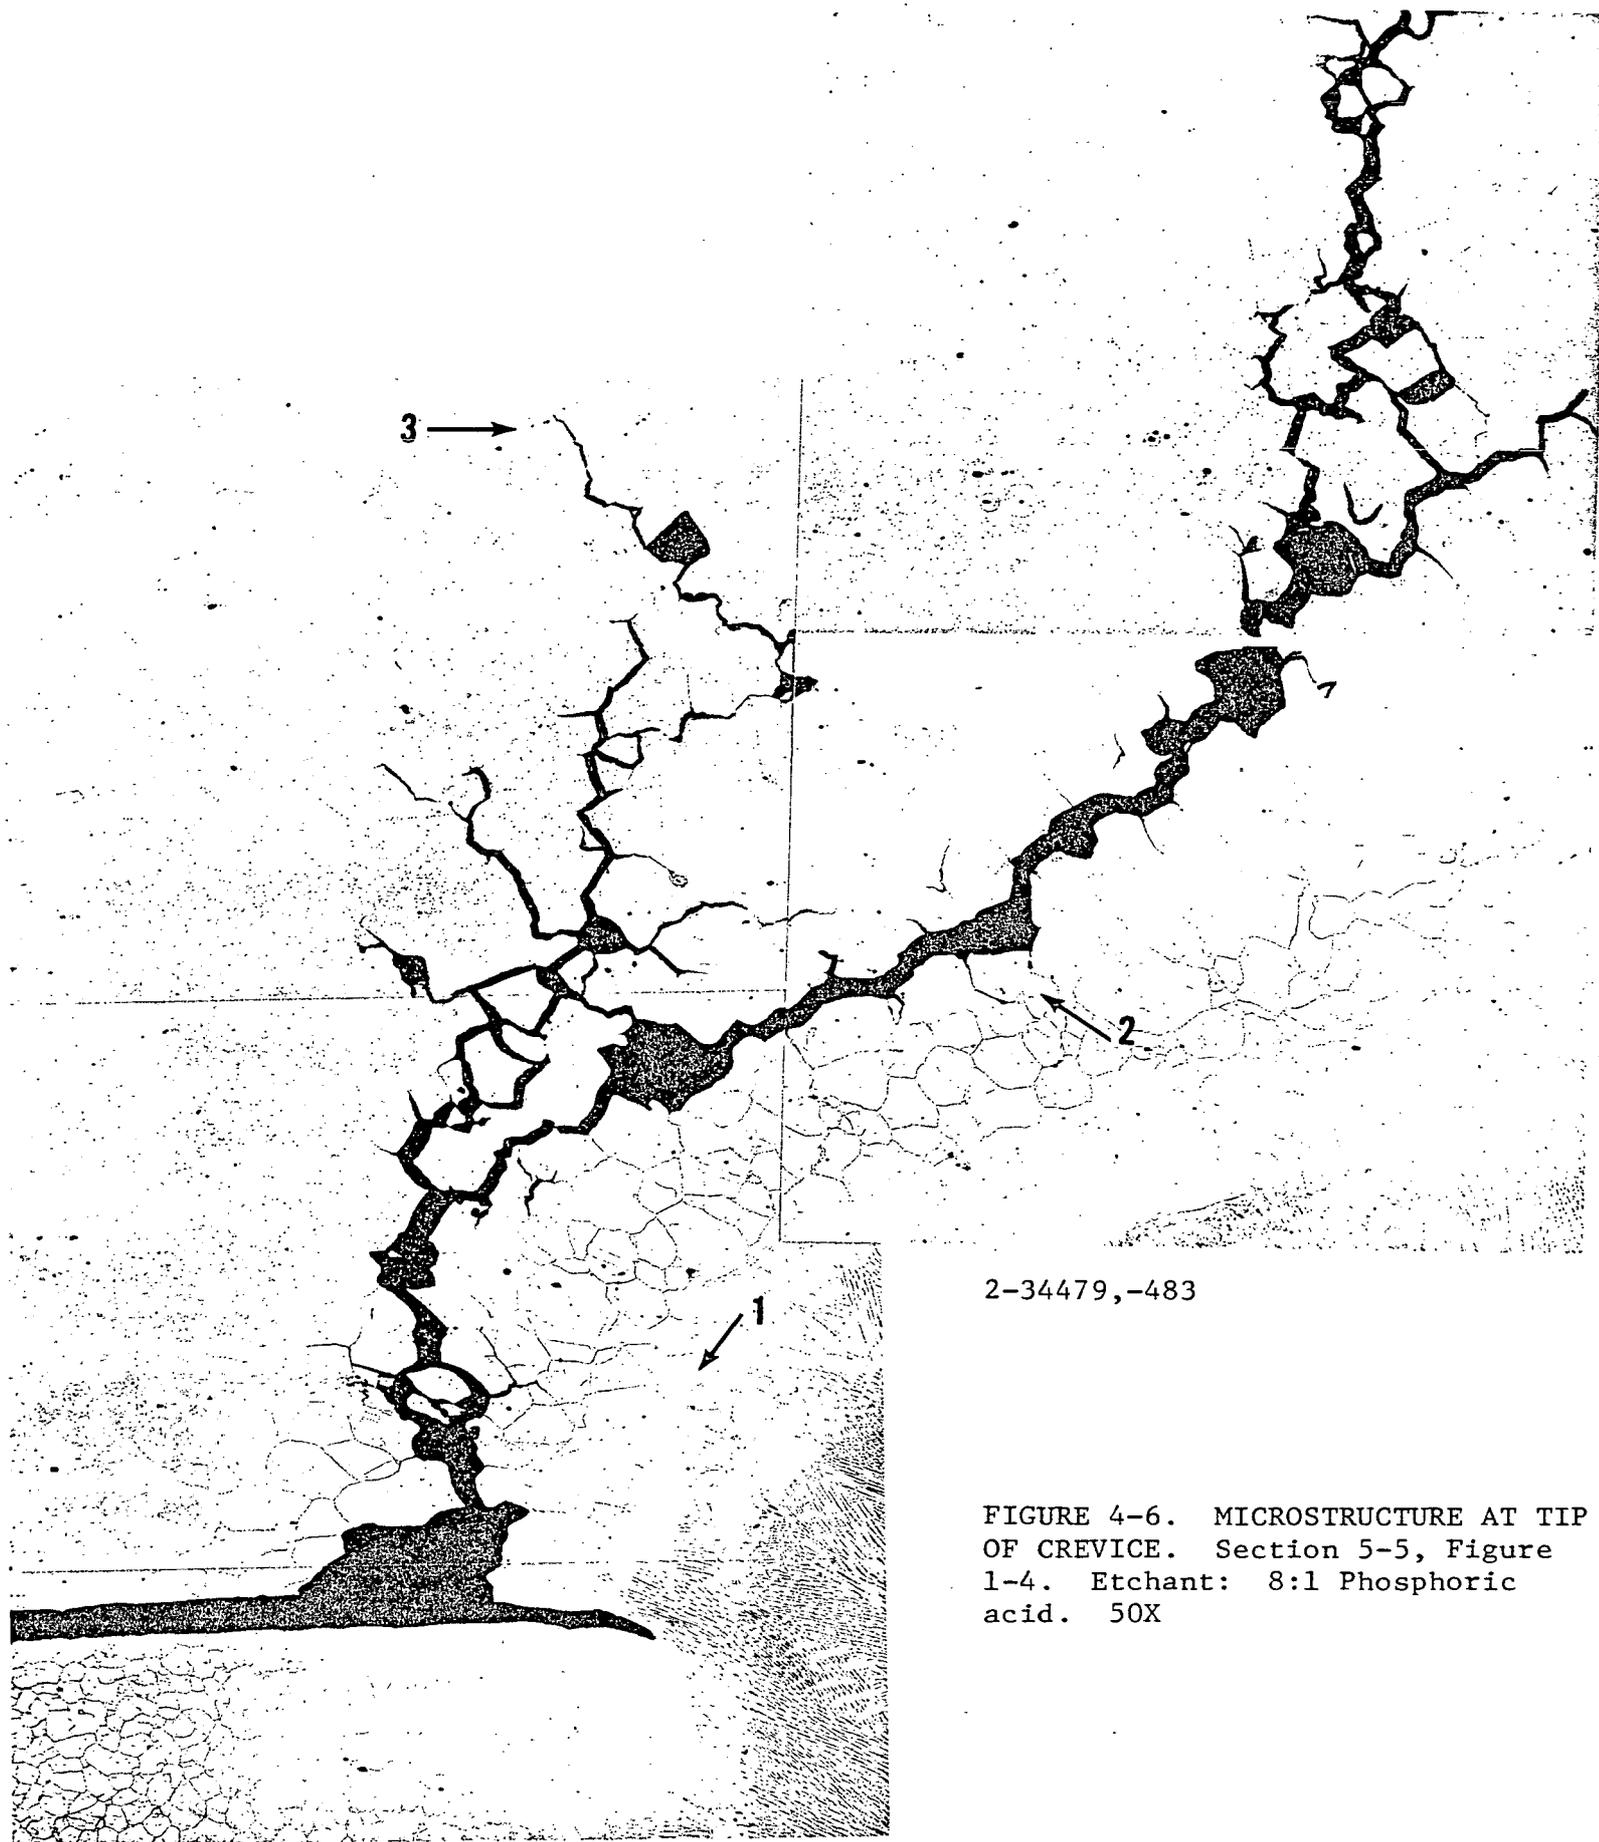
In each section the crack path was observed to be completely intergranular and crack initiation occurred within the HAZ of the root pass of the thermal sleeve attachment weld, see Figures 4-1, 4-4 and 4-6. The initial portion of the cracking followed a path parallel to the contour of the root pass fusion line. The cracks did not initiate exactly at the tip of the crevice where the highest stresses would be expected. This factor indicates that the weld metal is less susceptible than the base metal to the particular cracking mechanism.

FIGURE 4-6. MICROSTRUCTURE AT TIP OF CREVICE. Section 5-5, Figure 1-4. Etchant: 8:1 Phosphoric acid. 50X

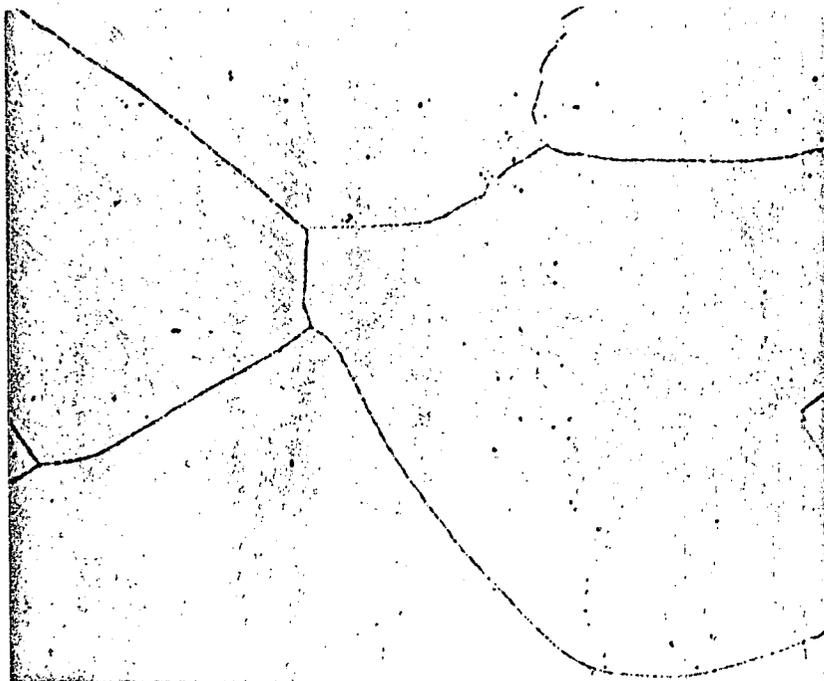
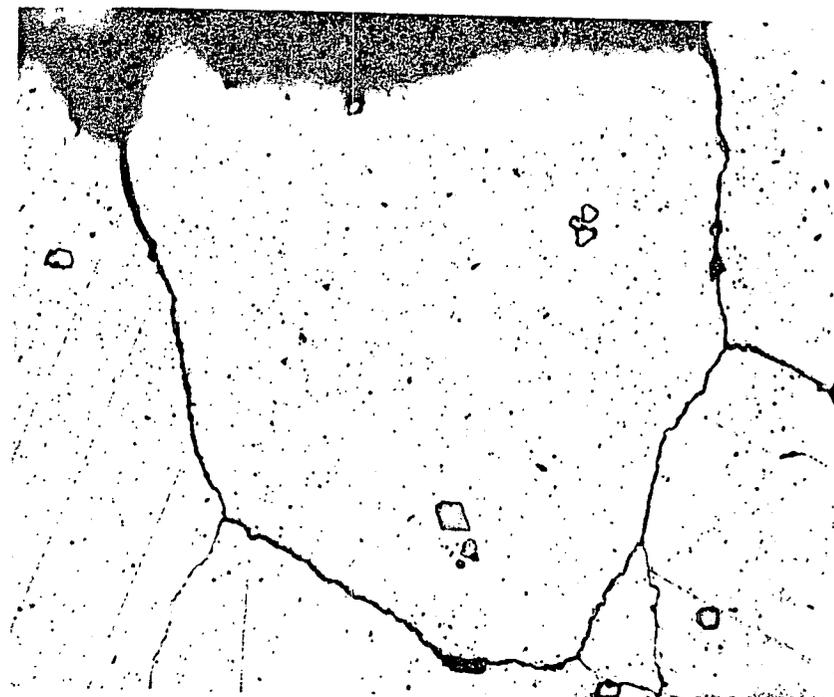
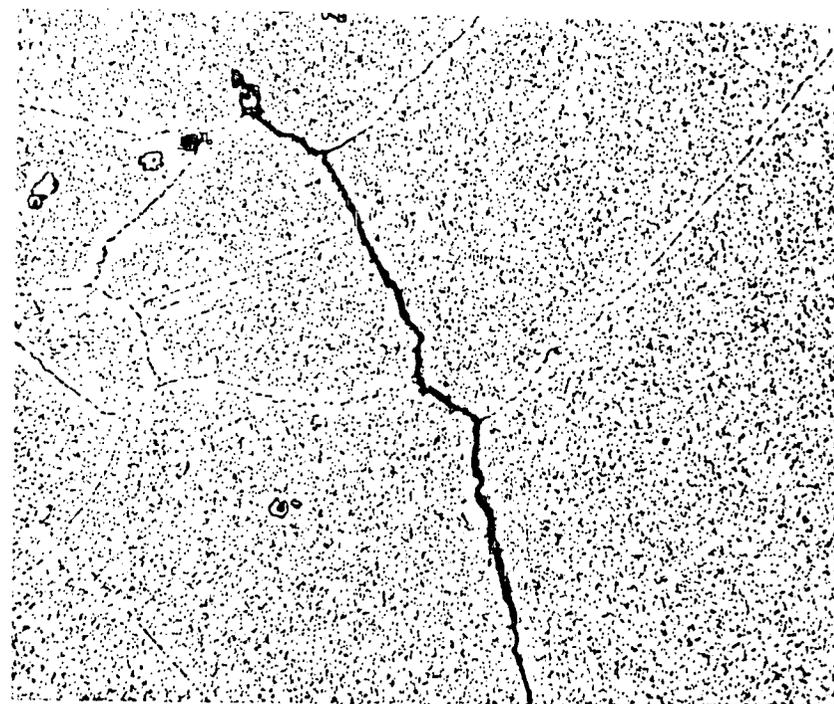
FIGURE 4-7. MICROSTRUCTURE IN VICINITY OF MAIN CRACK. Section 5-5, See Figure 4-6 for locations. Etchant: 8:1 Phosphoric acid. 500X

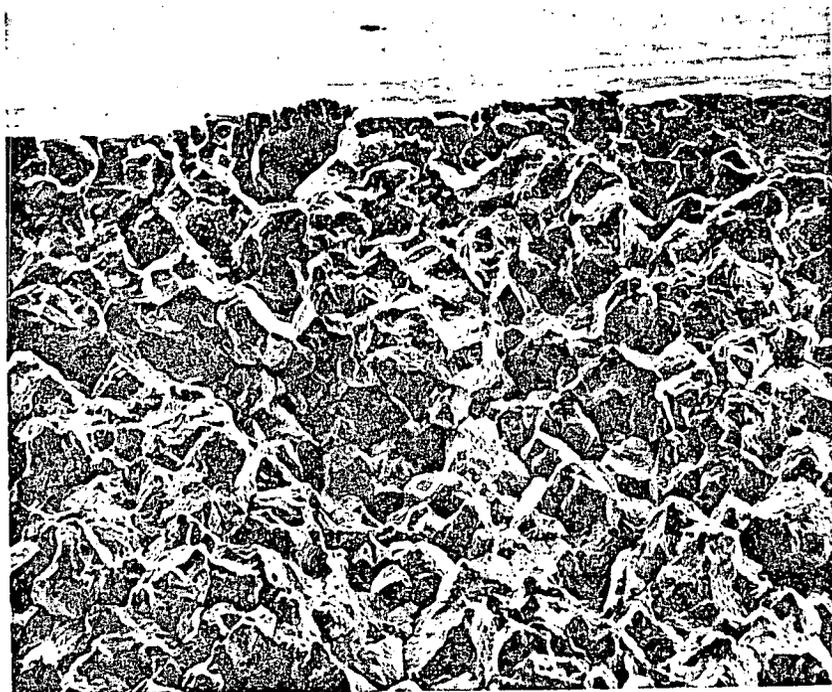
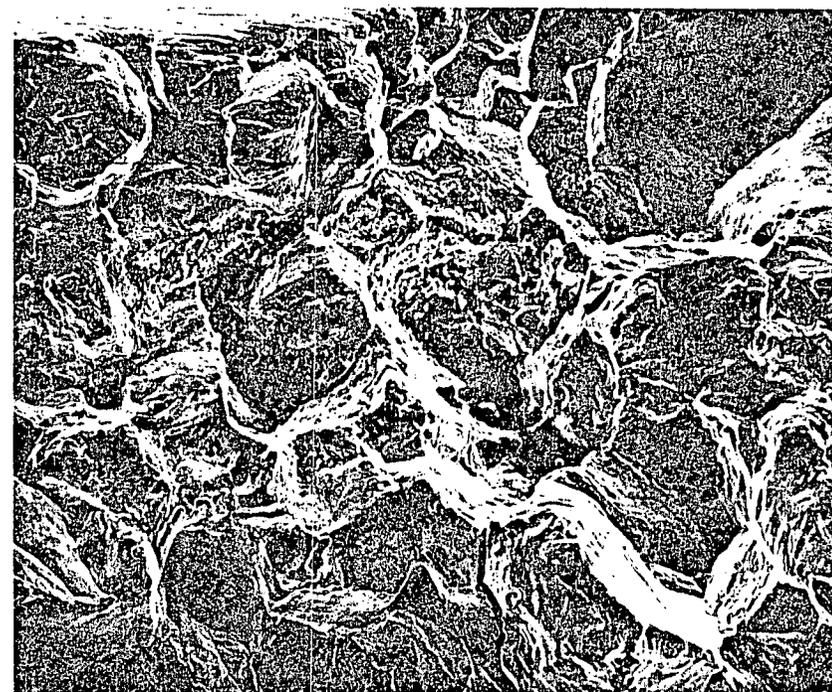
The fracture surface exhibited completely intergranular features at all locations examined. The intergranular nature of the fracture is evident in the lower magnification fractographs of Figures 4-9, 4-10 and 4-11. No evidence of any form of step-wise crack propagation was evident.

FIGURE 4-9. SEM FRACTOGRAPHS FROM CRACK SURFACE.
Specimen No. 1, Location 1, Figure 4-8.

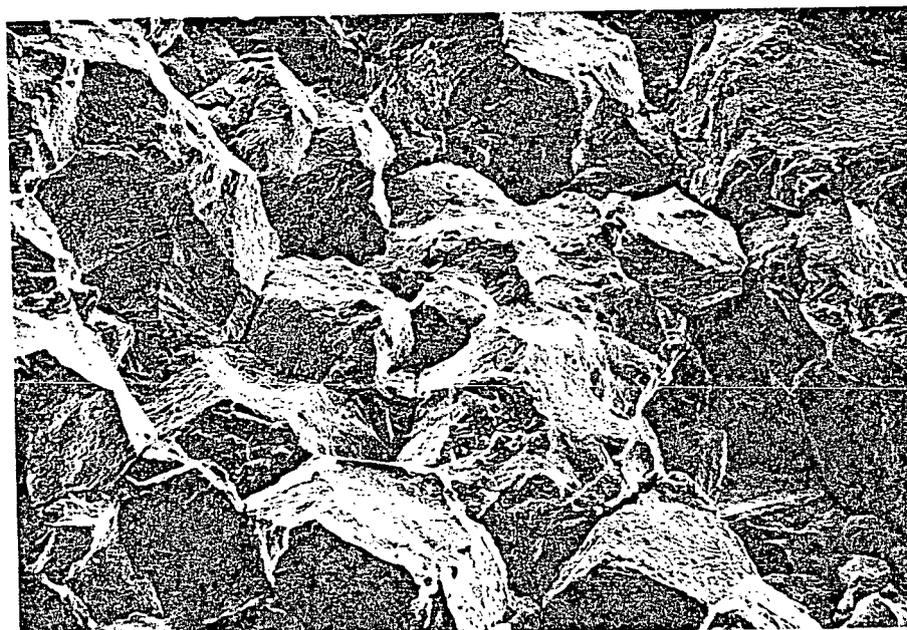
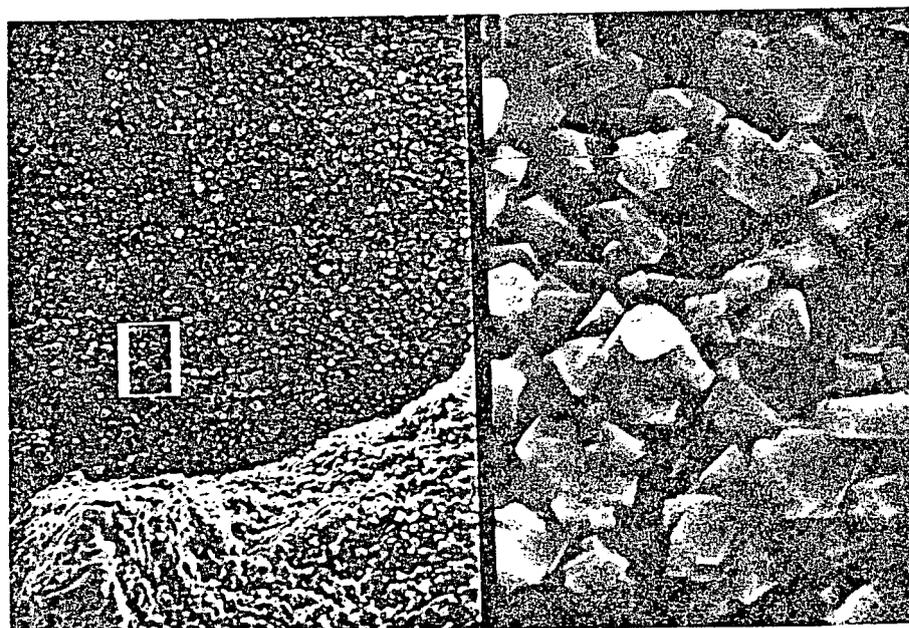
FIGURE 4-10. SEM FRACTOGRAPHS FROM CRACK SURFACE.
Specimen No. 1, Location 2, Figure 4-8.

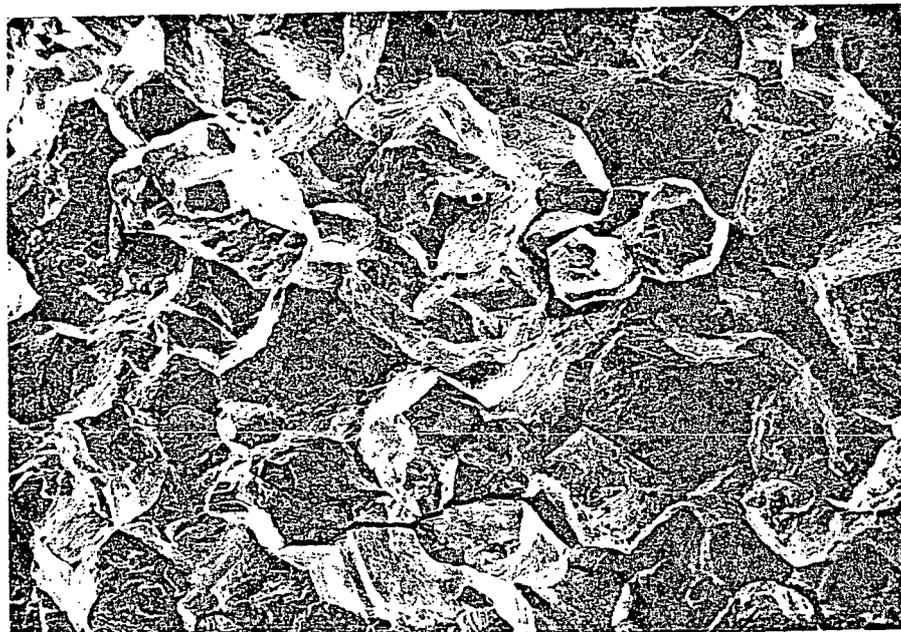
FIGURE 4-11. SEM FRACTOGRAPHS FROM CRACK SURFACE.
Specimen No. 1, Location 3, Figure 4-8.

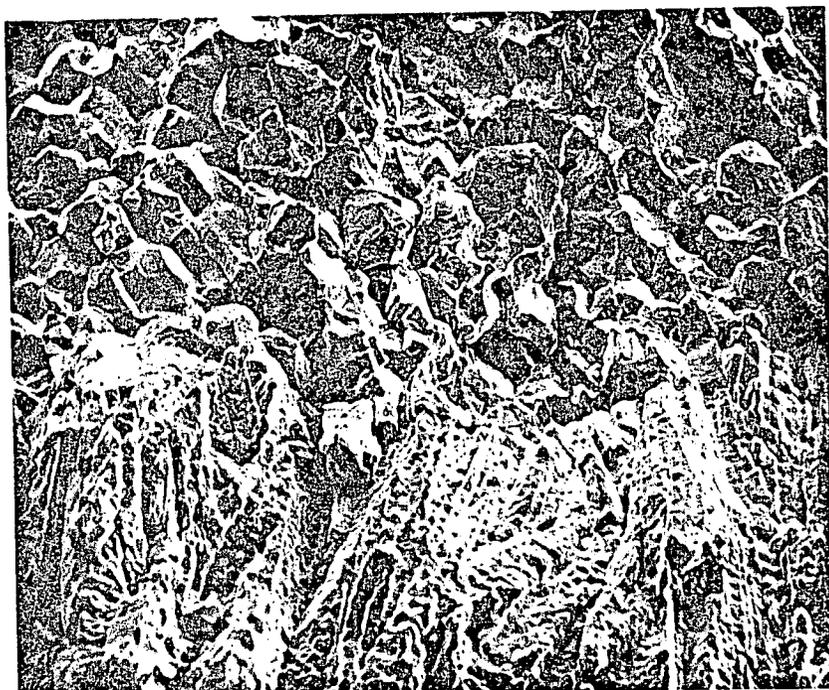
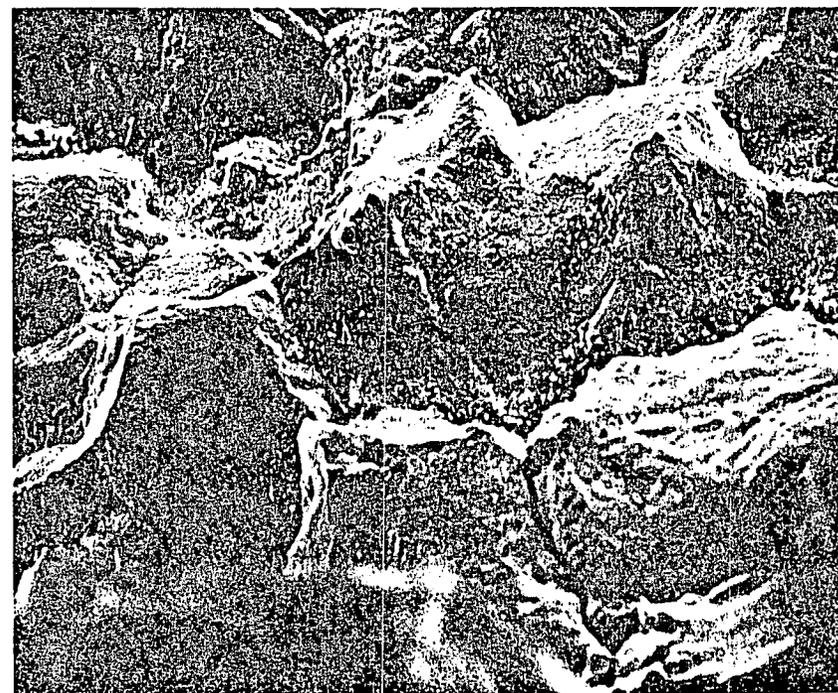
Some differences in the details of the intergranular facets were noted at various locations on the specimen. These differences are attributed to the surface condition and/or the presence of adherent deposits. At locations near the crack origin, individual facets exhibited fine-scale rounded features and surface deposits were not readily apparent, see Figure 4-9. Distinctly crystalline surface deposits were observed at locations a short distance from the inside edge as shown in Figure 4-10. At locations near the transition to weld metal fracture, other forms of surface deposit were noted as shown in Figures 4-11 and 4-12. In these cases, the deposit is clearly different from the crystalline deposits observed closer to the inside edge.

FIGURE 4-12. SEM FRACTOGRAPHS FROM CRACK SURFACE.
Specimen No. 1, Location 4, Figure 4-8.

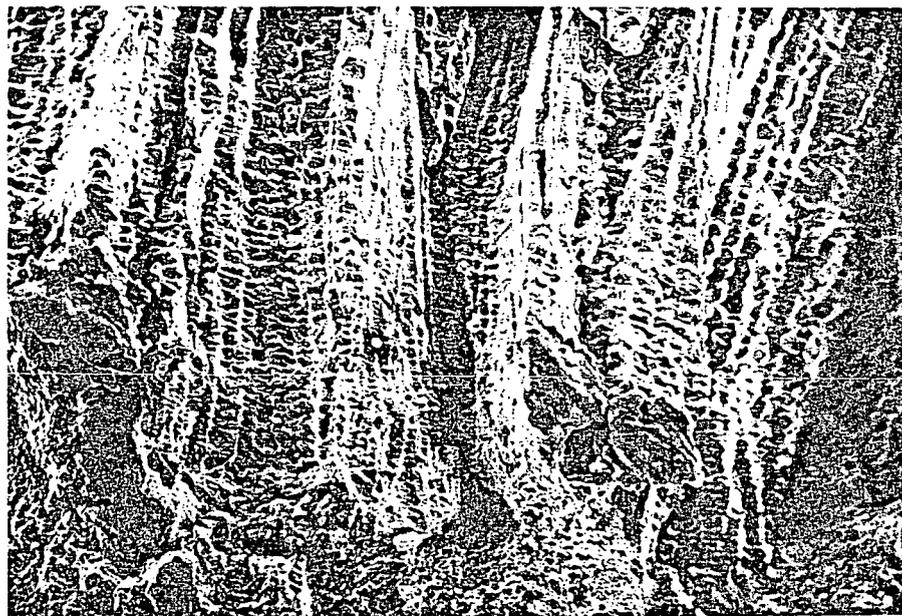
The typical topographic features of the zone of crack propagation in weld metal are shown in Figure 4-13. It is evident from these features that crack propagation in this zone occurred in an intercolumnar mode. The transition in surface topography at the intersection of the crack with the repair weld is strictly due to the characteristically different microstructures of the weld metal and base metal.

FIGURE 4-13. SEM FRACTOGRAPHS FROM CRACK SURFACE.
Specimen No. 1, Location 5, Figure 4-8.
