**RE: License No. SUA-1139, Highland Reclamation Project
Monitor Well MFG-3**

HIGHLAND URANIUM PROJECT		ExxonMobil	
CHLORIDE AND SULFATE CONCENTRATION TRENDS FOR MFG-SERIES MONITORING WELLS		PROJECT No. 677520022	
		DATE 08/08/2011	
		FIGURE No. 1

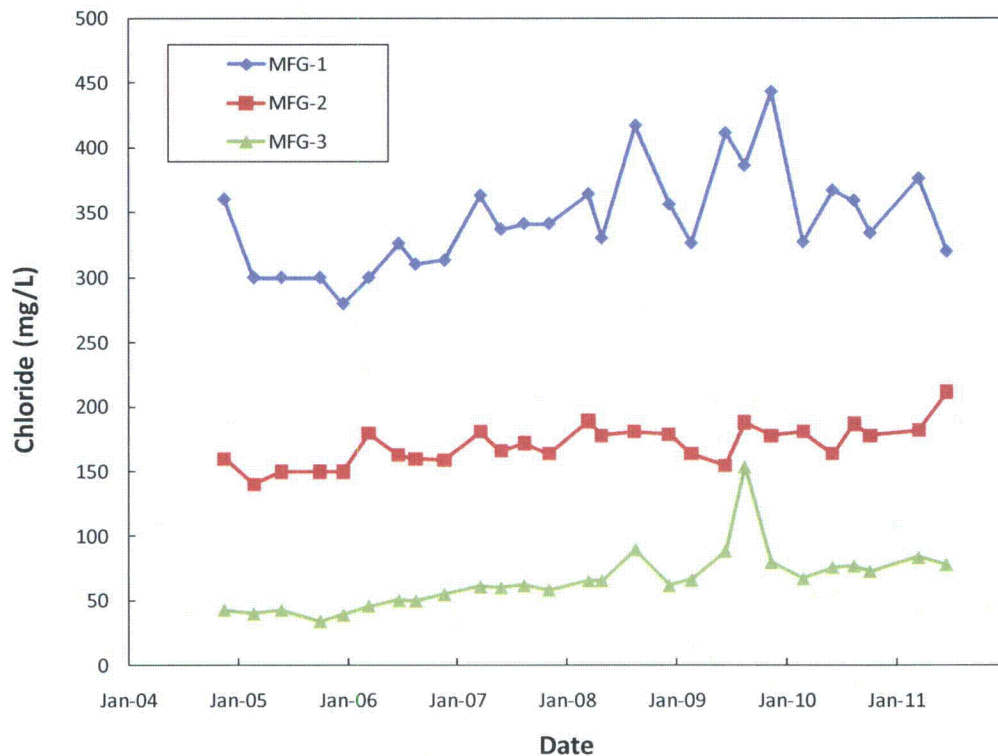
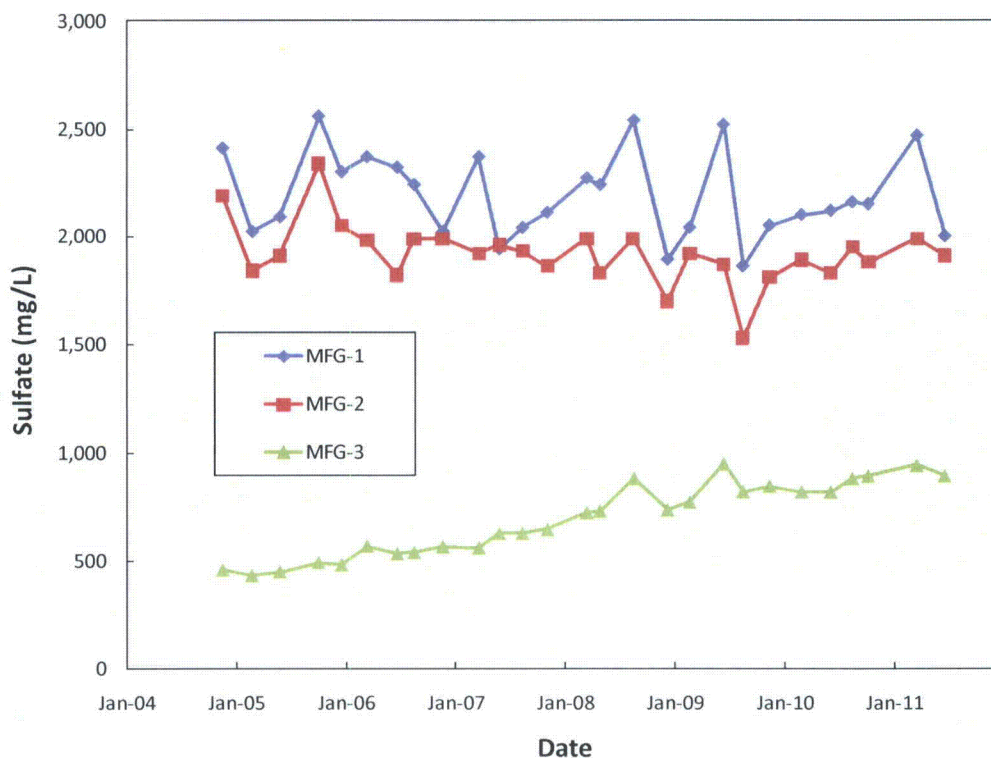
EMES has evaluated selected constituent concentration trends in OBSS wells MFG-1, MFG-2, and MFG-3. Wells MFG-1, -2, and -3 are screened in the 50SS, 40SS, and 30SS units of the OBSS, respectively. Figure 1 shows the historic concentrations of the tailings indicator constituents chloride and sulfate in the OBSS. Wells MFG-1 and MFG-2 have had consistently elevated concentrations of chloride and sulfate that indicate tailings impacts to the 50SS and 40SS. The concentrations of chloride and sulfate in MFG-3 (30SS) were much lower in comparison when this monitoring well was first installed and sampled in late 2004. However, an increasing trend in the concentrations of chloride and sulfate concentrations began around 2006 (Figure 1), suggesting that downward

migration of groundwater from the 50SS and 40SS may be influencing groundwater quality in the 30SS.

The OBSS units are separated from each other by highly impermeable shale units. Therefore, the increasing trends in the chloride and sulfate seen in Figure 1 suggest that there may be hydraulic communication between the upper OBSS units and the 30SS that likely has resulted from a faulty bentonite seal around the monitoring well during installation. The potential exists for additional impacts to the lower 30SS in the future if the pathway at the faulty well remains over the long-term.

In order to eliminate the potential for downward migration of constituents, EMES proposes abandoning MFG-3 and replacing it with a new well (MFG-3b) which would also be completed in the 30SS, for continued monitoring of the water quality in the 30SS. Because the MFG series wells were installed and are monitored at the request of NRC, EMES requests that the NRC provide concurrence with the abandonment and replacement of MFG-3, so that the work can proceed prior to winter.
