SUBJECT: LER 87-014-00: on 870514, Groups II, III & IV isolations & standby gas treatment initiation occurred. Caused by inadequate premainenance review. Piping & instrument diagram will be revised. Personnel counseled. W/870616 ltr.

FACILITY NAME (1) <b>Duane Arnold Energy Center (DAEC)</b>	DOCKET NUMBER (2) <b>0 5 0 0 0 3 3 1</b>	PAGE (3) <b>1 OF 0 4</b>
---	---	-----------------------------

TITLE (4)  
**Groups II, III, and IV Isolations Due to Inadequate Pre-Maintenance Review**

Subject: Duane Arnold Energy Center  
Docket No. 50-331  
Op. License DPR-49  
Licensee Event Report No. 87-014

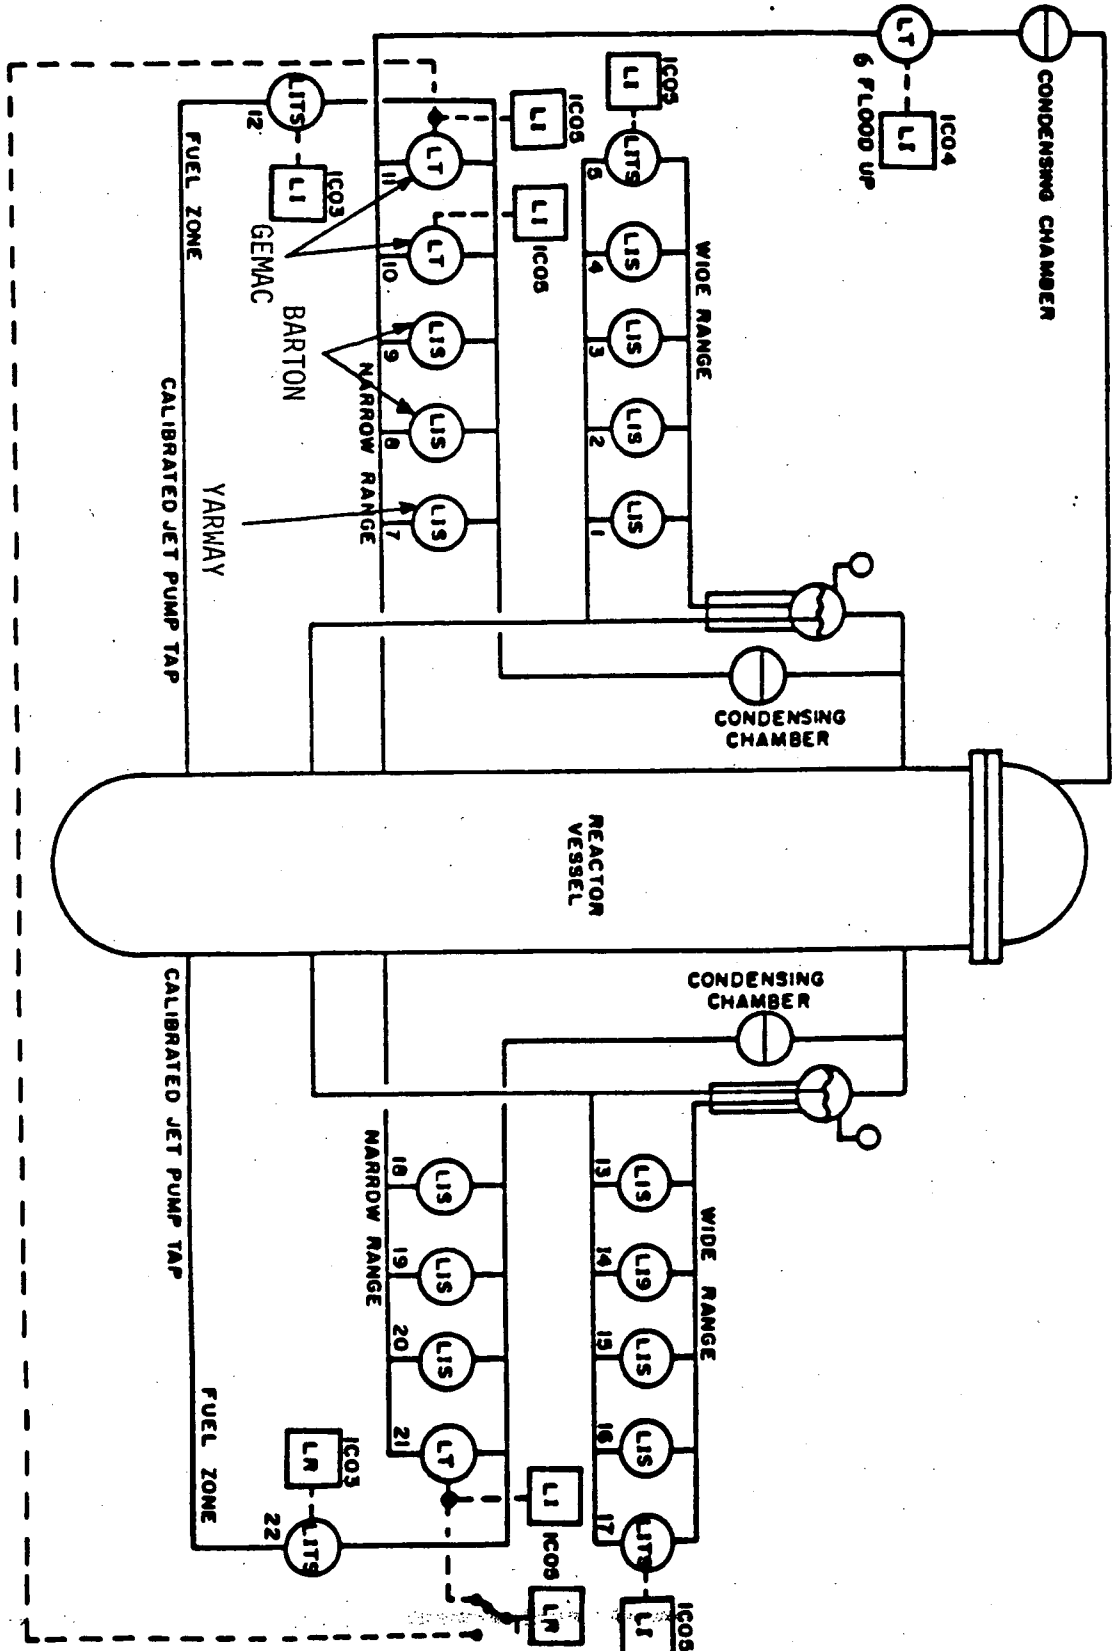
FIGURE 1  
Level Instrumentation Simplified Diagram

On May 14, 1987 at 2254 hours with the plant shut down for the cycle 8/9 refuel outage and approximately 20% of the core reloaded, Groups II, III, and IV isolations, and Standby Gas Treatment (SBGT) (EIS System Code Identifier BH) initiation occurred during planned maintenance work on the high side rack shutoff valve for the Feedwater Control (JB) GEMAC level transmitters (JB-LT-4559, & JB-LT-4561). The intention was to drain off the high side of the reference leg to the GEMAC transmitters. The draining of the high side of the transmitters has no effect on any system trips. The Reactor Protection System (RPS, JC) received a low reactor water level signal (170 inches above top of active fuel (TAF)) when operations personnel attempted to drain the high side reference leg of the GEMAC level transmitters. GEMAC level transmitters (LT-4559 and LT-4561), Narrow Range YARWAY level switch (LIS-4561), and Narrow Range BARTON level switches (LIS-4592A, & LIS-4592B) share a common instrument line (see figure 1). Isolation and draining of the high side of the narrow range GEMAC level transmitters also effects the low side of the YARWAY and BARTON level switches. LT-4559 and LT-4561 are installed in a transposed configuration in comparison with LIS-4592A, LIS-4592B, and LIS-4561, i.e., the high and low pressure taps are reversed. This unique equipment configuration is not readily apparent on the applicable Piping and Instrument Diagram (P&ID, M-115), and upon draining of the intended high side of the GEMAC transmitter, the low side of the BARTON and YARWAY switches were also drained. Hence, this caused a low reactor water level (170 inches above TAF) signal to be received, and Group II through IV isolations, and SBGT system initiation. Group V valves were tagged out at the time of the event so isolation of these valves did not take place.

The intermediate cause of the event was the uniqueness of the equipment installation and lack of detail on P&ID M-115.

The root cause of the event was determined to be personnel error. Utility licensed operations personnel and contract maintenance personnel did not fully understand the relative configuration of the level transmitters. The effects of the isolation and draining the low pressure side of the YARWAY and BARTON level switches were known but not identified since the P&ID did not identify the unique installation of the GEMAC Transmitters.

As immediate corrective actions, the Operations Supervisor alerted operations personnel and the training department to this unique equipment configuration (GEMAC high-low vs YARWAY & BARTON low-high). As additional corrective actions, P&ID M-115 is being revised to include a high and low insignia to be placed next to the transmitters and level switches in question, also the GEMAC transmitters high pressure and low pressure isolation valves will be labeled in the field during the on-going equipment labeling project. In addition, maintenance and operations personnel will be required to read this LER to stress the importance of accurate Corrective Maintenance Action Request (CMAR) pre-work reviews.
