SUBJECT: LER 86-020-01: on 861015, charcoal beds of control bldg  
 standby filter units inadvertently sprayed w/water &  
 rendered inoperable. Caused by inadequate procedure. Procedure  
 is being revised. W/870713 ltr.

FACILITY NAME (1) <b>Duane Arnold Energy Center (DAEC)</b>	DOCKET NUMBER (2) <b>0 5 0 0 0 3 3 1</b>	PAGE (3) <b>1 OF 0 6</b>
---------------------------------------------------------------	---------------------------------------------	-----------------------------

TITLE (4)  
**Inadvertent Deluge of Standby Filter Units Due to Inadequate Procedure**

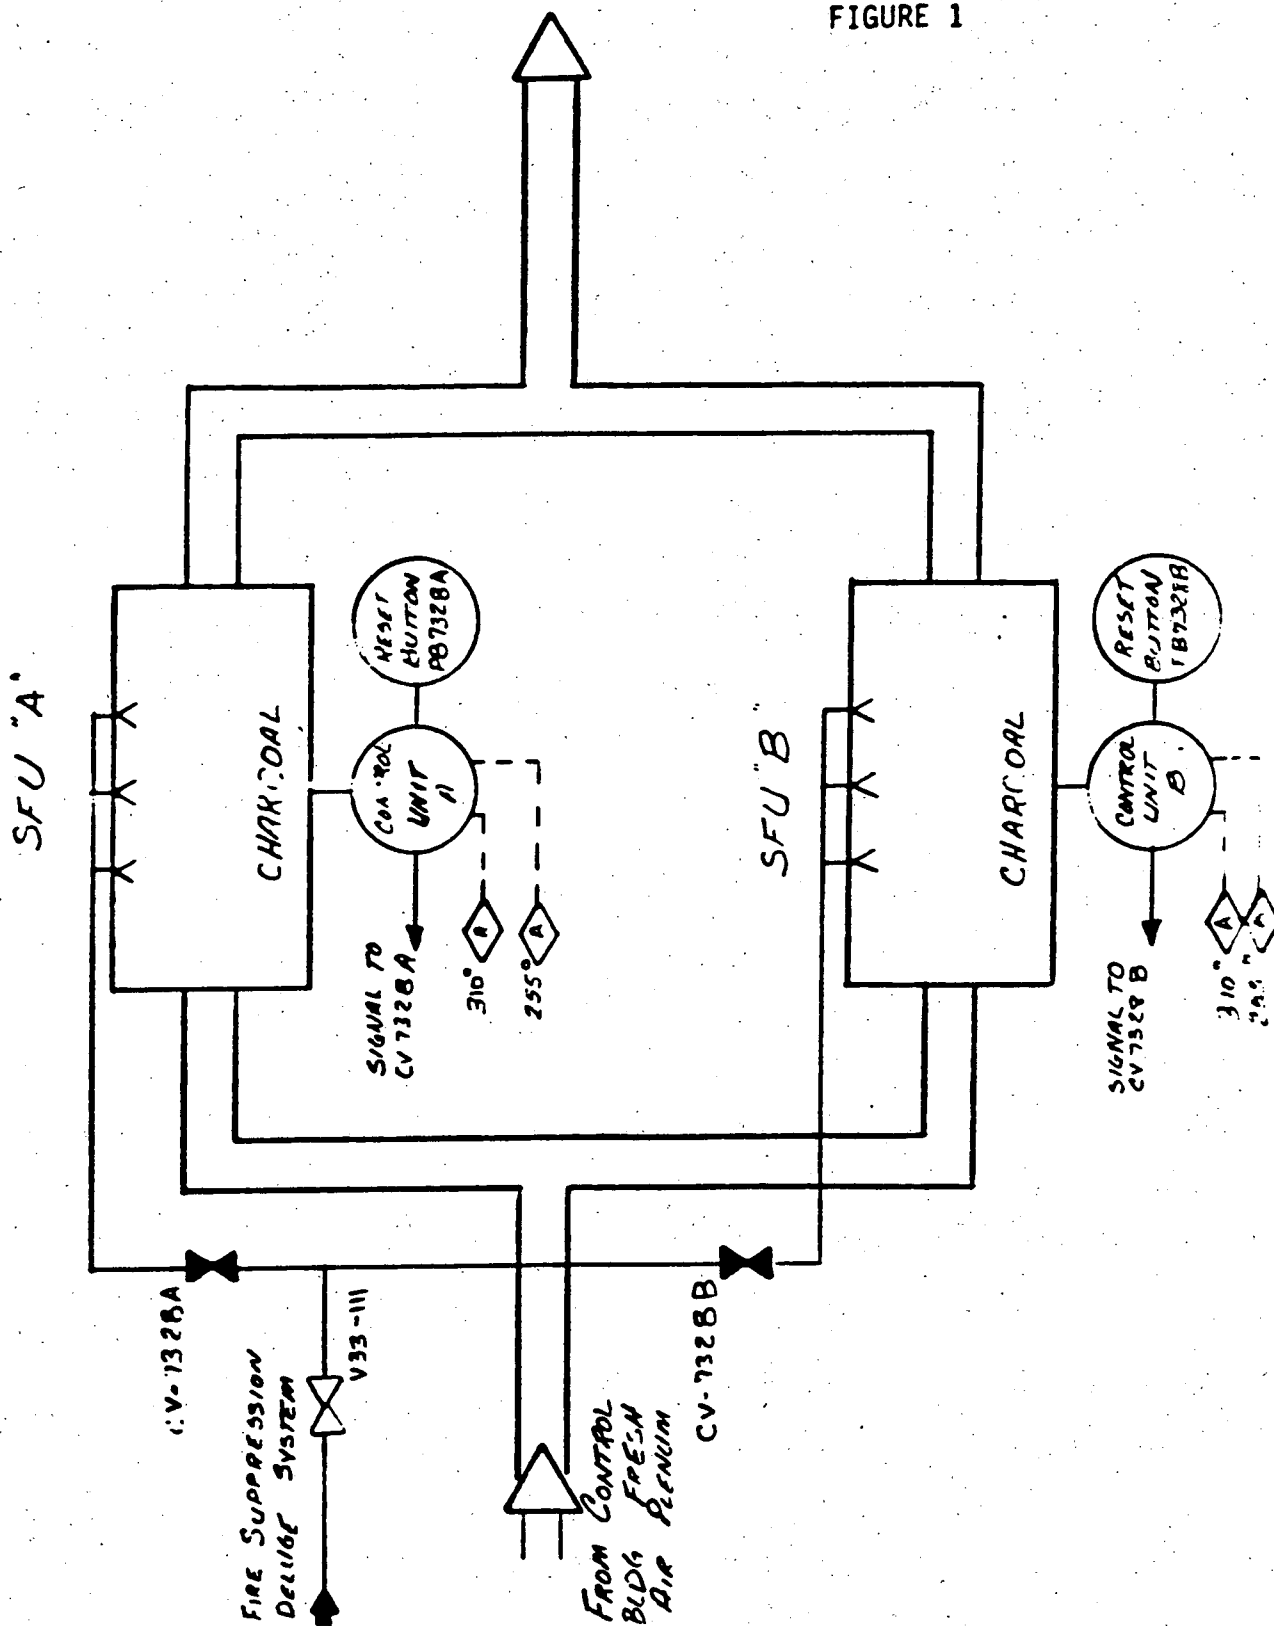
FIGURE 1

Each control unit monitors the temperature in the SFU charcoal bed. If the temperature reaches 255° F an alarm is sounded and a permissive signal is sent to the normally closed deluge isolation valve control that will allow manual opening. These valves for the A and B trains respectively are CV-7328A and CV-7328B (EIIS Code VI-TCV-7328A and VI-TCV-7328B). If the temperature reaches 310° F an alarm is annunciated in the Control Room and the deluge isolation valve automatically opens (see figure 1).

However, during the functional testing the 310° automatic initiation alarm sealed open the normally closed SFU isolation valve. Clearing the Control Room alarms did not break the seal-in logic and close the valve. To close this valve and break the seal-in logic, reset button (PB7328A and PB7328B) must be pressed. Since the instructions did not require pushing the reset button, the carbon beds of the Standby Filter Units were sprayed with water when the deluge system was unisolated.

The cause of the event was an inadequate procedures. The maintenance instructions should have included a step to push the reset buttons (PB7328A and PB7328B) (EIIS Code VI-IS-7328A and VI-IS-7328B) to reset the valves. The Control Room annunciators are actuated by the temperature switches. So no control room indication was present that showed the deluge valves were open after the test signals were removed and the annunciators reset.

The charcoal filters of the Standby Filter Units were replaced. The preventive maintenance procedures will be revised before it is next scheduled to be worked to include pushing the reset button when the test is completed. As a further corrective action, an engineering review has been initiated to consider installing 2 deluge isolation valves, one for each train of the SFU's. This will allow isolation for testing and maintenance of one deluge train while leaving the other in service. Also an engineering request has been initiated to change the control room annunciator to indicate valve position rather than temperature switch acutation.
