SUBJECT: LER 86-024-01: on 861121, outboard HPCI sys valve closed due to signal from pressure differential indicating switch PDIS2245. Caused by switch compartment moisture. Compartment dried & switch calibr. W/870722 ltr.

TITLE (4)
High Pressure Coolant Injection System Isolation from Steam Flow dP Switch Internal Leak

Subject: Duane Arnold Energy Center
Docket No. 50-331
Op. License DPR-49
Licensee Event Report No. 86-024, Revision 1

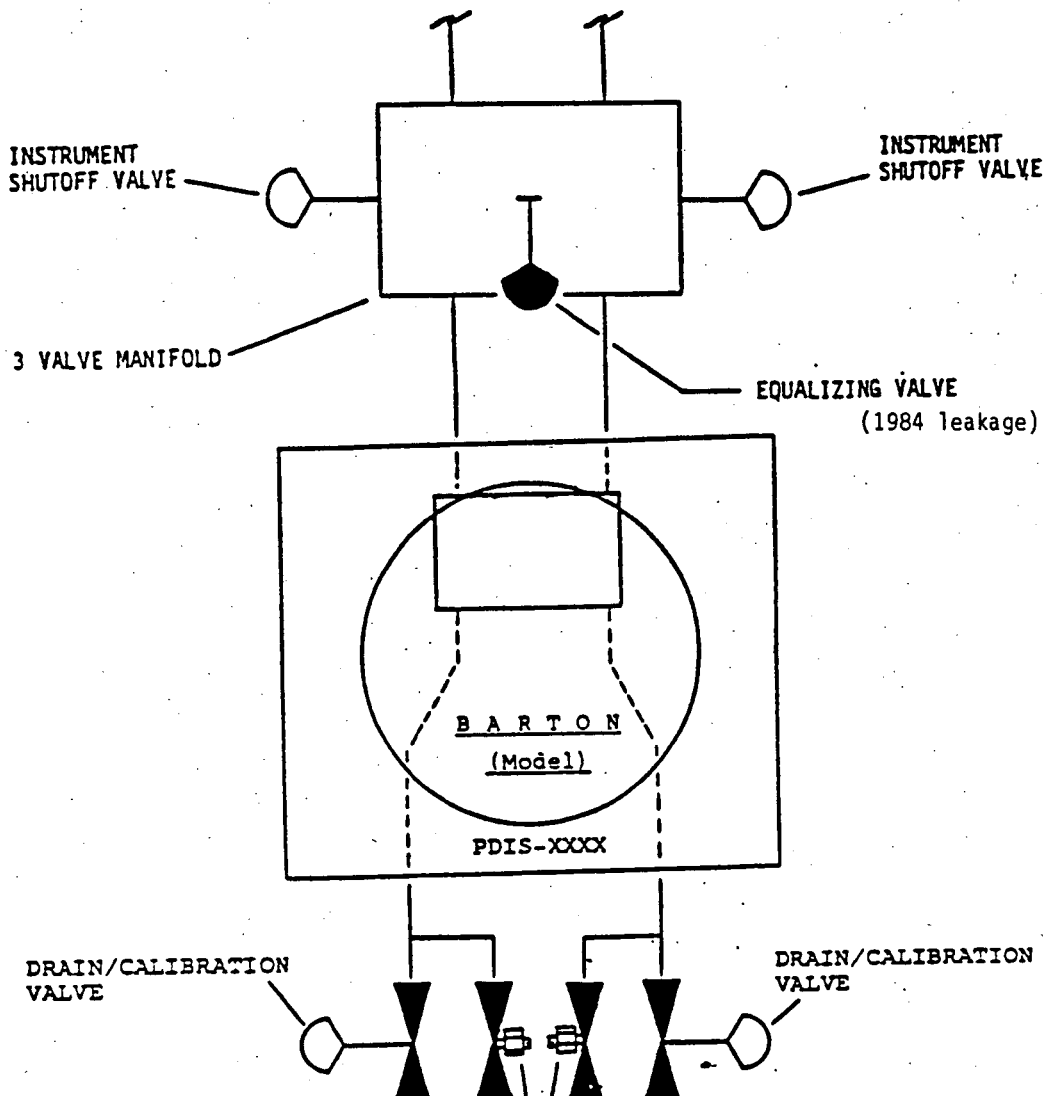
Figure 4 - Barton PDIS with Manifold

The instrument water line manifold directly above PDIS2245 was noted to be leaking during the 1987 refueling outage, and was replaced on April 1, 1987. A pathway exists for leakage from this manifold to the back side of PDIS2245 where the bellows assembly is attached. From there, the water could seep in between the PDIS and bellows assembly. Per discussions with the manufacturer the torque tube seal into the PDIS switch compartment is not a hermetic seal, and water introduced into this area on the back side of the PDIS could eventually work its way into the switch compartment.

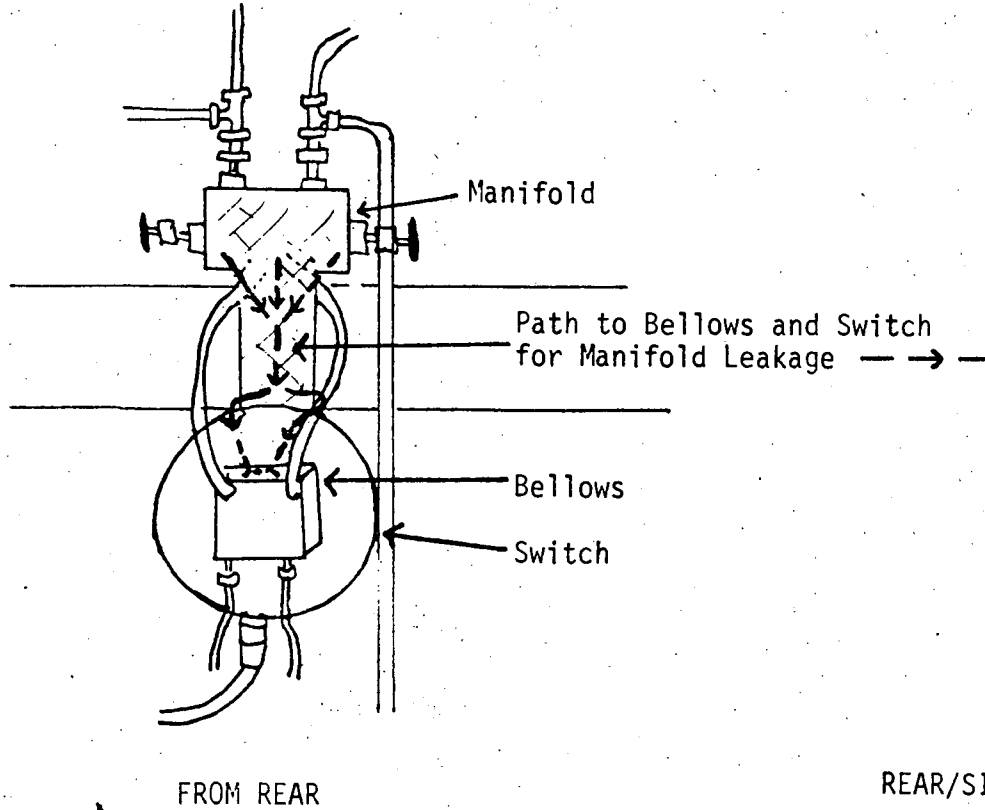
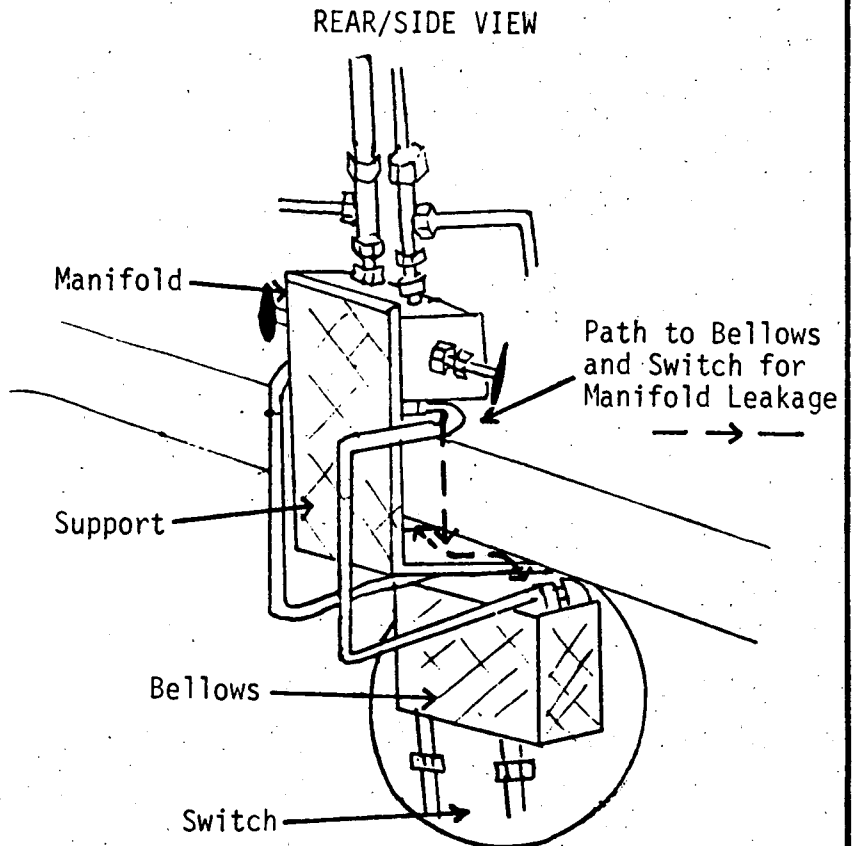
FIGURE 5

The root cause of the HPCI isolation signal from PDIS2245 on November 21, 1986 is deemed to be the intrusion of water from the leaking manifold above the switch into the switch compartment via the torque tube seal. This is based on the visual evidence obtained during the inspection of PDIS2245 and its bellows assembly, which indicated an outside source for the water, the previous

Water Intrusion into
Barton 288 From Leaking
Overhead Manifold:
Two Views

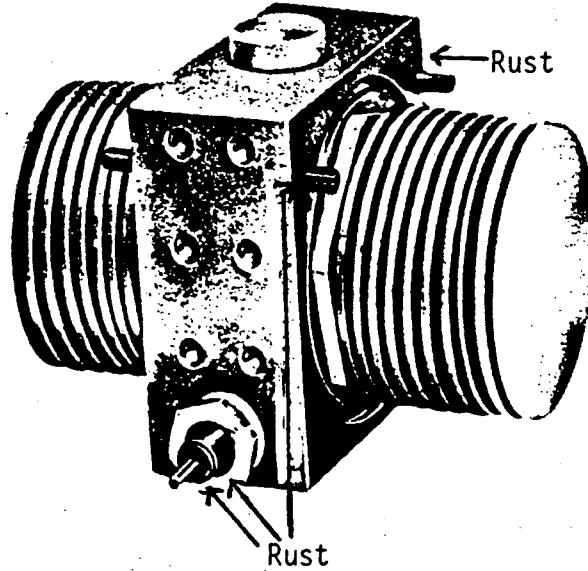
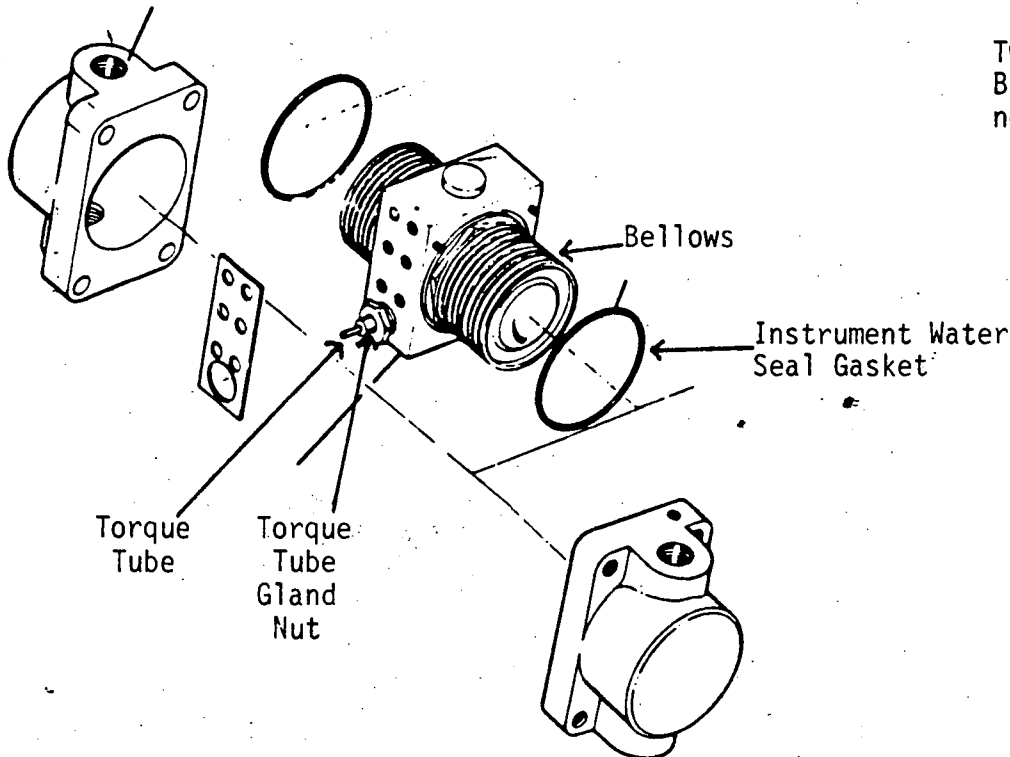
FIGURE 6

During the next reexamination of the switch on December 3, 1986, a small quantity of water (several drops) was again found within the switch compartment. The switch trip setpoint was found within calibration, however. The source of the leakage into the switch compartment was pinpointed as the dial rod seal. An examination of plant records and discussions with plant personnel indicate dial rod seal leakage has not been previously experienced at the Duane Arnold Energy Center. As a corrective action, surveillance on this instrument is being increased pending receipt of a qualified replacement switch. The seal area and switch compartment will be visually inspected three times per week during times which the switch is required to be operable. A qualified like replacement switch is on order. Following replacement of PDIS2245, it will be further examined to determine the root cause and source of the leakage. An update to this LER will be filed following completion of this examination. A check of PDIS2245's switch compartment on December 16, 1986, with the reactor in cold shutdown, found no water had entered the compartment since it was last inspected on December 3, 1986.

Two views of ITT Barton 224 DPU, noting rust sites.
