SUBJECT: LER 86-024-01: on 861121, outboard HPCI sys valve closed due to signal from pressure differential indicating switch PDIS2245. Caused by switch compartment moisture. Compartment dried & switch calibr. W/870722 ltr.

LICENSEE EVENT REPORT (LER)

FACILITY NAME (1) Duane Arnold Energy Center (DAEC)										DOCKET NUMBER (2) 0 5 0 0 0 3 3 1					PAGE (3) 1 OF 1							
TITLE (4) High Pressure Coolant Injection System Isolation from Steam Flow dP Switch Internal Leak																						
EVENT DATE (5)			LER NUMBER (6)				REPORT DATE (7)			OTHER FACILITIES INVOLVED (8)												
MONTH	DAY	YEAR	YEAR	SEQUENTIAL NUMBER	REVISION NUMBER	MONTH	DAY	YEAR	FACILITY NAMES None				DOCKET NUMBER(S) 0 5 0 0 0									
1	1	2	1	8	6	8	6	0	2	4	0	1	0	7	2	2	8	7	0 5 0 0 0			
OPERATING MODE (9) N		THIS REPORT IS SUBMITTED PURSUANT TO THE REQUIREMENTS OF 10 CFR 8: (Check one or more of the following) (11)																				
POWER LEVEL (10) 01914		20.402(b)				20.406(c)				60.73(a)(2)(iv)				73.71(b)

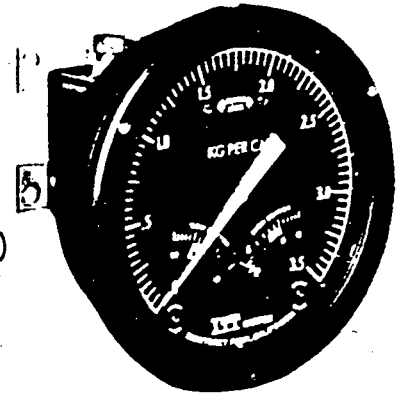
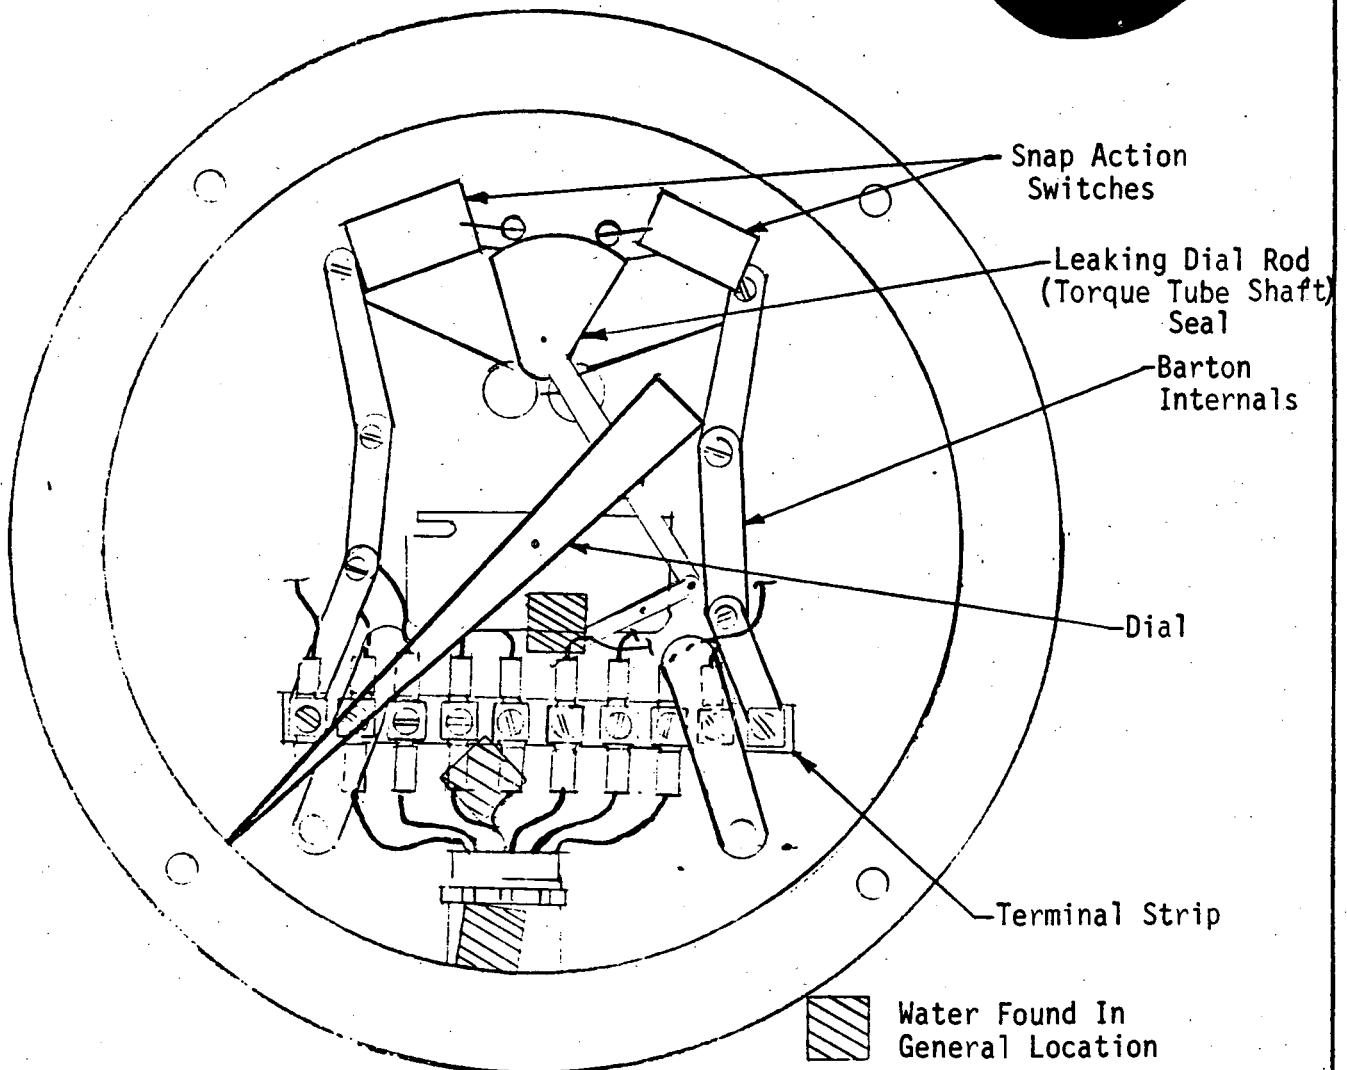
FIGURE 1. Barton 288A (PDIS-2245)
General Representation of Barton 288 Switch Internals

When PDIS2245 was examined on November 21, 1986, a small amount of water was found in the switch compartment. An amount approximately equal to one drop was seen in the area of the dial rod (torque tube shaft) seal, and on the terminal strip. Several drops were found to have accumulated in the lowest area of the switch compartment. (See Figure 1, 2, and 3.) The switch compartment was dried and PDIS2245 recalibrated successfully. The suspected point of water leakage into the switch compartment was the dial rod seal, as the rod extends into the Differential Pressure Unit behind the switch where the water filled bellows are located. However the rod seal area was observed for approximately two hours with no further leakage apparent.

From examination of PDIS2245, the cause of the automatic HPCI isolation at 0822 hours on November 2, 1986 was determined to be moisture within the switch compartment, which likely resulted in a momentary short of contacts at the terminal strip and the subsequent isolation signal. Further examination of PDIS2245 was planned to determine if continued leakage existed, and if so the source of that leakage.

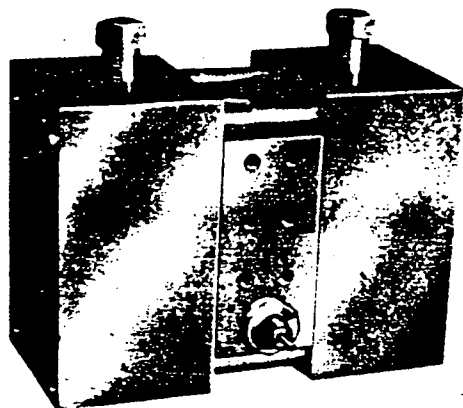
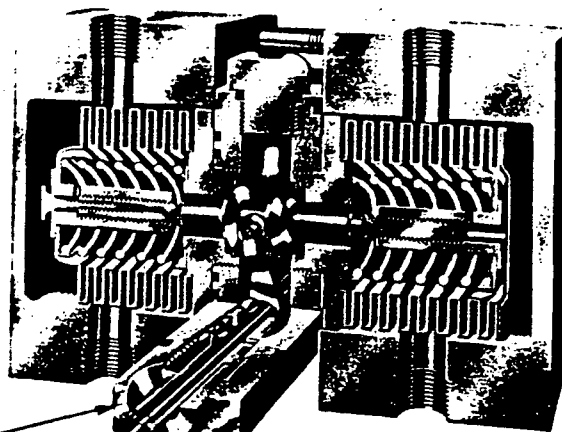
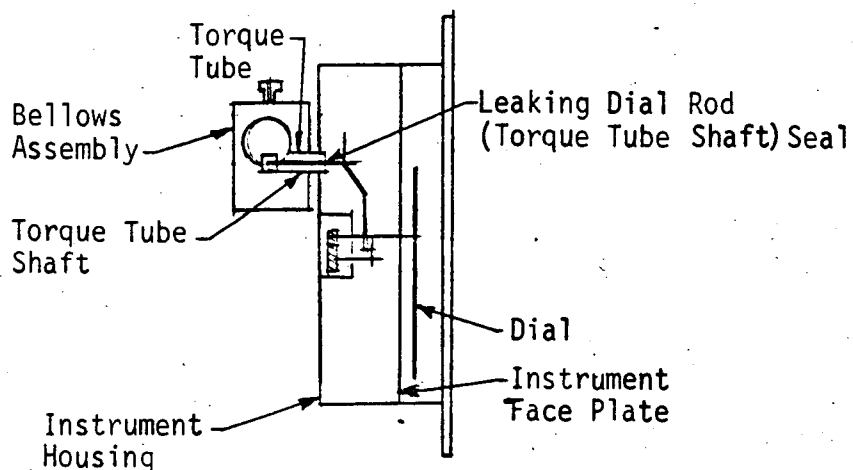
Figure 2. DPU 224 and Mounting Schematic

The instrument water line manifold directly above PDIS2245 was noted to be leaking during the 1987 refueling outage, and was replaced on April 1, 1987. A pathway exists for leakage from this manifold to the back side of PDIS2245 where the bellows assembly is attached. From there, the water could seep in between the PDIS and bellows assembly. Per discussions with the manufacturer the torque tube seal into the PDIS switch compartment is not a hermetic seal, and water introduced into this area on the back side of the PDIS could eventually work its way into the switch compartment.

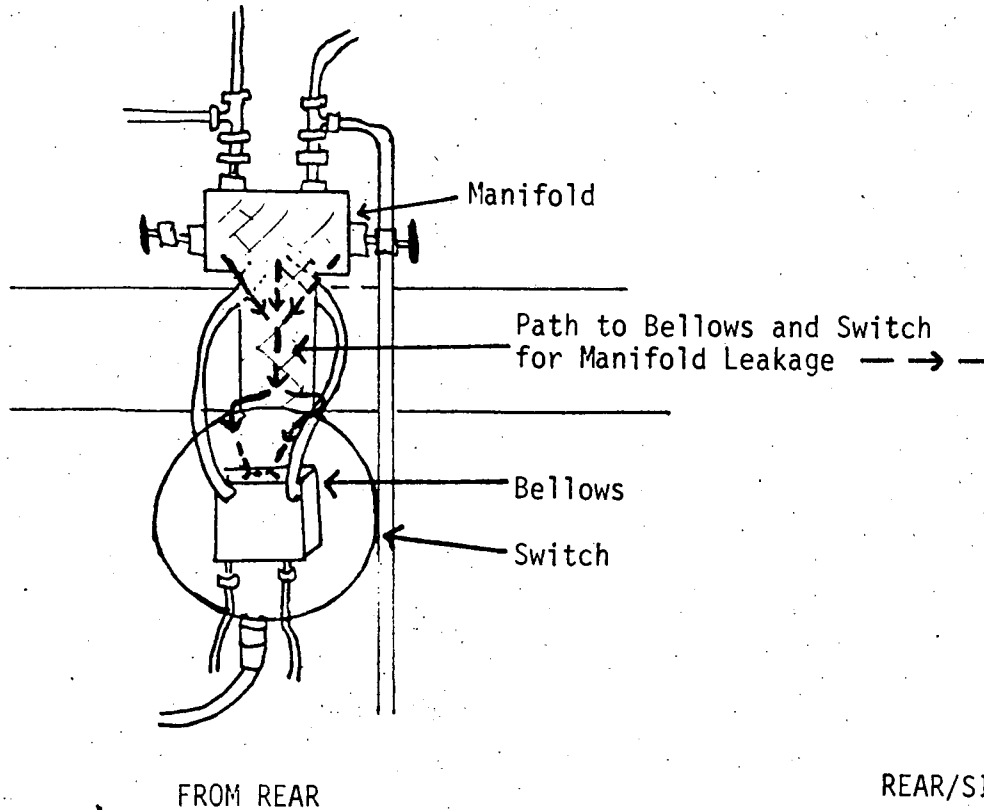
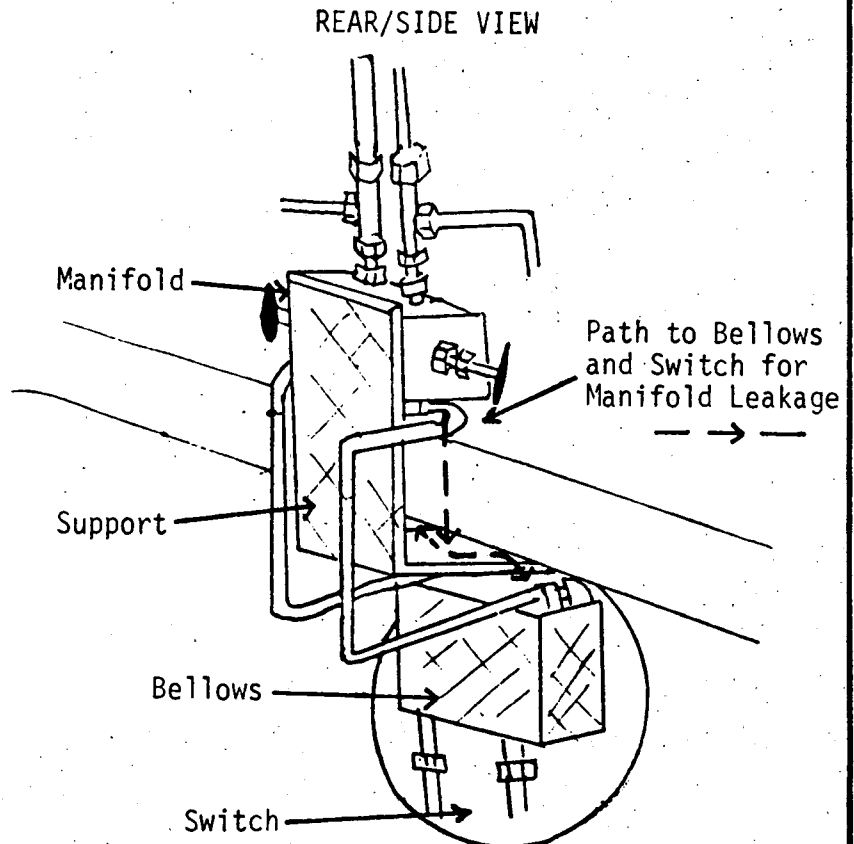
FIGURE 5

The root cause of the HPCI isolation signal from PDIS2245 on November 21, 1986 is deemed to be the intrusion of water from the leaking manifold above the switch into the switch compartment via the torque tube seal. This is based on the visual evidence obtained during the inspection of PDIS2245 and its bellows assembly, which indicated an outside source for the water, the previous

Water Intrusion into
Barton 288 From Leaking
Overhead Manifold:
Two Views

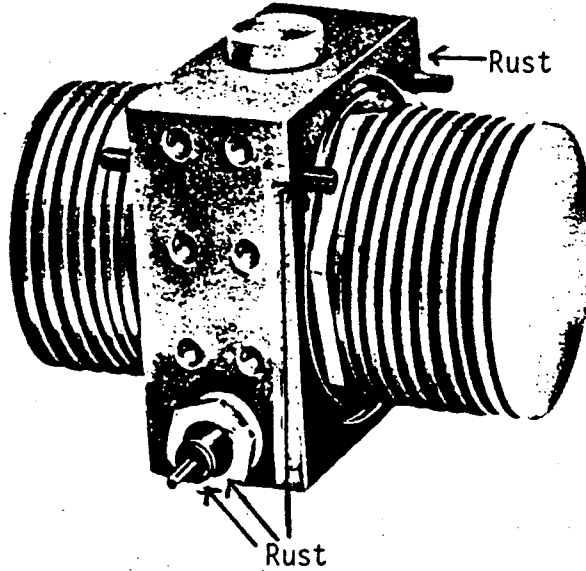
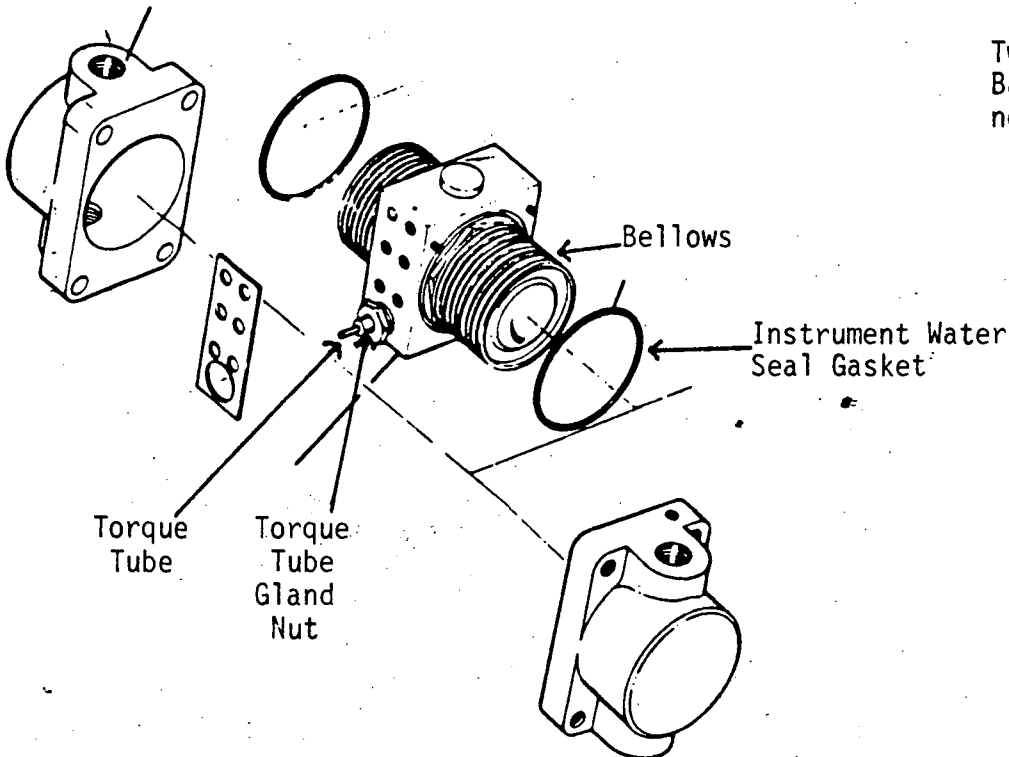
FIGURE 6

Two views of ITT Barton 224 DPU, noting rust sites.
