SUBJECT: Forwards response to request for addl info re control room
 habitability evaluation.Attachment A to ltr describes 900919
 event & design mods planned. ✓

Subject: Duane Arnold Energy Center
Docket No: 50-331
Op. License No: DPR-49
Response to Request for Additional
Information Regarding DAEC's Control
Room Habitability Evaluation
Reference: Letter, C. Shiraki (NRC) to L. Liu (IELP)
dated August 2, 1991
File: A-107a

RESPONSE TO REQUEST FOR ADDITIONAL INFORMATION

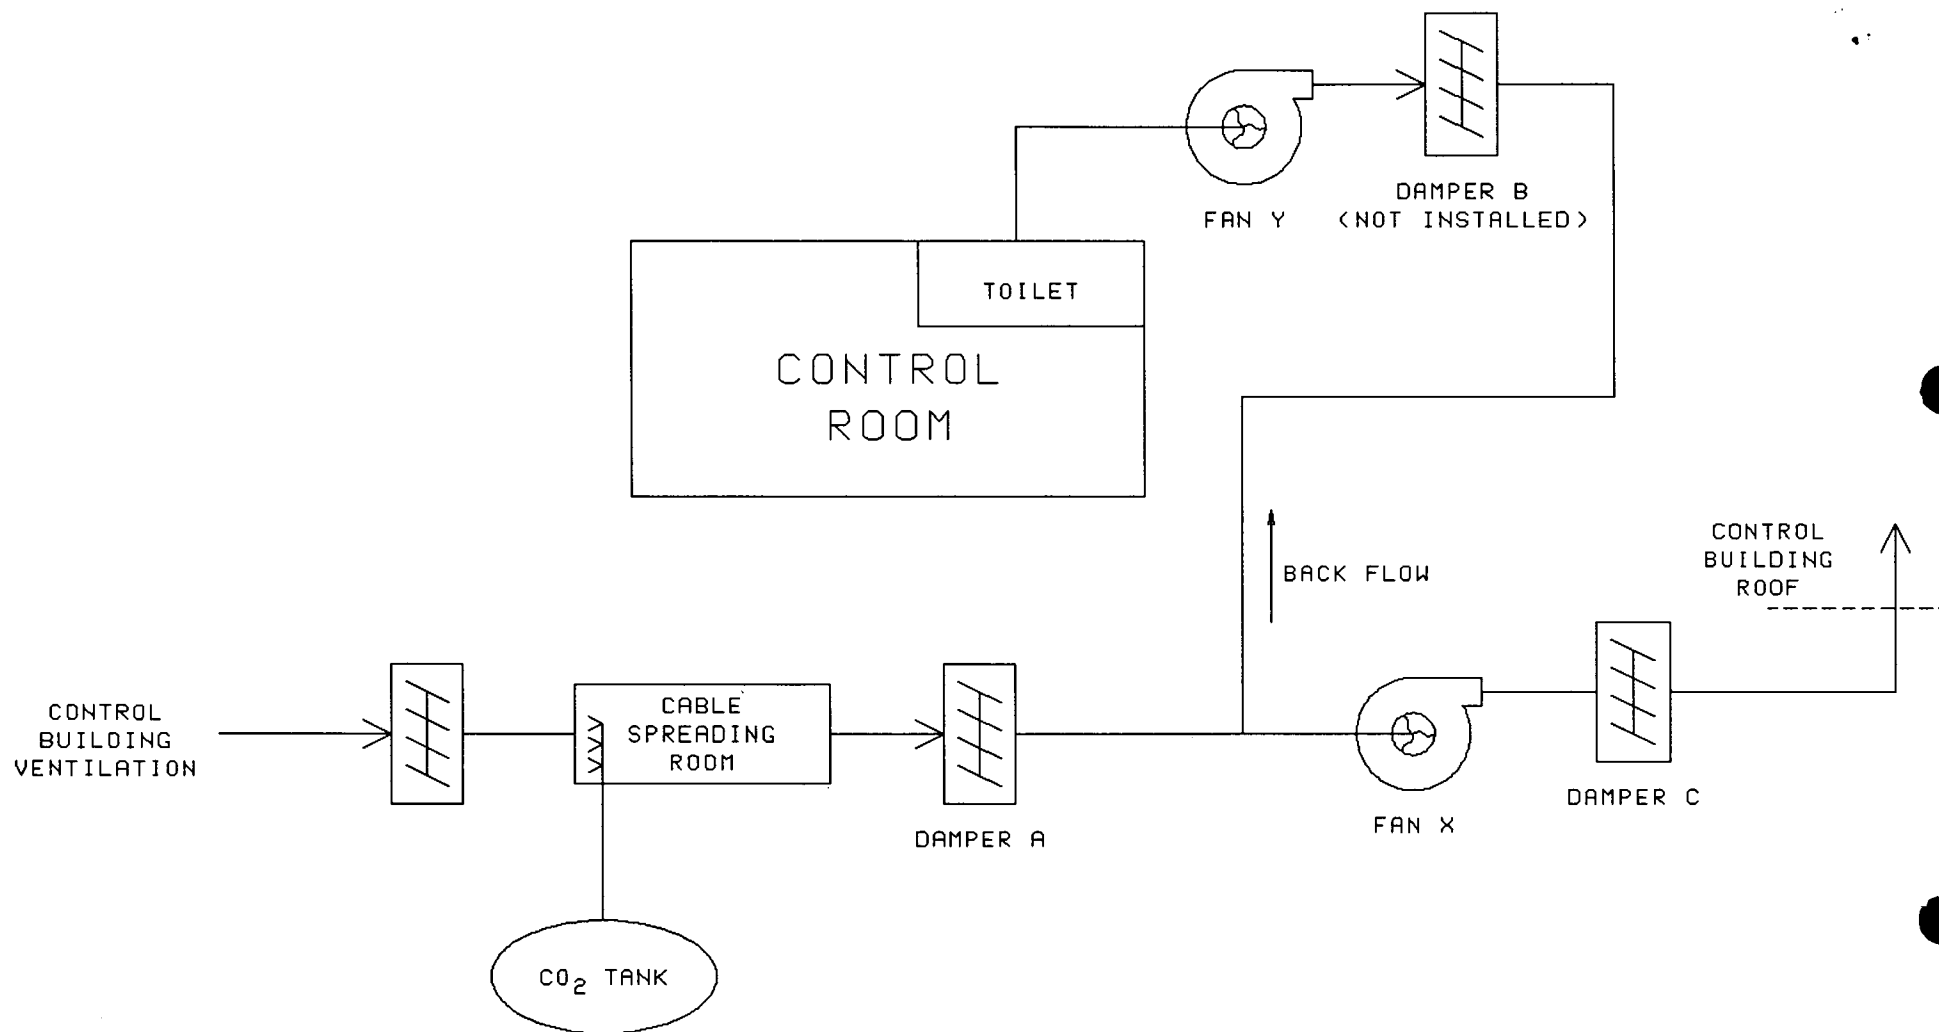
CONTROL BUILDING VENTILATION
(Simplified)

The modifications to the ventilation system were completed in May 1974. Additional fire dampers were installed in the Cable Spreading Room and the CO₂-actuated logic on the room exhaust damper (see Damper A Attachment B) was replaced with 360 degree F fusible links. The exhaust damper would then remain open until the fusible links sensed an actual fire (360 degrees F) thereby maximizing the availability of a vent path to prevent overpressurization of the Cable Spreading Room.

It was during the investigation of the September 19, 1990, event that we identified that the backdraft damper (see Damper B) which was intended to prevent air from backflowing into the Control Room from the Cable Spreading Room was never installed. Design documentation has always reflected a damper in the line and consequently, its presence was assumed in the later habitability evaluations. Despite vigorous efforts, we are unable to explain its absence. Additionally, we determined that upon CARDOX actuation, the room exhaust fan (see Fan X) secures and the fan's discharge damper (see Damper C) closes, effectively blocking the intended vent path. Therefore, the 1974 ventilation modifications were ineffective in that a CARDOX initiation can still pressurize the Cable Spreading Room and, without the backdraft damper, CO₂ can backflow into the Control Room.

Design modifications have been initiated which will address the backflow through the control room exhaust fan (see Fan Y) and ensure the proper venting of the Cable Spreading Room in the event of a CARDON initiation. These design changes will be complete prior to shutdown for the Cycle 11 refueling outage. Additionally, post-modification testing will be performed during the Cycle 11 outage to verify the effectiveness of these modifications. Upon successful completion of this testing, the Control Room habitability evaluation described in UFSAR Section 6.4 will be revised to reflect the analysis of and corrective actions resulting from the September 19, 1990 event.
