SUBJECT: Forwards response to request for addl info re control room  
 habitability evaluation. Attachment A to ltr describes 900919  
 event & design mods planned.

Subject: Duane Arnold Energy Center  
Docket No: 50-331  
Op. License No: DPR-49  
Response to Request for Additional  
Information Regarding DAEC's Control  
Room Habitability Evaluation  
Reference: Letter, C. Shiraki (NRC) to L. Liu (IELP)  
dated August 2, 1991  
File: A-107a

## RESPONSE TO REQUEST FOR ADDITIONAL INFORMATION

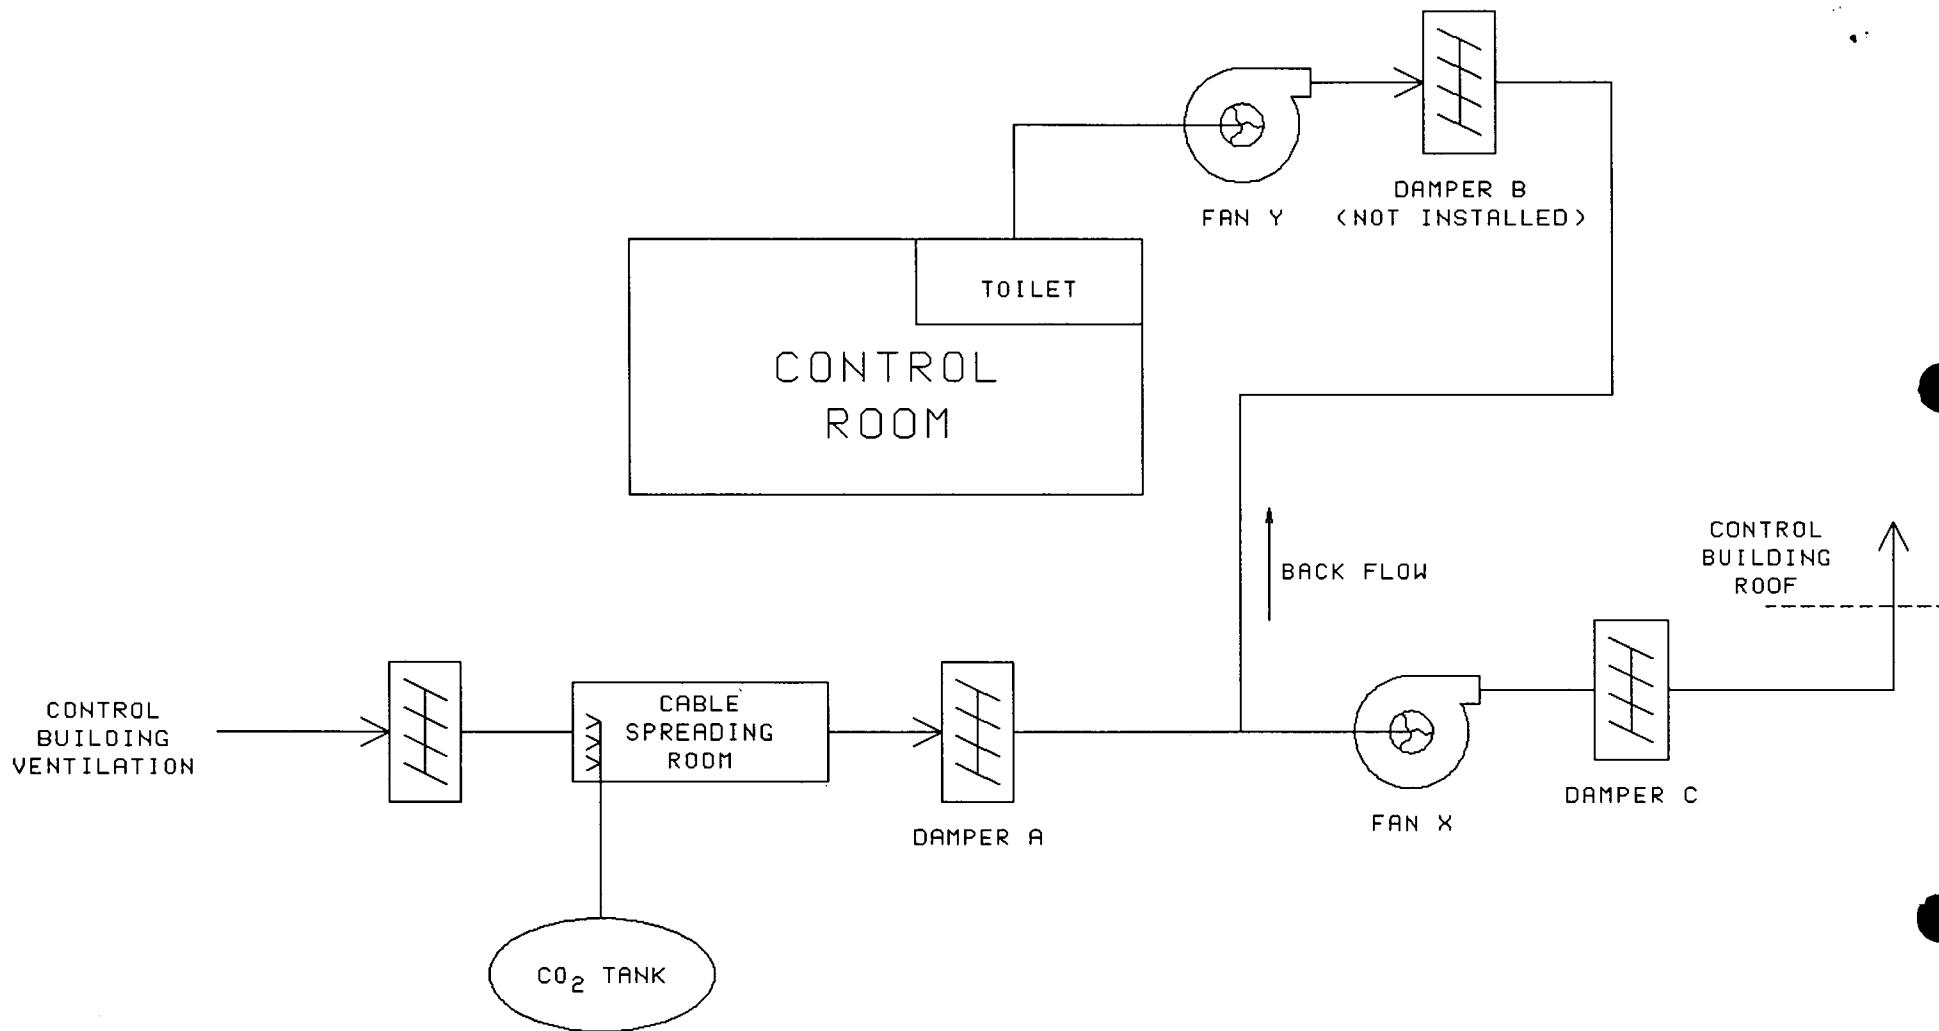
CONTROL BUILDING VENTILATION  
(Simplified)

The modifications to the ventilation system were completed in May 1974. Additional fire dampers were installed in the Cable Spreading Room and the CO<sub>2</sub>-actuated logic on the room exhaust damper (see Damper A Attachment B) was replaced with 360 degree F fusible links. The exhaust damper would then remain open until the fusible links sensed an actual fire (360 degrees F) thereby maximizing the availability of a vent path to prevent overpressurization of the Cable Spreading Room.

It was during the investigation of the September 19, 1990, event that we identified that the backdraft damper (see Damper B) which was intended to prevent air from backflowing into the Control Room from the Cable Spreading Room was never installed. Design documentation has always reflected a damper in the line and consequently, its presence was assumed in the later habitability evaluations. Despite vigorous efforts, we are unable to explain its absence. Additionally, we determined that upon CARDOX actuation, the room exhaust fan (see Fan X) secures and the fan's discharge damper (see Damper C) closes, effectively blocking the intended vent path. Therefore, the 1974 ventilation modifications were ineffective in that a CARDOX initiation can still pressurize the Cable Spreading Room and, without the backdraft damper, CO<sub>2</sub> can backflow into the Control Room.

Design modifications have been initiated which will address the backflow through the control room exhaust fan (see Fan Y) and ensure the proper venting of the Cable Spreading Room in the event of a CARDOX initiation. These design changes will be complete prior to shutdown for the Cycle 11 refueling outage. Additionally, post-modification testing will be performed during the Cycle 11 outage to verify the effectiveness of these modifications. Upon successful completion of this testing, the Control Room habitability evaluation described in UFSAR Section 6.4 will be revised to reflect the analysis of and corrective actions resulting from the September 19, 1990 event.
