Action Request Print: 080501182

Description (General Tab)

Type	ID	CRC	Functional Description
EQ-MEL	S22420MG003	Critical-A	"NEIL" EMERGENCY DIESEL GENERATOR 2MG003

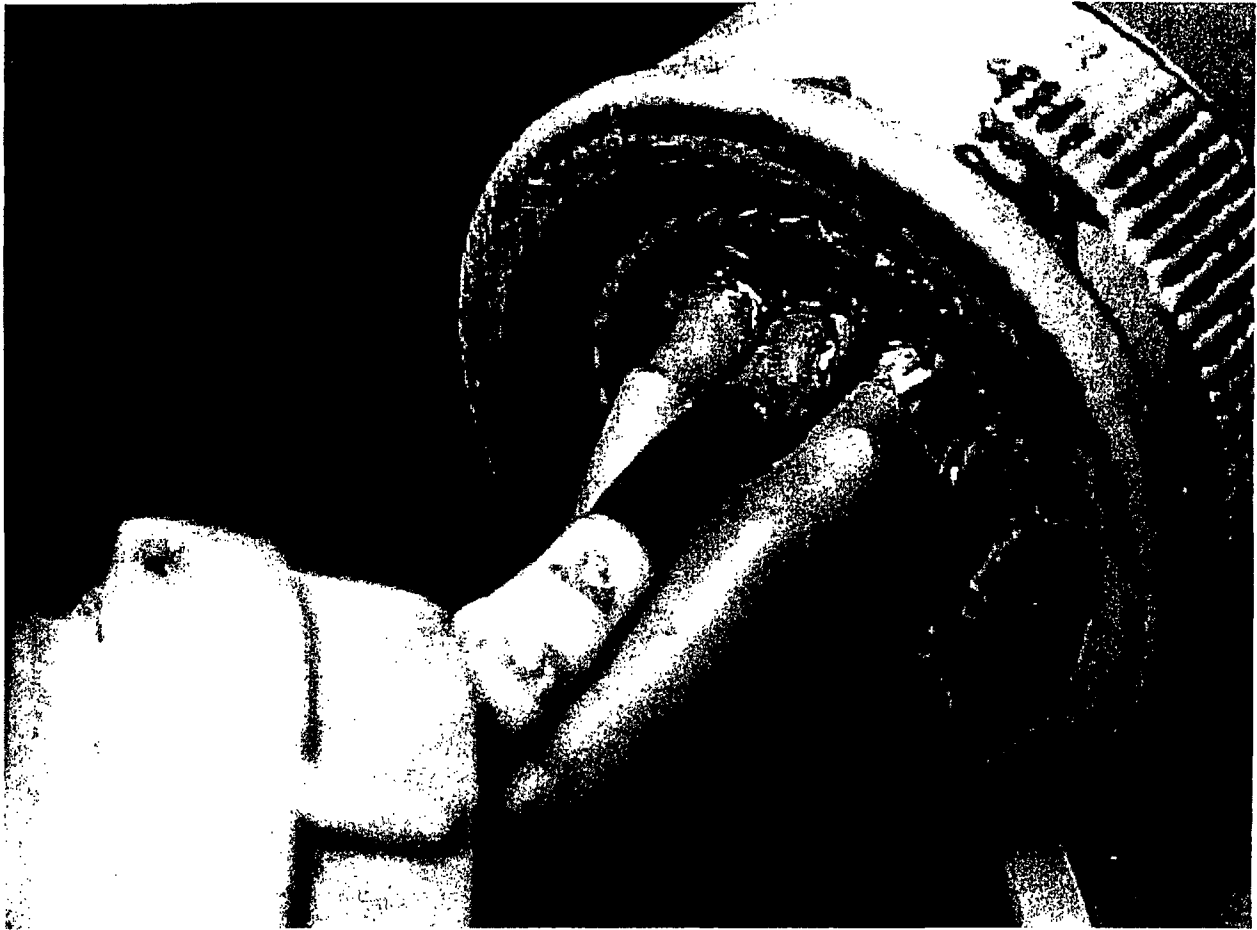
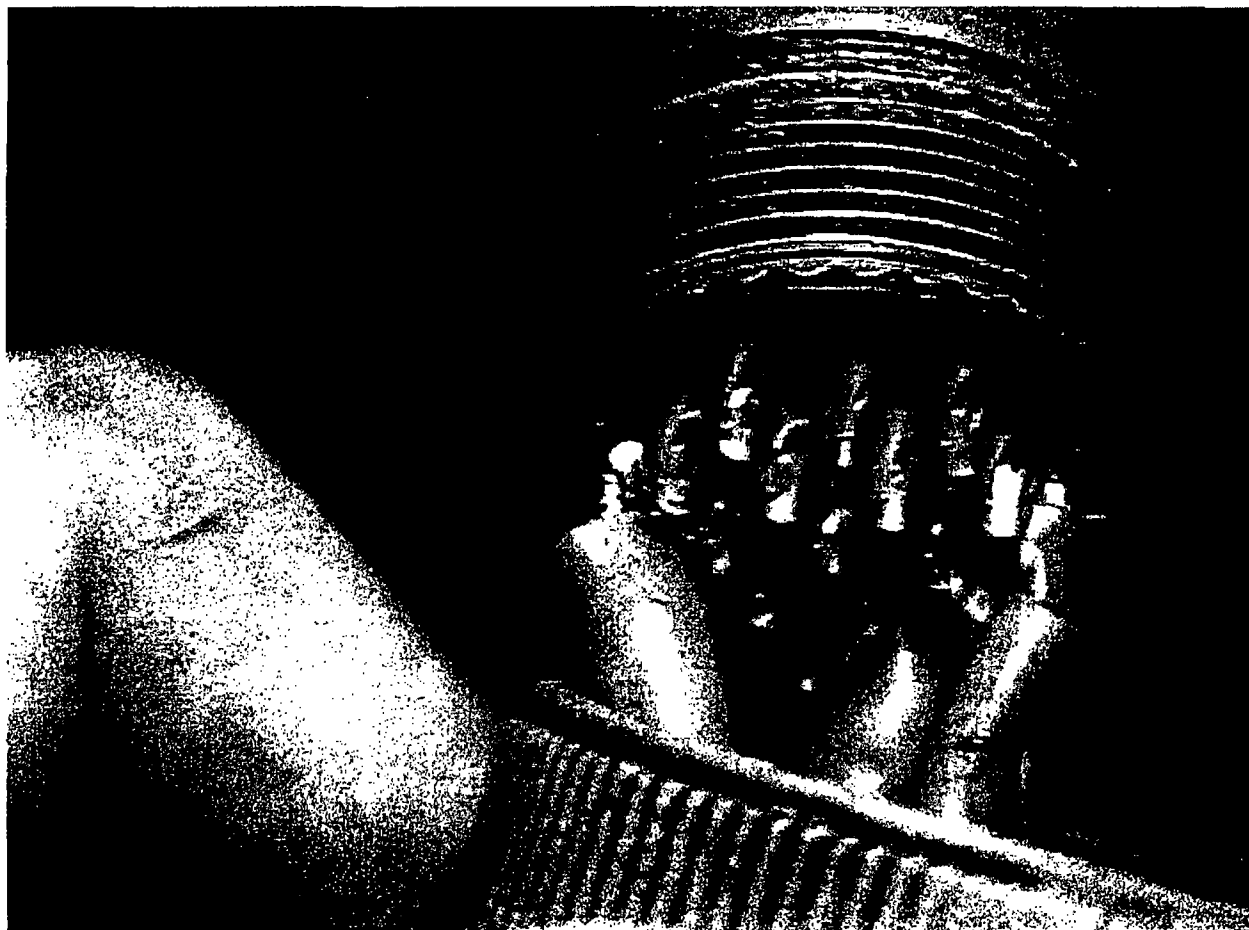
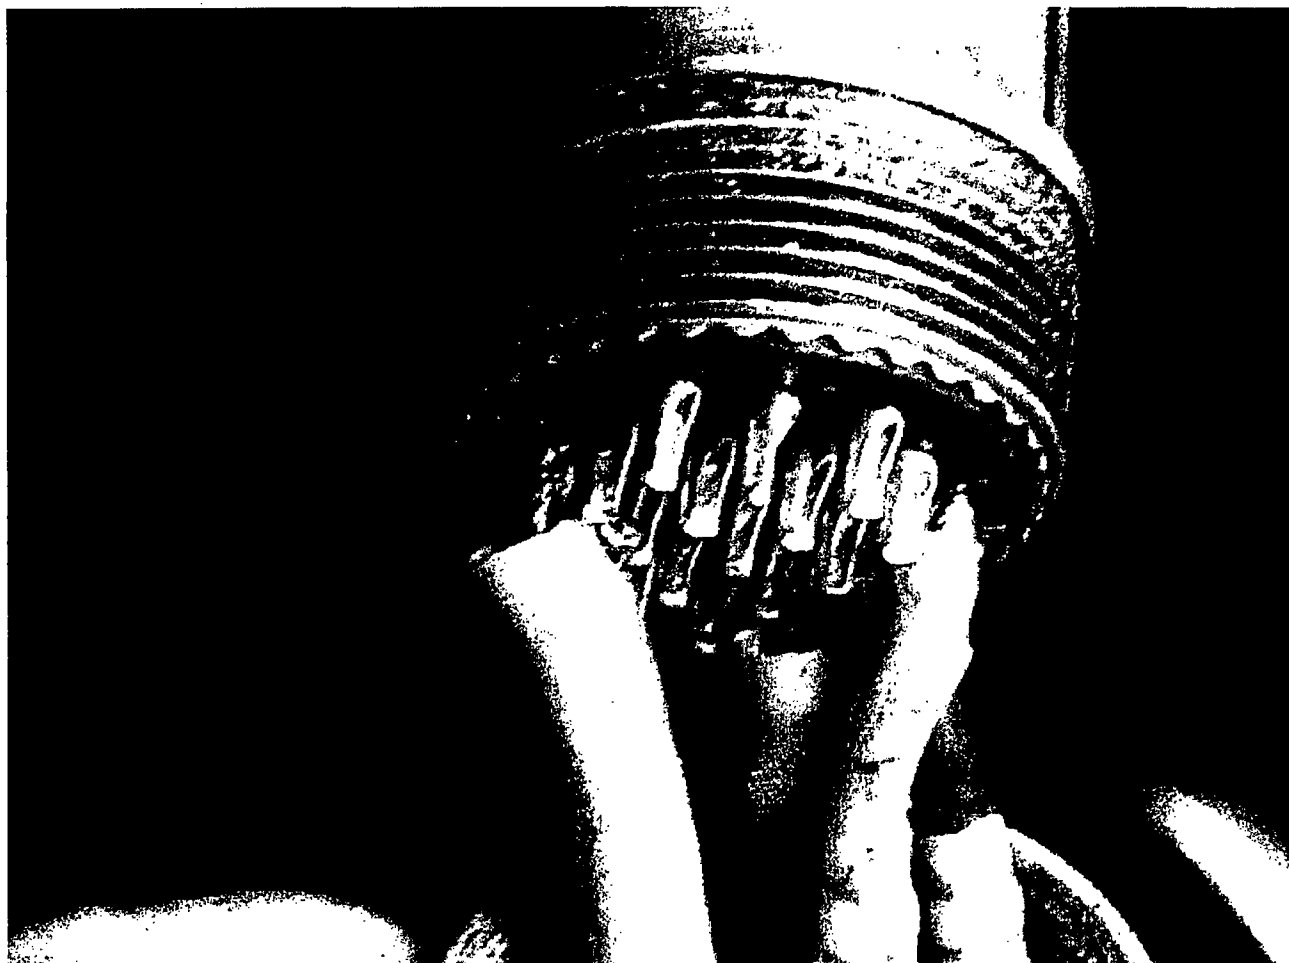
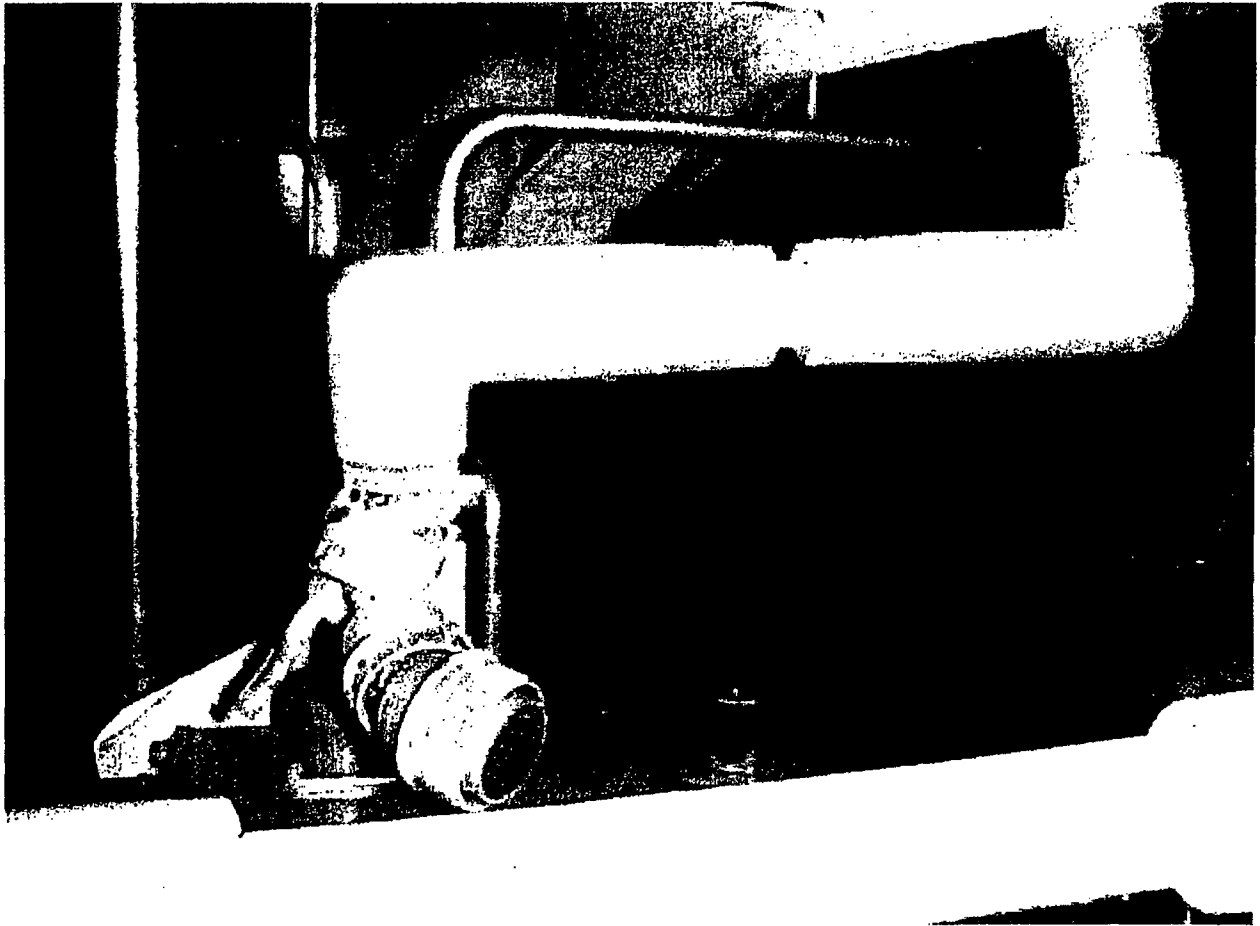
1. ENG #2 AMPHENOL CONNECTOR ATTACHING WIRE ASSY TO EGB WOODWARD GOVERNOR NEEDS TO BE REPLACED. THE SOLDER AT THE CONNECTOR IS DEGRADING AND IN FAIR FUNCTIONAL CONDITION. (SEE ATTACHED PICS)

2. BOTH ENGINES HAVE FIXED CONDUIT RUNNING FROM TERM BOXES 373 AND 375 ON EAST AND WEST END OF MOTORS. FROM THE TERM BOX'S THE RIGID CONDUIT RUNS THROUGH SEVERAL 90 DEGREE RIGID 90 DEGREE BODIES ALL THE WAY UP TO THE GOVERNORS WITH ONLY THREE INCHES OF WIRE ASSEMBLY TO PLAY WITH BEFORE CONNECTING TO GOVERNORS. REQUEST ENGINEER EVALUATION OF RUNNING FLEX CONDUIT AT LEAST OVER THE LAST SEVERAL FEET FROM THE FIRST (T) CONDUIT BODY. (SEE ATTACHED PICS)

3. ENGINE #1 THE LAST TWO 90 DEGREE BODY AND T BODY ARE VERY LOOSE MOVE EASILY. UNABLE TO TIGHTEN WITH OUT REMOVING WIRE ASSEMBLY ATTACHED TO WOODWARD GOVERNOR.

Conduit between electronic governor and the mechanical governor is loose and needs to be retightened or replaced prior to making 2G003 Operable.

Discussed with Electrical Engineering (Battish) and the concern is not that this condition renders the EDG Inoperable, but rather that the EDG (2G003) would be returned to service in a degraded condition which could eventually lead to failure of the wiring between the electronic and mechanical governors. The EDG's have been in service for over 25 years with the current conduit configurations and we have not seen any failures to date. The loose conduit is a long term wear issue which could eventually cause a failure of the wiring or amphenol plug connections due to the excessive vibrations when the EDG is running. Any EDG would be considered Operable with loose conduits, but should be repaired at earliest opportunity.

Notification text -- Replace or Repair the loose flex conduit referenced in the AR. DESCRIPTION -- 1. ENG #2 AMPHENOL CONNECTOR ATTACHING WIRE ASSY TO EGB WOODWARD GOVENOR NEEDS TO BE REPLACED. THE SOLDER AT THE CONNECTOR IS DEGRADING AND IN FAIR FUCTIONAL CONDITION. (SEE ATTACHED PICS)

Notification text -- Evaluate whether additional design changes and/or PMs are necessary for 2G003 conduit support installed per MO 08052216
