SONGS - MEng-SEng. Report:

**ASSESSMENT OF THE IMPACT OF THE DEGRADED CONNECTIONS BETWEEN
BREAKER 2D201 AND BATTERY 2B008 ON THE FUNCTIONALITY-OPERABILITY
OF THE BATTERY 2B008**

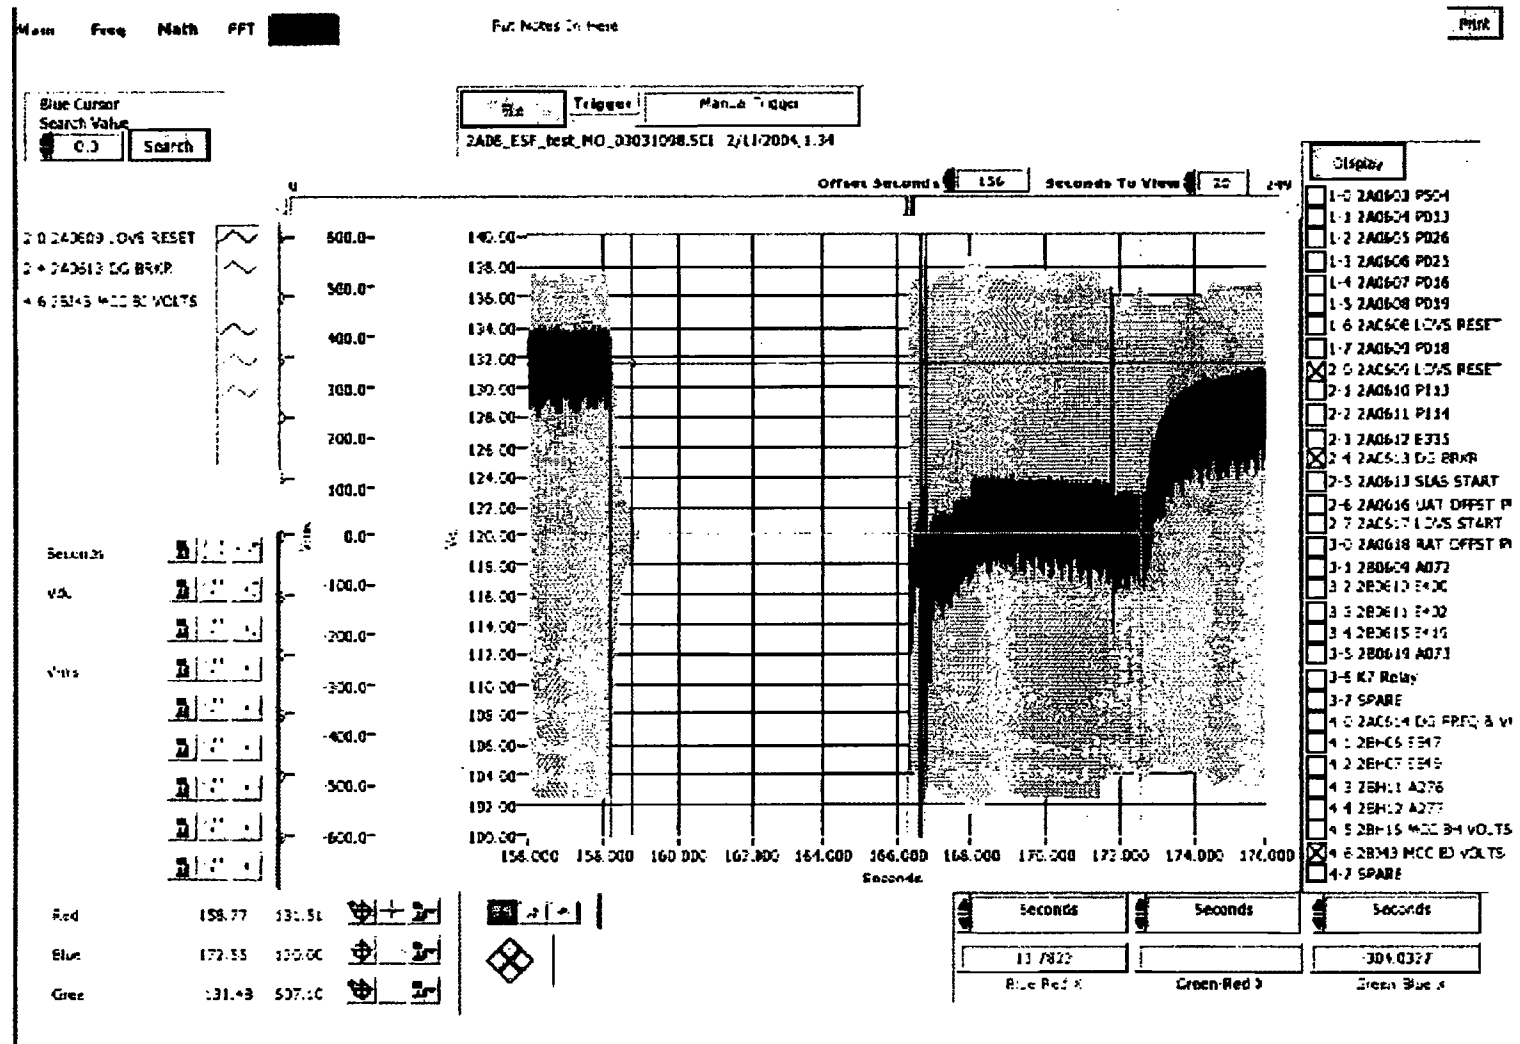
- Figure 1 shows a trace from an ESF test carried out on 2/11/2004.
- Figure 2 shows a trace from an ESF test carried out on 11/29/2007, almost three years after the 2D002 breaker replacement.
- Figure 3 shows a trace from an LOVS test carried out on 1/28/2008, just a few weeks before the discovery of the degraded condition of the connections.

Figure 1 – ESF test on affected circuit on 2/11/2004 before the breaker replacement. Test duration of the test about 15 seconds.

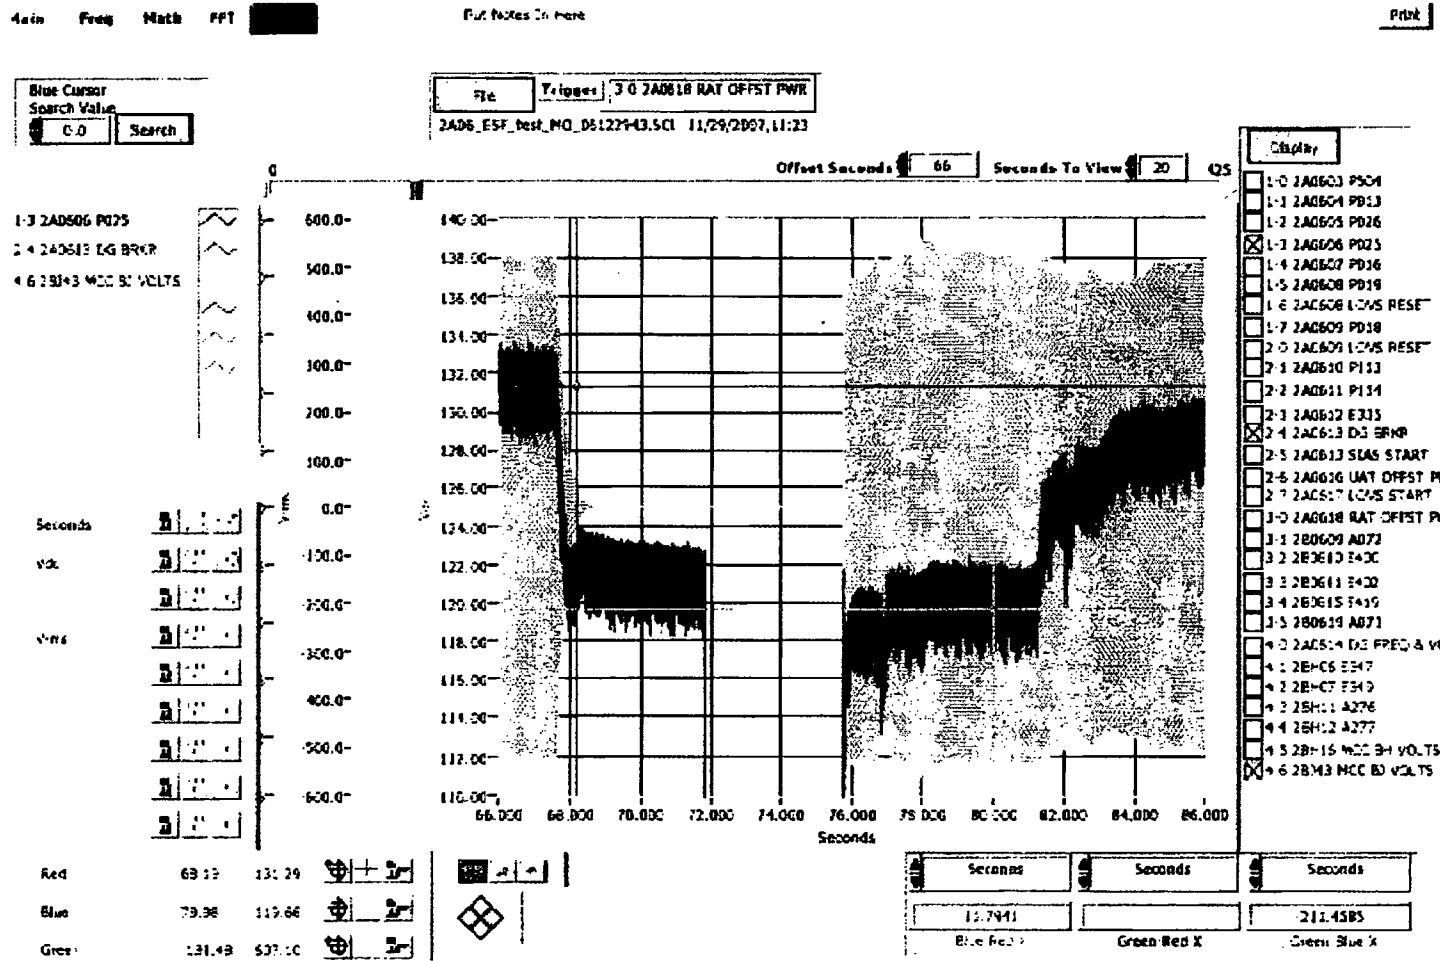
Figure 2 – ESF test on affected circuit on 11/29/2007 after breaker replacement. It is important to note no significant changes in the test results between this test after breaker replacement and the one in Figure 1, before breaker replacement. Test duration about 15 seconds.

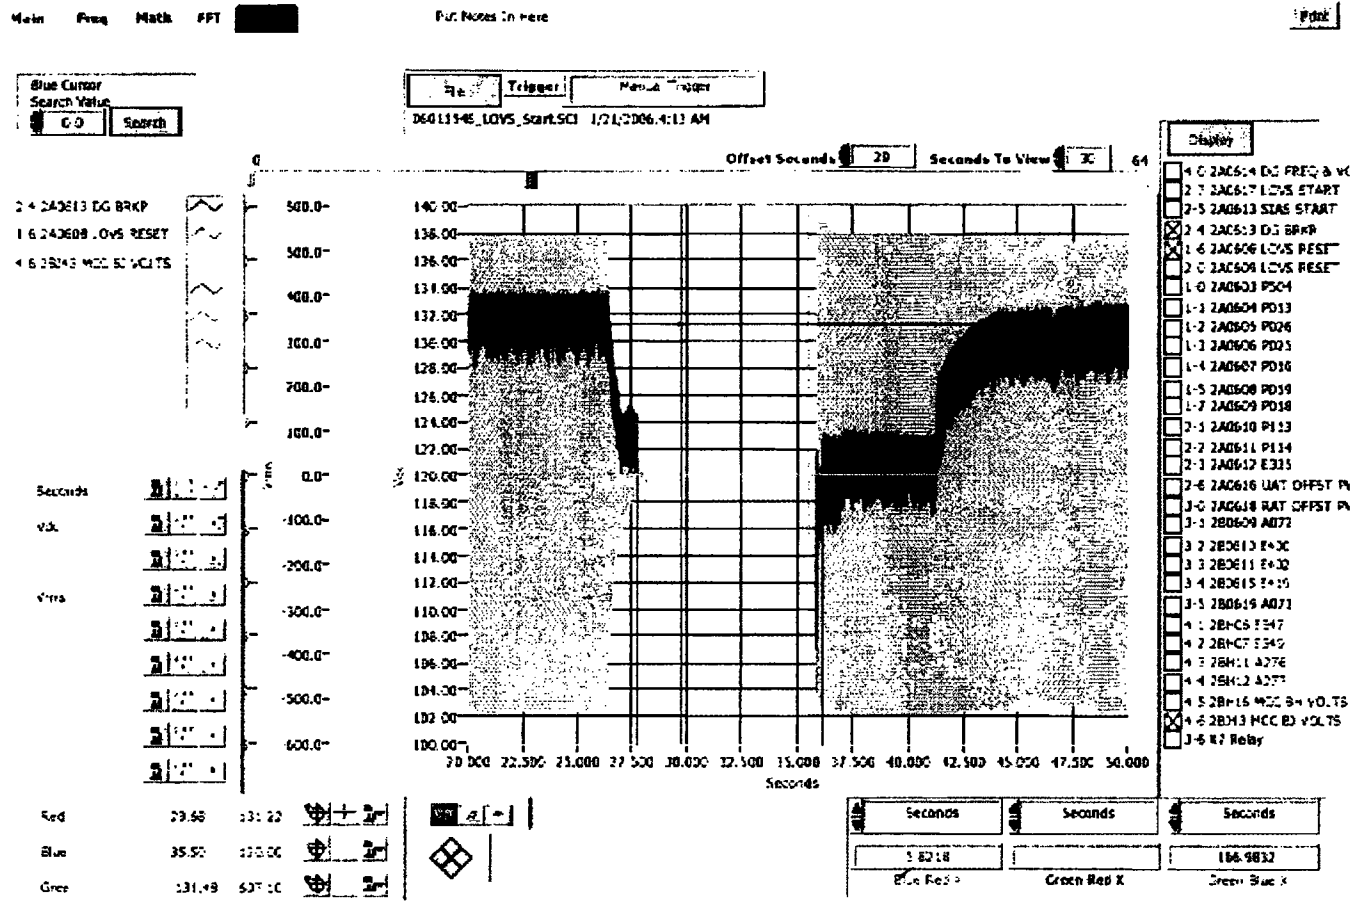
Figure 3 – LOVS test on affected circuit on 1/21/2008 performed a few weeks before the degraded condition of the connection was discovered. The test results were satisfactory. Test duration about 15 seconds.

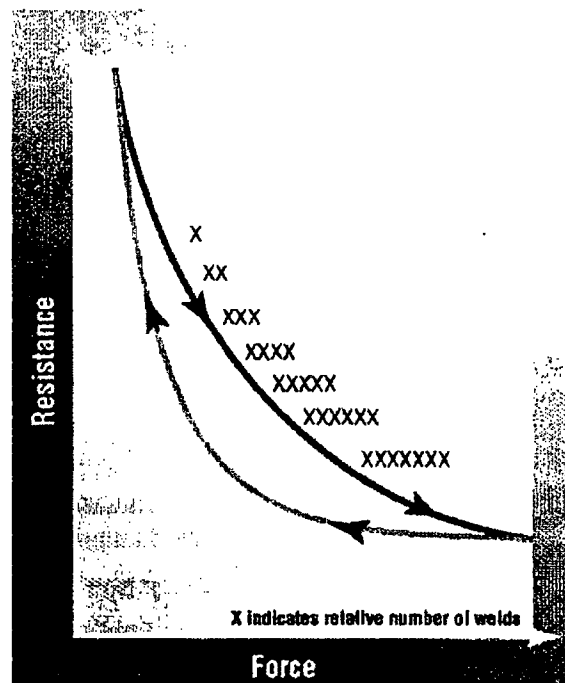
All the aforementioned are in accordance with the assumption based on existing knowledge (as shown graphically in Figure 5), that once a clean contact was established on March 2004, losing pressure did not immediately result in an increase of contact resistance. This only happened after the 4-day period of swing-charger current flowing thru the impacted joint.

Figure 5 [4] – Contact theory says that contact points are actually cold welds. If the high contact force is decreased, the contact resistance remains constant and does not increase until a much lower force is reached.

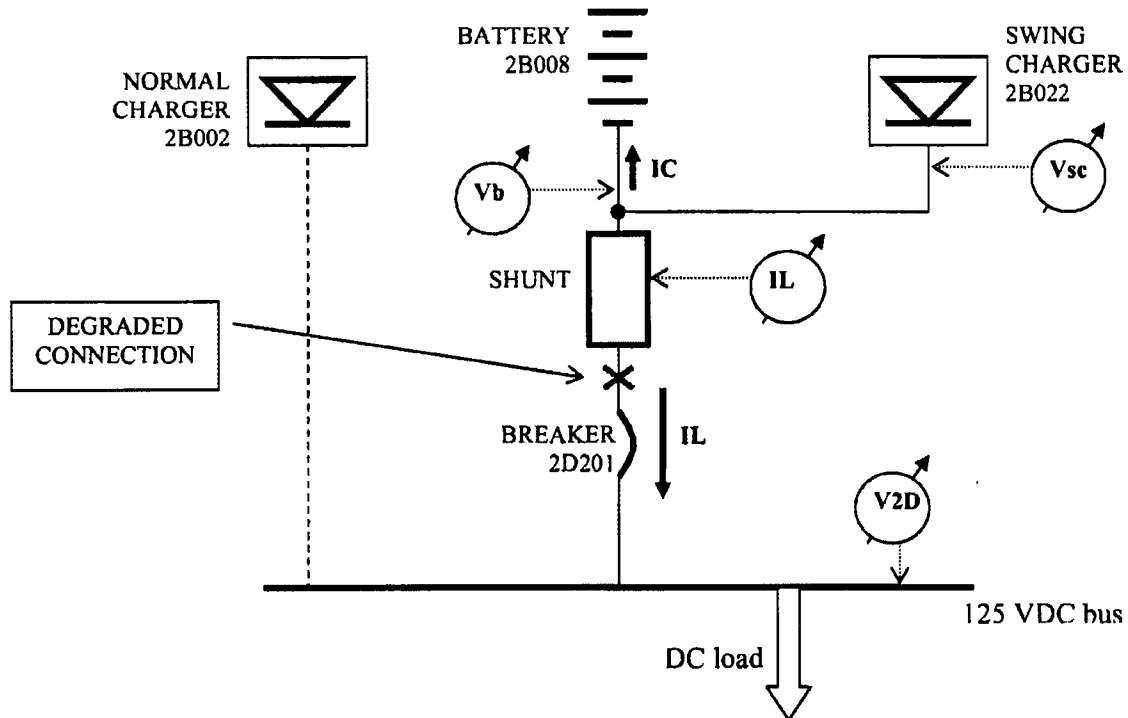
1) Calculation of contact resistance while the swing charger is working:

On 3/17/08, when the normal charger (2B002) was removed from service and the swing charger (2B022) was placed in service, the swing charger voltmeter read 131.52 (+/- 0.15) VDC and 112 ADC. Based on plant computer data, the 2D2 bus voltage under these conditions was between 130.7 and 131.8 VDC. Based on this information, the 2D201 connection resistance at this time would be 0 to 8 mΩ.

IL = 112 ADC (from MO #08011467)
Vsc = 131.52 +/- 0.15 VDC = 131.67-131.37 VDC
V2D = 130.7-131.8 VDC (RTime reading of 132 VDC and calibration data from Notification #200055175).

$$R_{\min} = (131.37 - 131.37)/112 = 0 \text{ m}\Omega$$

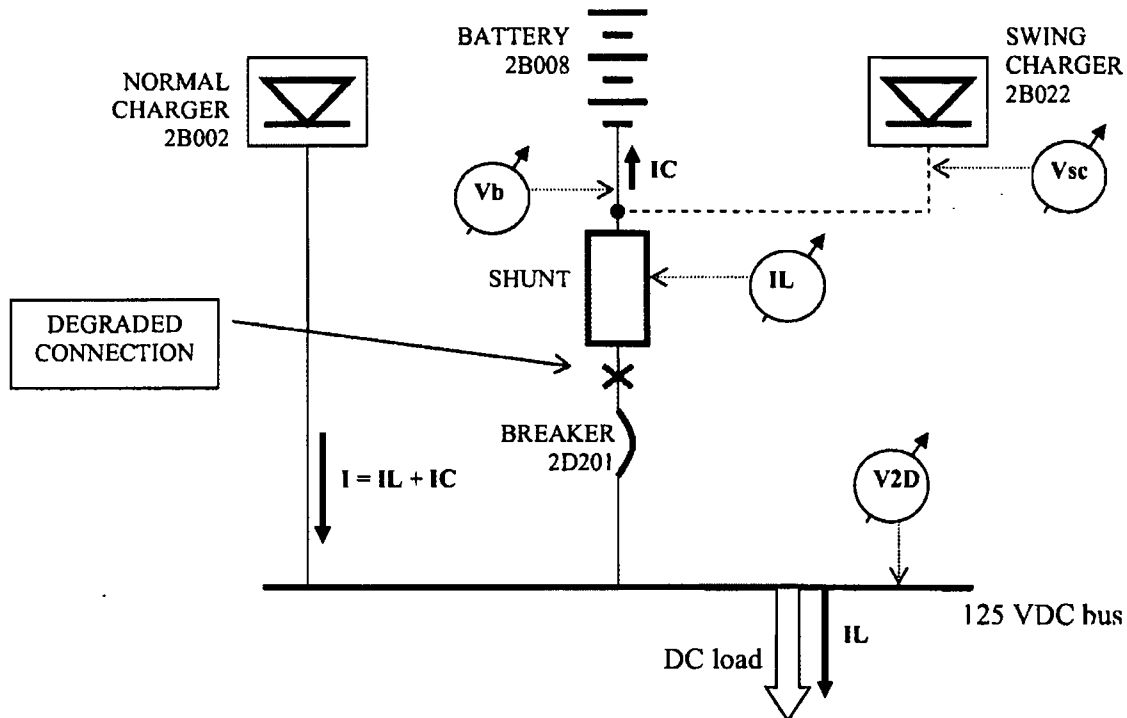
2) Calculation of contact resistance when the normal charger resumed operation:

On 3/21/08, when the normal charger (2B002) was returned to service, the 2D2 bus voltage was 130.7-131.8 VDC. The battery terminal voltage under these conditions was 131.38 (+/- 0.15) VDC. Assuming a typical float current of 0.1 amps into the battery, the corresponding connection resistance at this time would be equal to 0-5.7 Ω . Statistically, this resistance is orders of magnitude higher than the connection resistance on 3/17/08.

$$\begin{aligned} I_C &= 0.1 \text{ ADC} \\ V_b &= 131.38 \pm 0.15 \text{ VDC} = 131.53\text{-}131.23 \text{ VDC} \\ V_{2D} &= 130.7\text{-}131.8 \text{ VDC} \end{aligned}$$

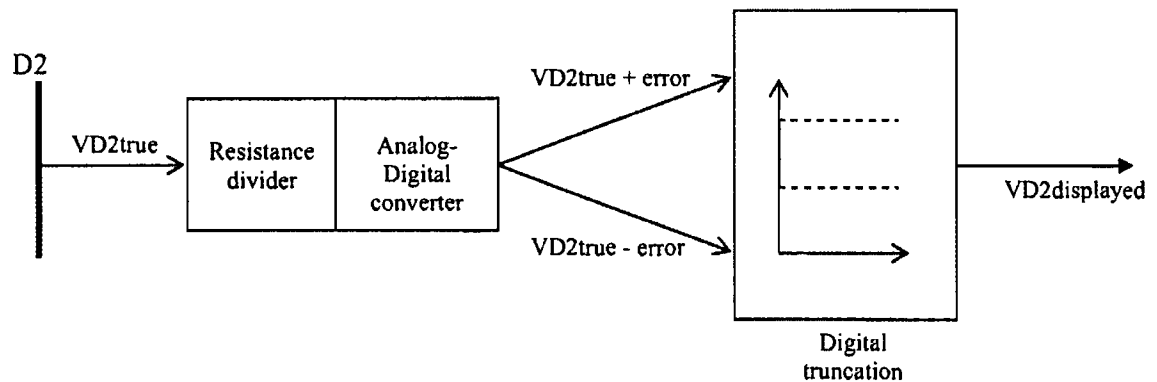
As shown on the schematic below, the value of VD2 is measured on a computer, after it is affected by the error of the resistance divider, analog-digital converter, and truncated at the computer. Thus, if the value displayed in the computer for VD2 is 132 VDC, then the true value at the bus is as shown below.

$$VD2_{\text{displayed}} = 132 \text{ VDC} \rightarrow \text{true value of VD2} = 130.8\text{-}131.7 \text{ VDC}$$
