VIRGINIA ELECTRIC AND POWER COMPANY
RICHMOND, VIRGINIA 23261

September 17, 2011

VIRGINIA ELECTRIC AND POWER COMPANY (DOMINION)
NORTH ANNA POWER STATION UNITS 1 AND 2
NORTH ANNA INDEPENDENT SPENT FUEL STORAGE INSTALLATION
SUMMARY REPORT OF AUGUST 23, 2011 EARTHQUAKE RESPONSE AND
RESTART READINESS DETERMINATION PLAN

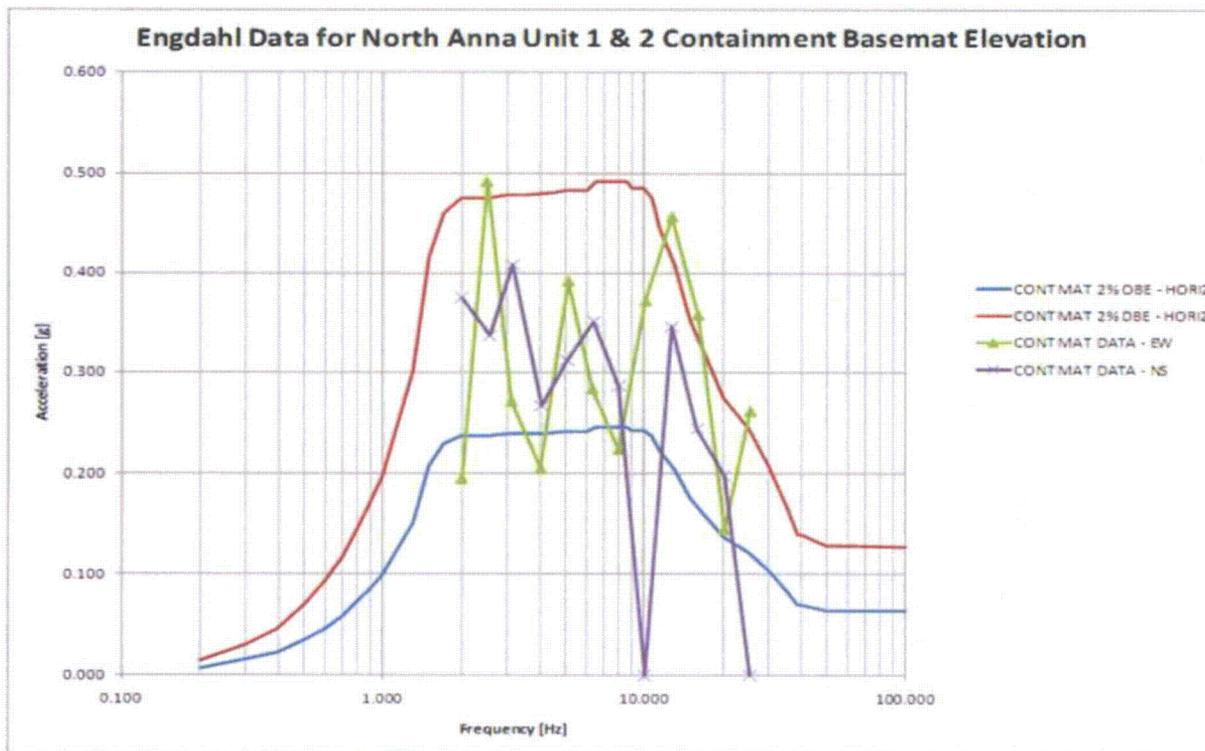
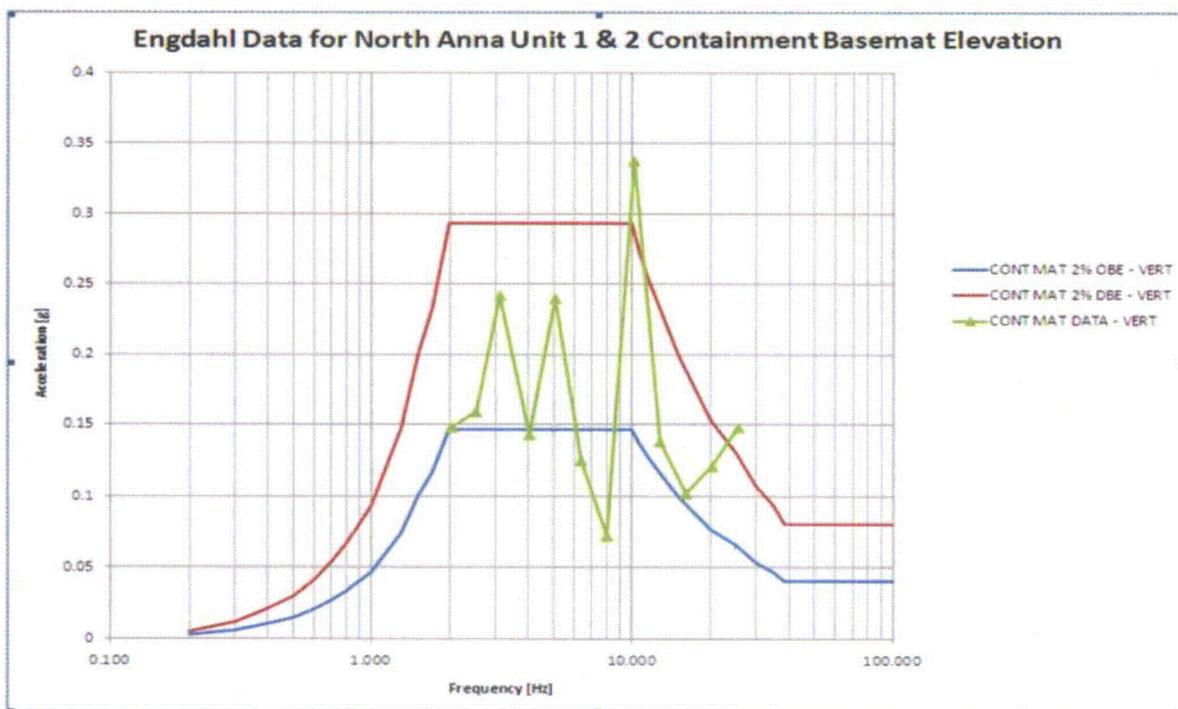
Figure 2.1 – Engdahl Data from Containment Basemat Recorder – Horizontal Directions

As demonstrated in Figure 2.1 for horizontal directions and Figure 2.2 for vertical directions, the Engdahl data for the Containment basemat elevation shows that OBE levels were exceeded. For DBE, however, there are only slight exceedances at a few frequencies.

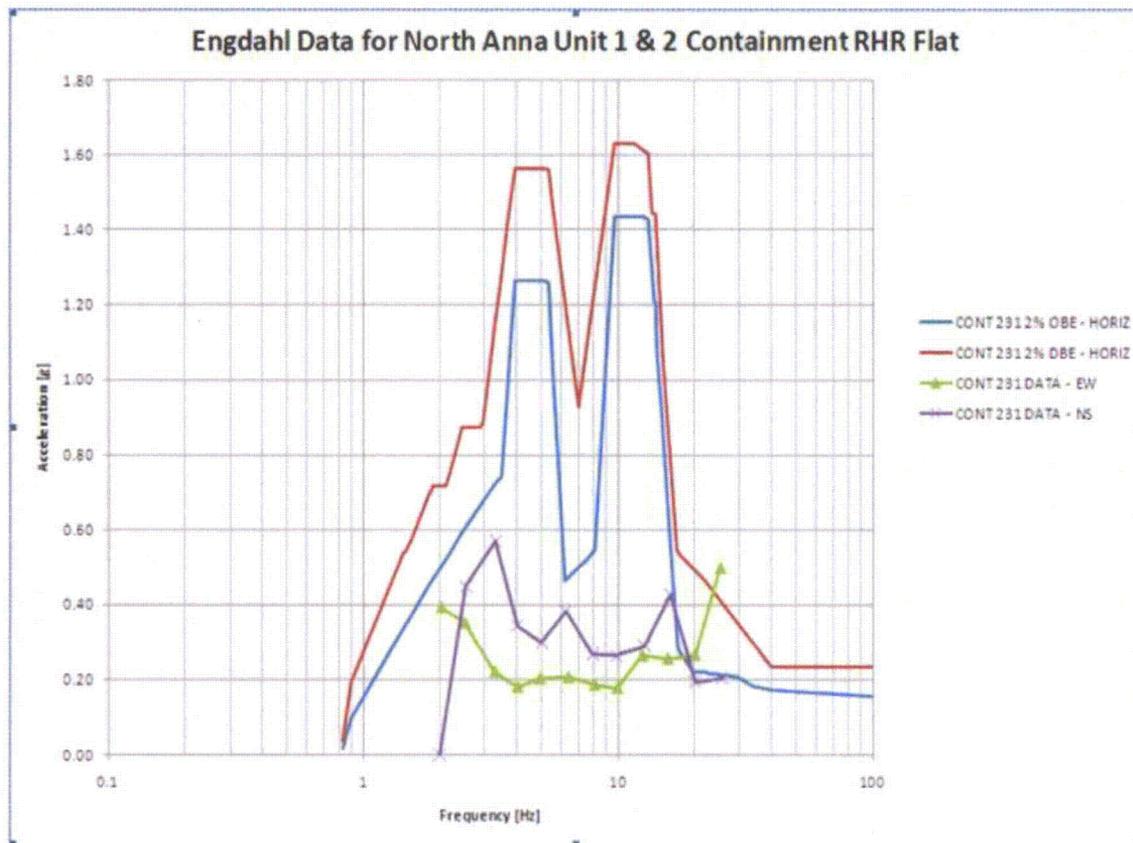
Figure 2.3 – Data from Containment RHR Flat Recorder – Horizontal Directions

As demonstrated in Figure 2.3, Engdahl recorded data in East-West and North-South directions at the RHR Flat elevation of Containment are less than OBE and DBE for frequency ranges up to approximately 16 Hz. Exceedances over DBE in the East-West direction occur around 25 Hz, in the high frequency range.

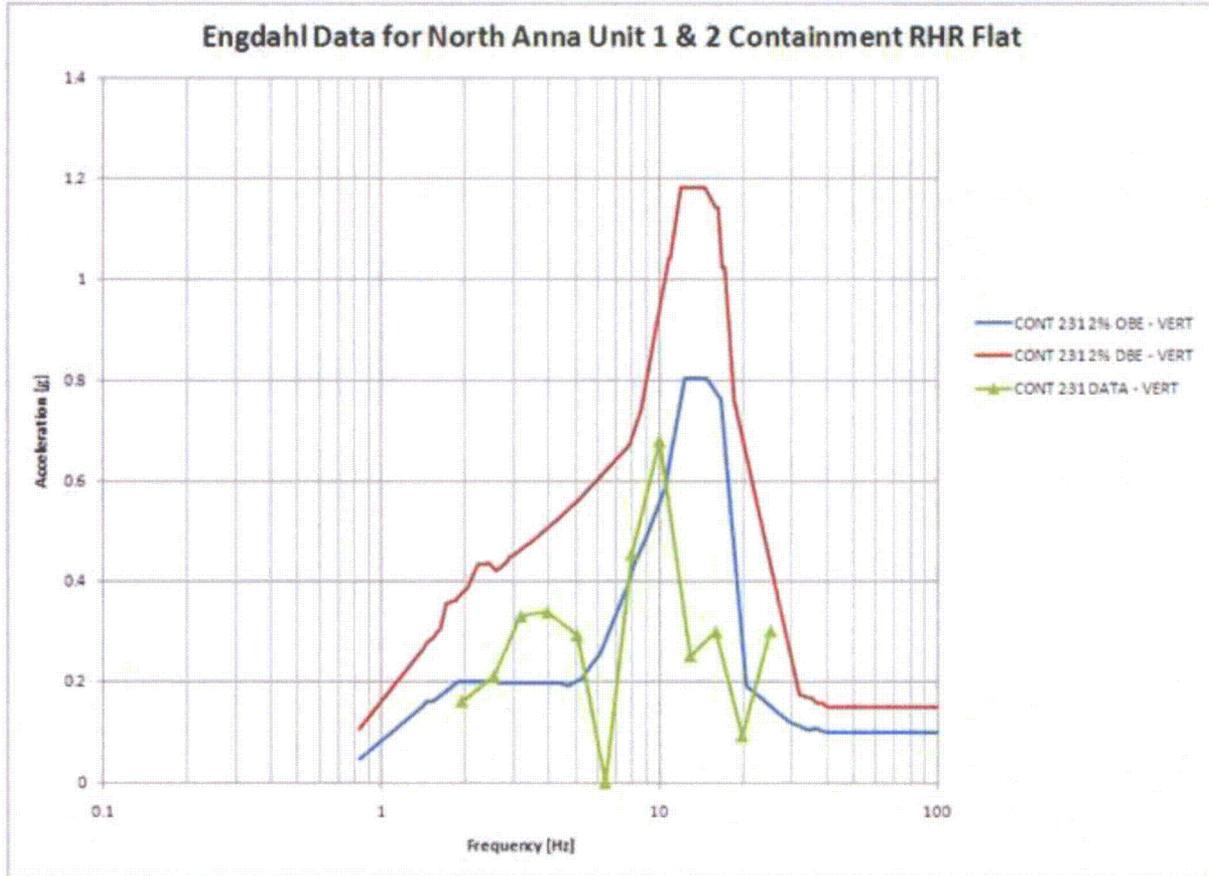
Figure 2.4 – Engdahl Data from Containment RHR Flat Recorder – Vertical Direction

As demonstrated in Figure 2.4, Engdahl recorded data in vertical direction at the RHR Flat elevation of Containment exceeds OBE in several frequencies, but remains less than DBE.

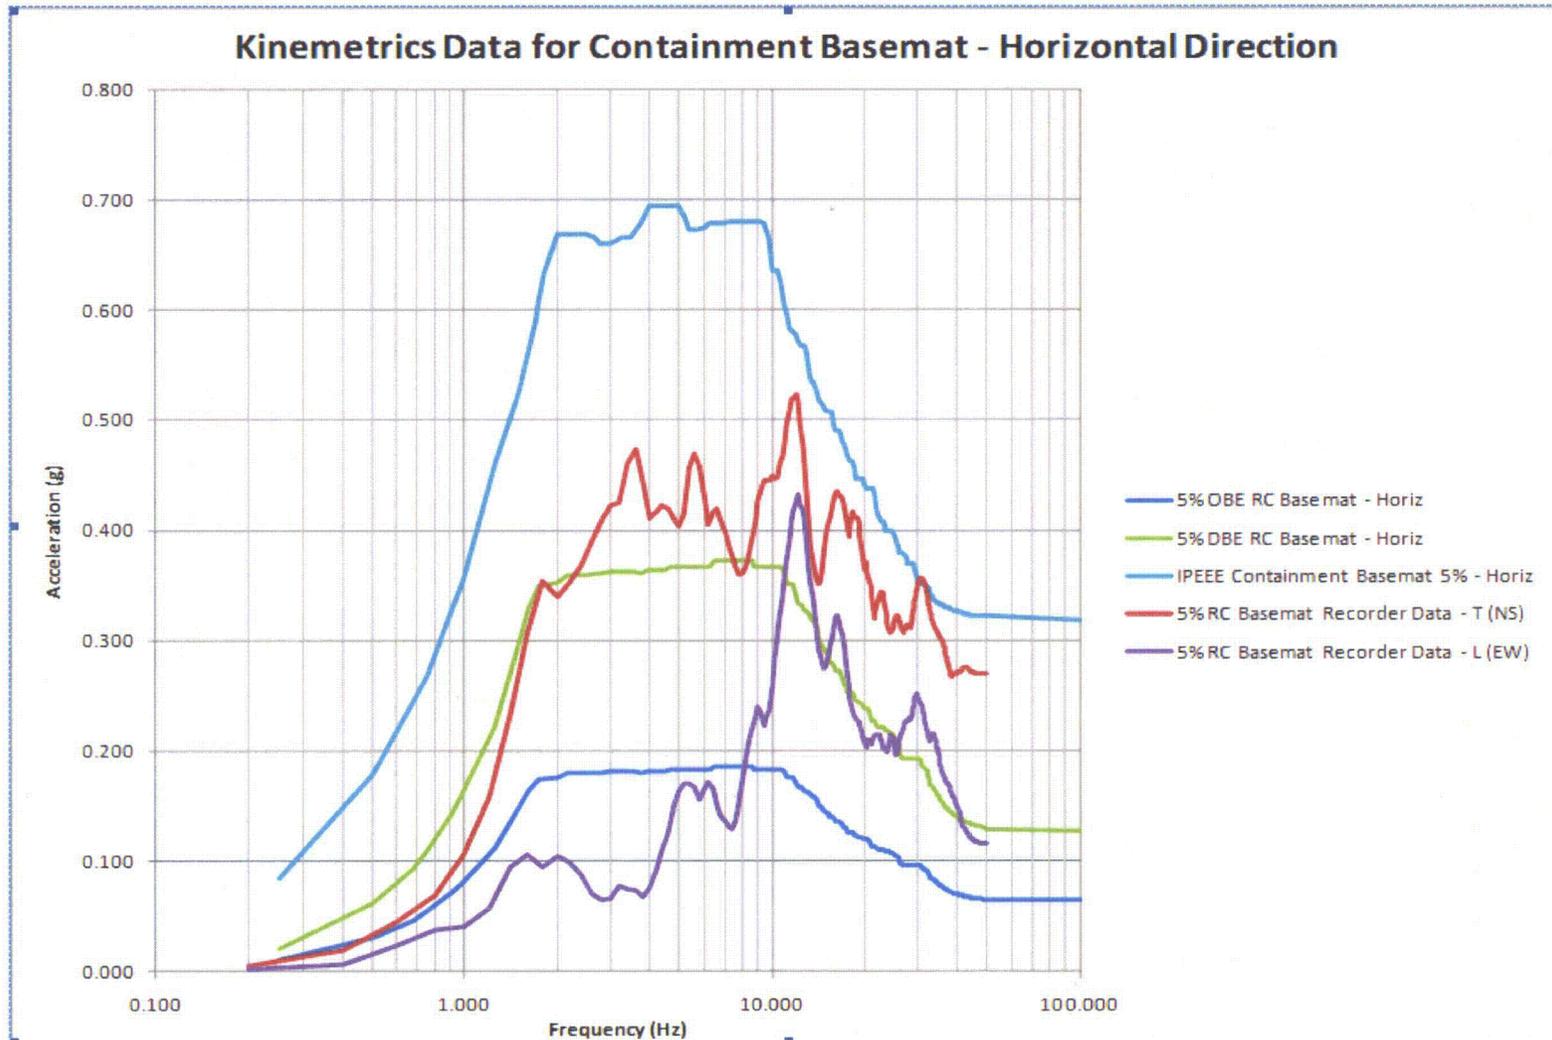
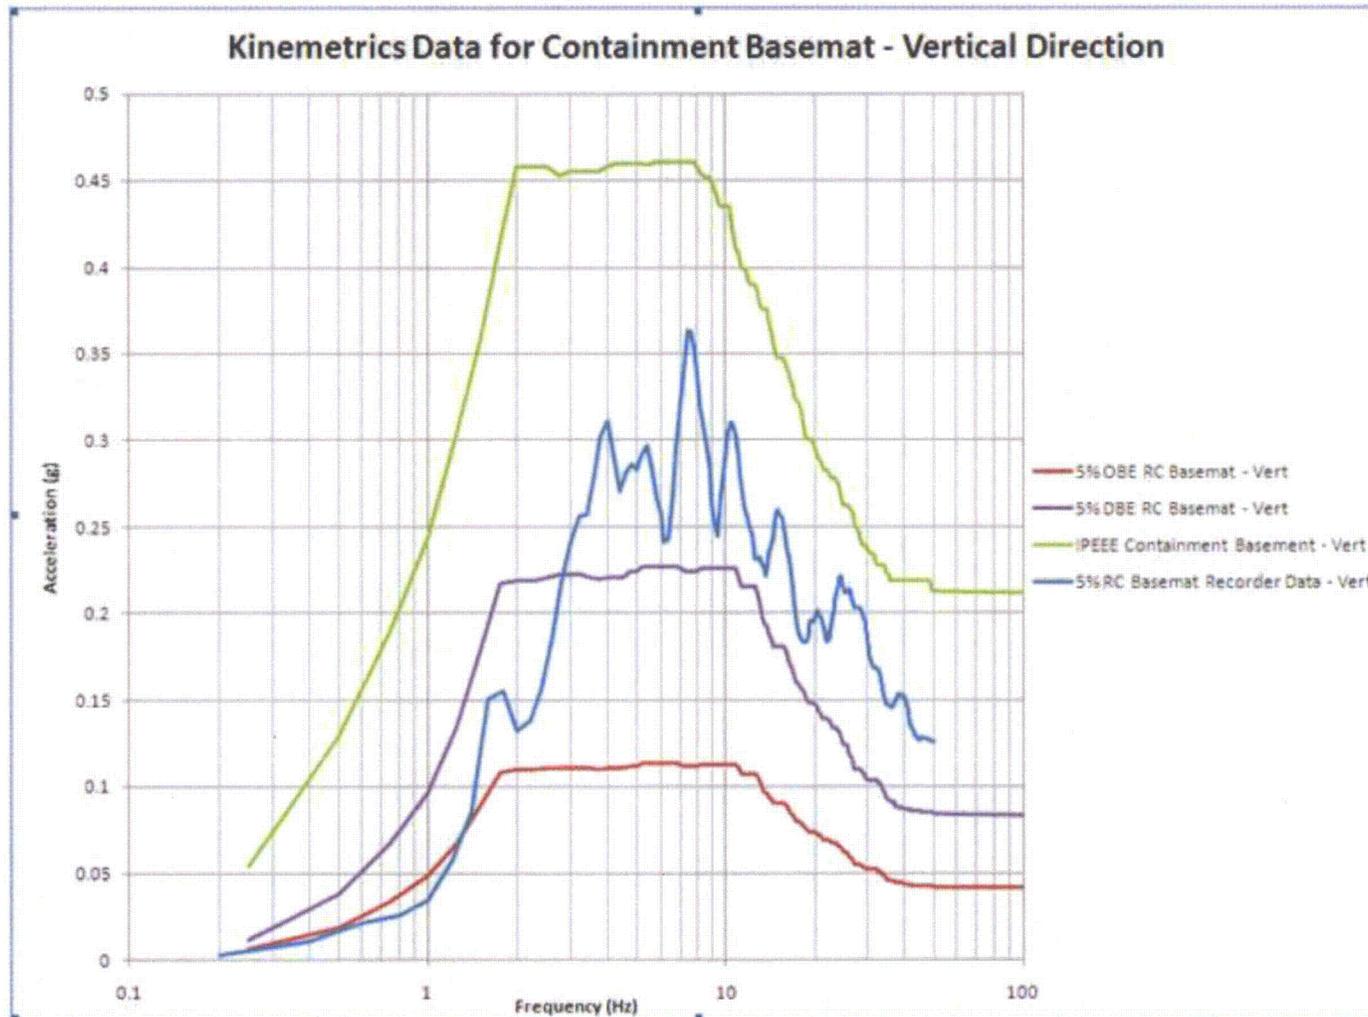
Figure 3.1 – Containment Basemat - Horizontal

As shown in Figures 3.1 and 3.2, the data shows that the OBE and DBE were exceeded in all three directions; however, for purposes of quantifying how much the recorded response spectra exceeds the design basis earthquake spectra, the average exceedance is calculated in the frequency range from 2 to 10 Hz. This calculation is made for the north-south and vertical directions only since the recorded spectrum in the east-west direction is completely enveloped in that range by the DBE spectrum. The range of 2 to 10 Hz is chosen since this is the range of frequencies associated with damage to engineered structures and much of the plant equipment as defined in EPRI report NP-5930 and Reg. Guide 1.166.

As shown above, the earthquake exceeded the DBE, on average, by about 12% in the N-S direction with the sharpest peak exceeding the corresponding DBE spectral ordinate by a factor of about 1.3, and about 21% in the vertical direction with the sharpest peak exceeding the DBE by a factor of about 1.6.
