General Electric Advanced Technology Manual

Chapter 7.2

Oyster Creek Log Summary

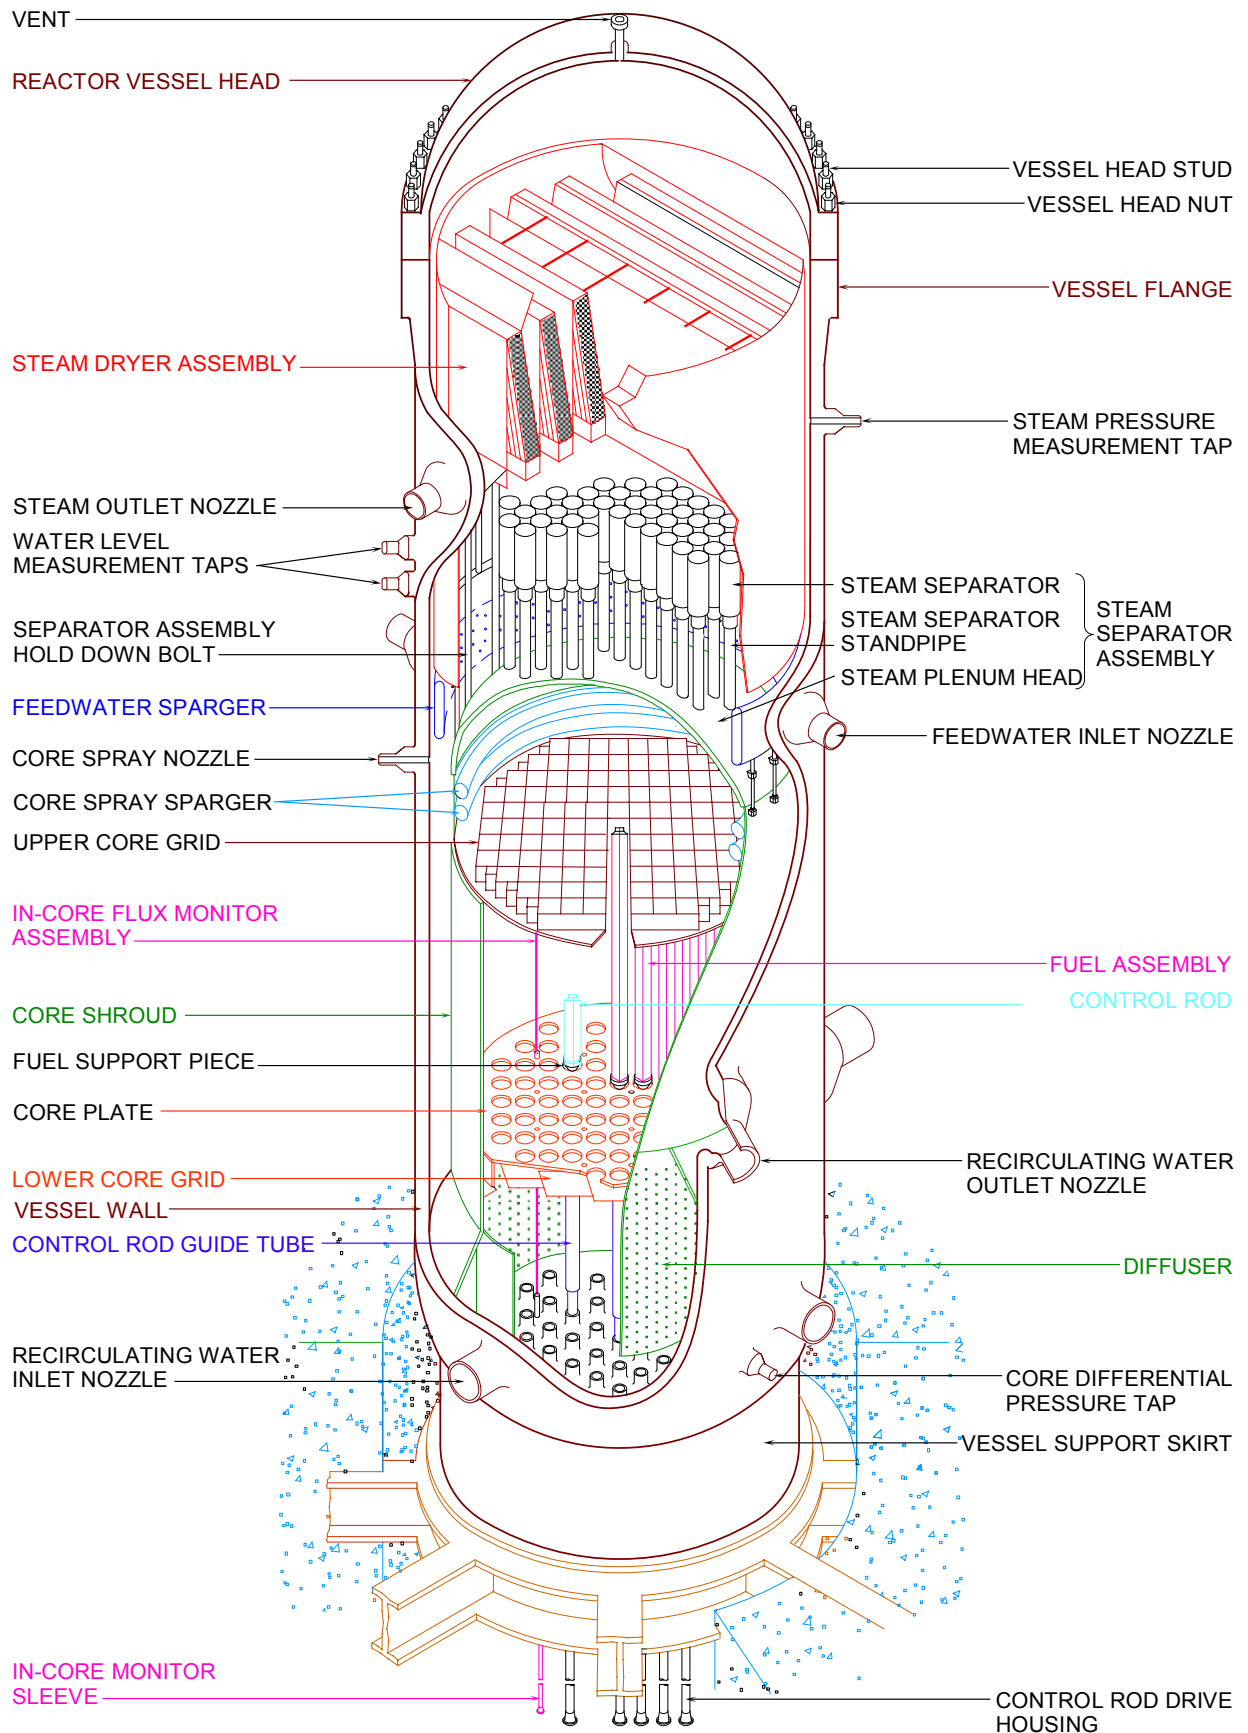
Figure 7.2-1 BWR/2 Reactor Vessel

Unlike other BWRs the BWR/2 reactor vessels do not have direct communication from the annulus region to the core inlet plenum. Water must exit the reactor vessel via recirculation loops and then reenter the vessel bottom head.

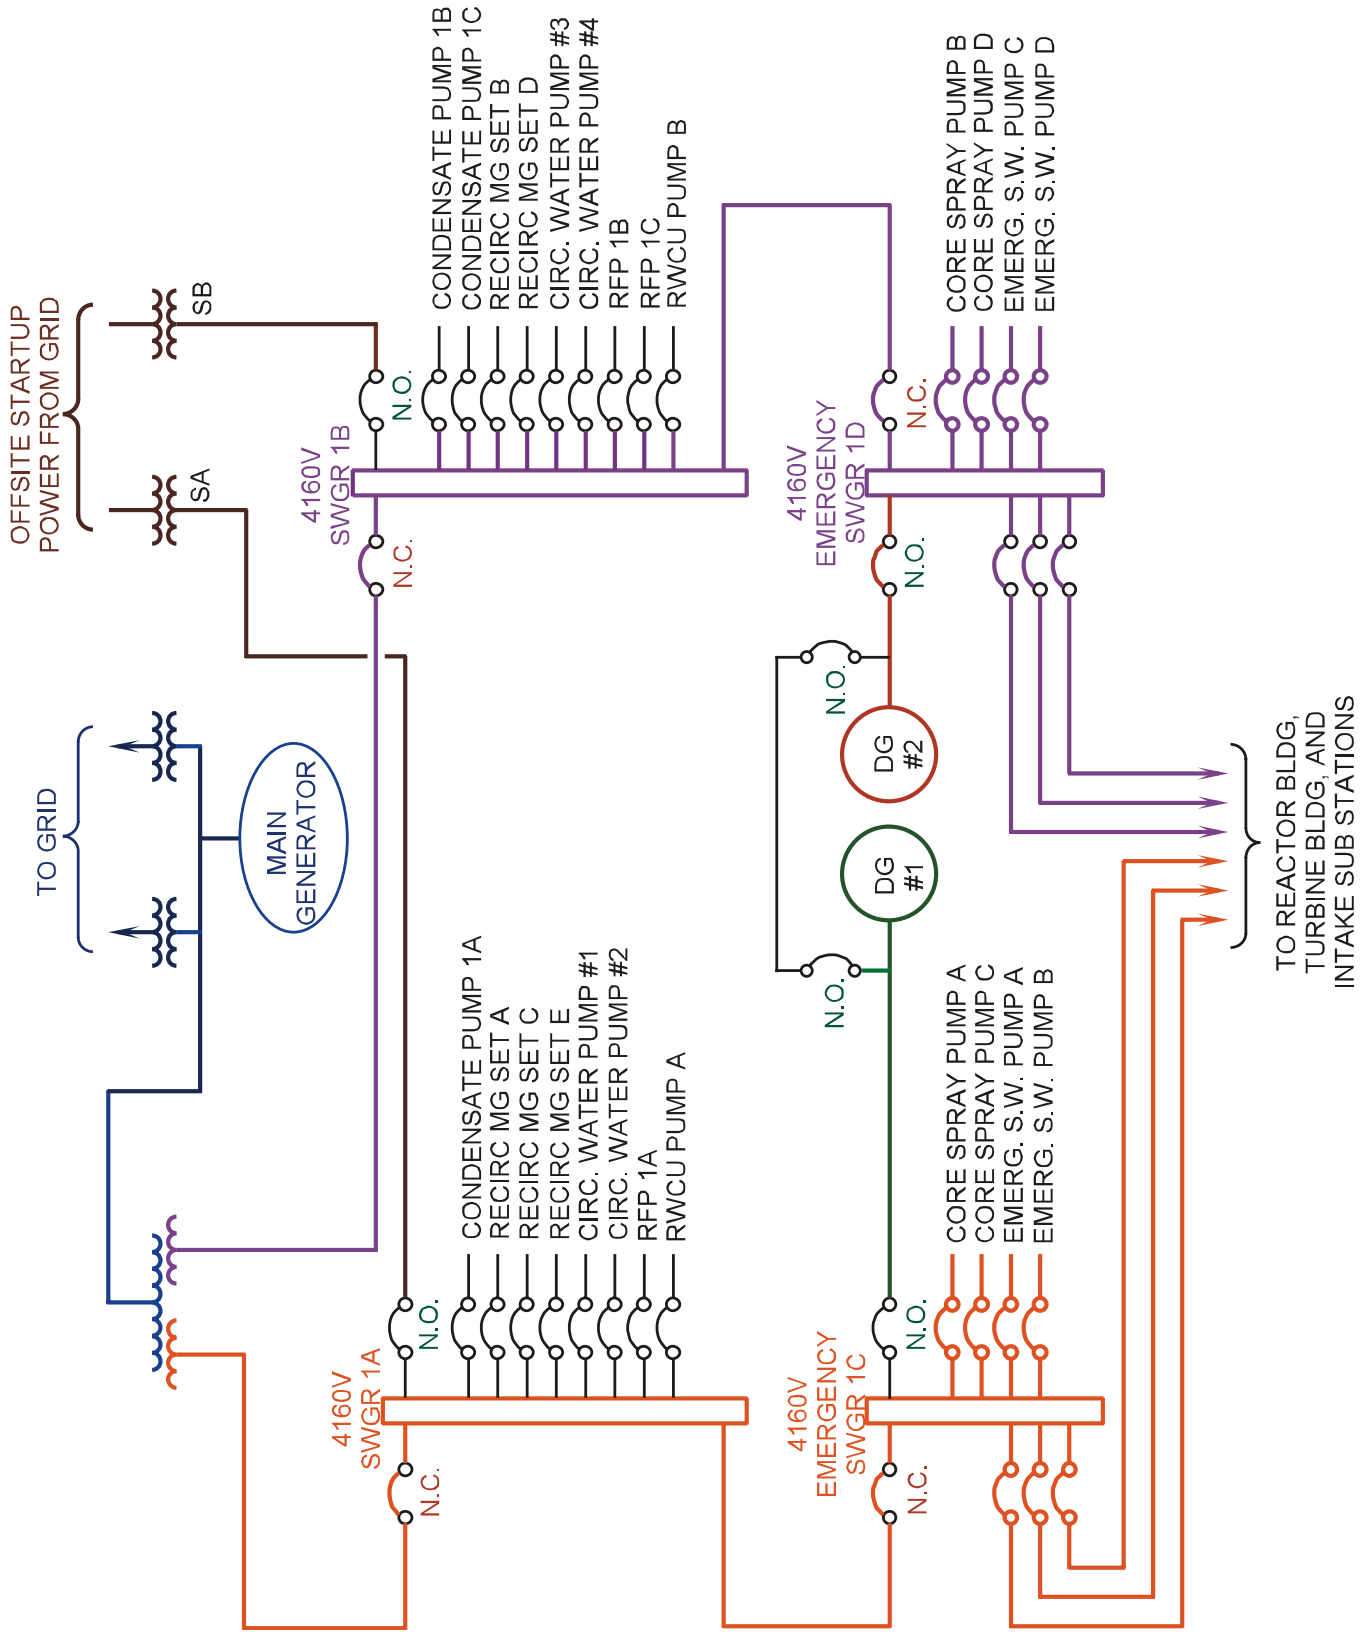
Figure 7.2-3 Oyster Creek Electrical Distribution

One of two startup transformers, SB, was out of service to perform an inspection of its associated 4160 volt cabling (permitted by Technical Specifications). Transformer SB supplies off site power to one half of the station electrical distribution system (Figure 7.2-1) when power is not available through the station auxiliary transformer. The 4160 volt busses which receive power from SB are 1B and 1D. Buss 1D supplies power to certain redundant safety systems and is designed to be powered from the number 2 diesel generator in the event power is not available from either the auxiliary or startup transformer. Buss 1B supplies 4160 volt power to non-safety related systems and hence, does not have a diesel backup power source.

The turbine generator subsequently tripped on reverse power as designed which initiated an automatic transfer of power to the startup transformers. Power to busses 1A and 1C successfully transferred from the auxiliary transformer to startup transformer SA. Since SB was out of service at this time, power was lost to busses 1B and 1D which caused an automatic start of the number 2 diesel generator.

Loss of power to bus 1B resulted in loss of condensate pumps and feedwater pumps B and C. Although power was available to the A condensate and feedwater pumps, the A feedwater pump tripped on low suction pressure. With mass inventory leaving the reactor vessel through the steam bypass valves with no make-up, reactor water level decreased.

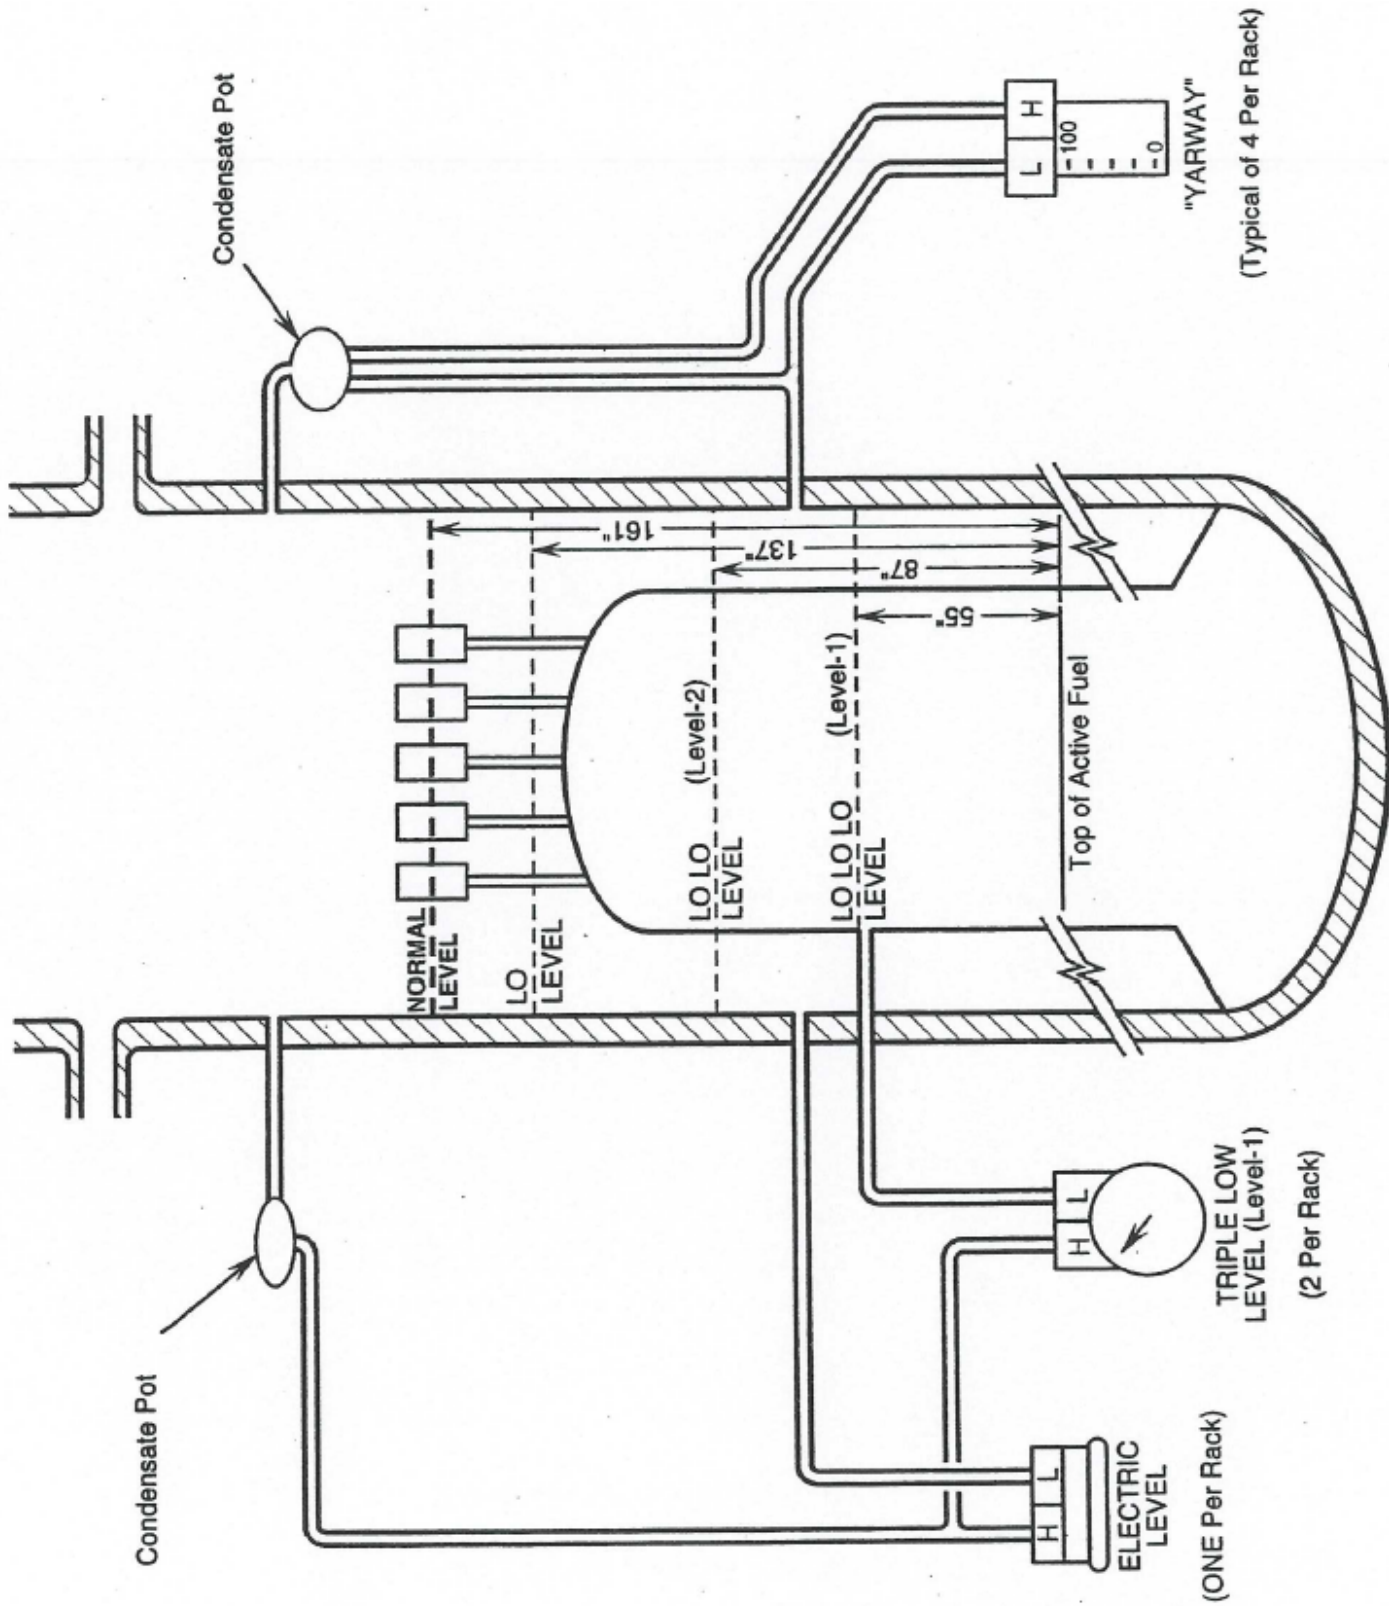
Figure 7.2-4 Oyster Creek Vessel Level Instrumentation

During performance of local alarm verification and indicator checks the low-low-low (level 1) water level indicators were found to be below their alarm setpoint (10 inches). A recheck performed locally showed that the pointers were active (moving) although they continued to read below their alarm point. Also the instruments were indicating at or slightly above their lower level of detection.

The C recirculation pump was started to provide a better indication of the plant cooldown rate. After the pump started, indicated water level dropped approximately 3 feet in less than two minutes causing the operator to stop the pump and investigate the reason for the level drop. In response to the level problem, the operator attempted to start the A feedwater pump. The pump failed to start due to a tripped overload on the auxiliary oil pump which provides an interlock in the feedwater pump starting sequence. The auxiliary oil pump was started locally followed by starting the A Feedwater pump. Indicated water level increased to a level corresponding to 13 feet 8 inches above the top of the core. The operator now recognized that all five recirculation loop discharge valves were closed and indicated water level and actual water level may not have been the same.

The A recirculation pump was placed in service which removed the disparity between the water level instruments. Indicated water level dropped approximately three feet to 11 feet 4 inches above the top of the fuel. Recirculation loop A temperature increased from 375°F to 465°F after starting the pump. In addition, the low-low-low water level condition cleared at this time.

The need for better communication between the downcomer region and the core region was apparent. Therefore, a Technical Specification revision was issued which required that at least two recirculation loops will be lined up with their respective suction and discharge valves open during all modes of plant operation. The requirement was so important that it was placed in the Safety Limit section of Technical Specification.

A confirmatory order, dated March 14, 1983, was issued that required an interlock system for the recirculation pump loops. In lieu of the interlock, Oyster Creek received approval for the installation of an alarm system that would provide annunciation when the fourth loop was isolated. This modification was required to be completed by October 1986.
