## Partial Collapse of the Willow Island Cooling Tower

This case study describes the safety culture shortcomings that led directly to the partial collapse of a natural draft, hyperbolic, reinforced concrete cooling tower at Willow Island, WV, on April 27, 1978. The cooling tower was one of two towers being constructed by Research-Cottrell, Inc., for the Pleasants Power Station, a coal-fired electric power station owned by Allegheny Energy Supply Company. The resulting deaths of 51 construction workers represent one of the most costly accidents, in human terms, of any in the U.S. construction industry's history.

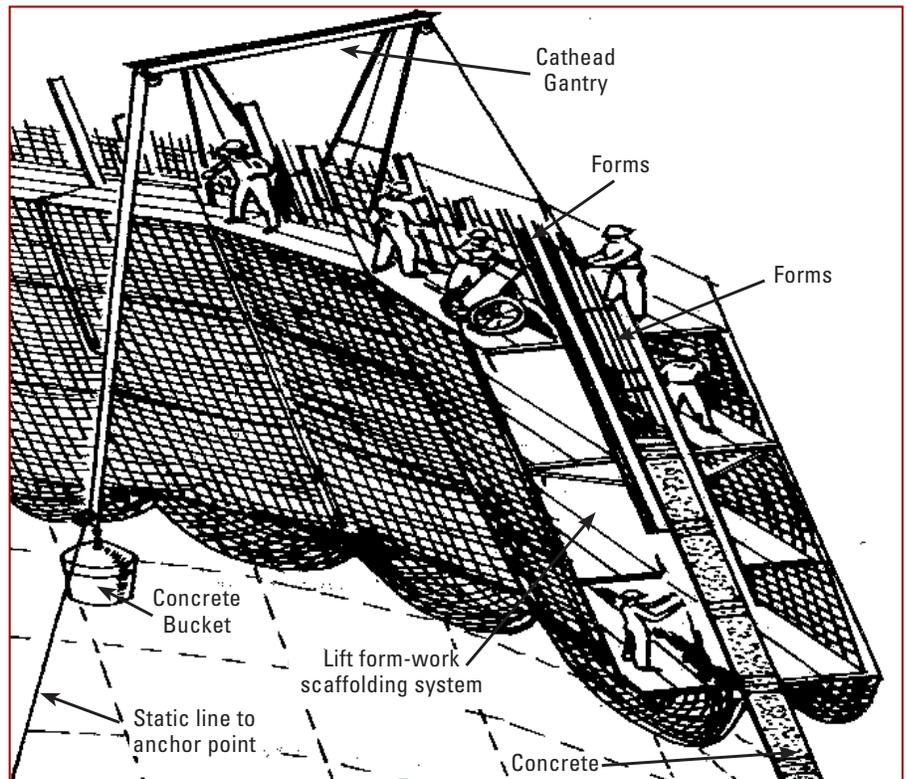
*Perspective of Scaffolding System (NBS Rpt, 1979)*

- The concrete that supported the lift form-work scaffolding system was of insufficient compressive strength to support the loads to which it was being subjected. The concrete had been placed only 18 hours before being required to support the lift form-work scaffolding system and had a predicted compressive strength of 220 pounds per square inch (psi) as noted in NBSIR 80-2010.<sup>4</sup> As further noted, the concrete would have started to fail at a compressive strength of 1,000 psi. In addition, the required concrete strength to support the lift form-work system should have included a factor of safety of 2 and consideration of the dynamic effects of the hoisting loads.
