REPORT ON THE
CALVERT CLIFFS UNIT 1
LOSS OF SERVICE WATER
ON MAY 20, 1980

by the
Office for Analysis and Evaluation
of Operational Data
December 1981

Prepared by: Eugene V. Imbro

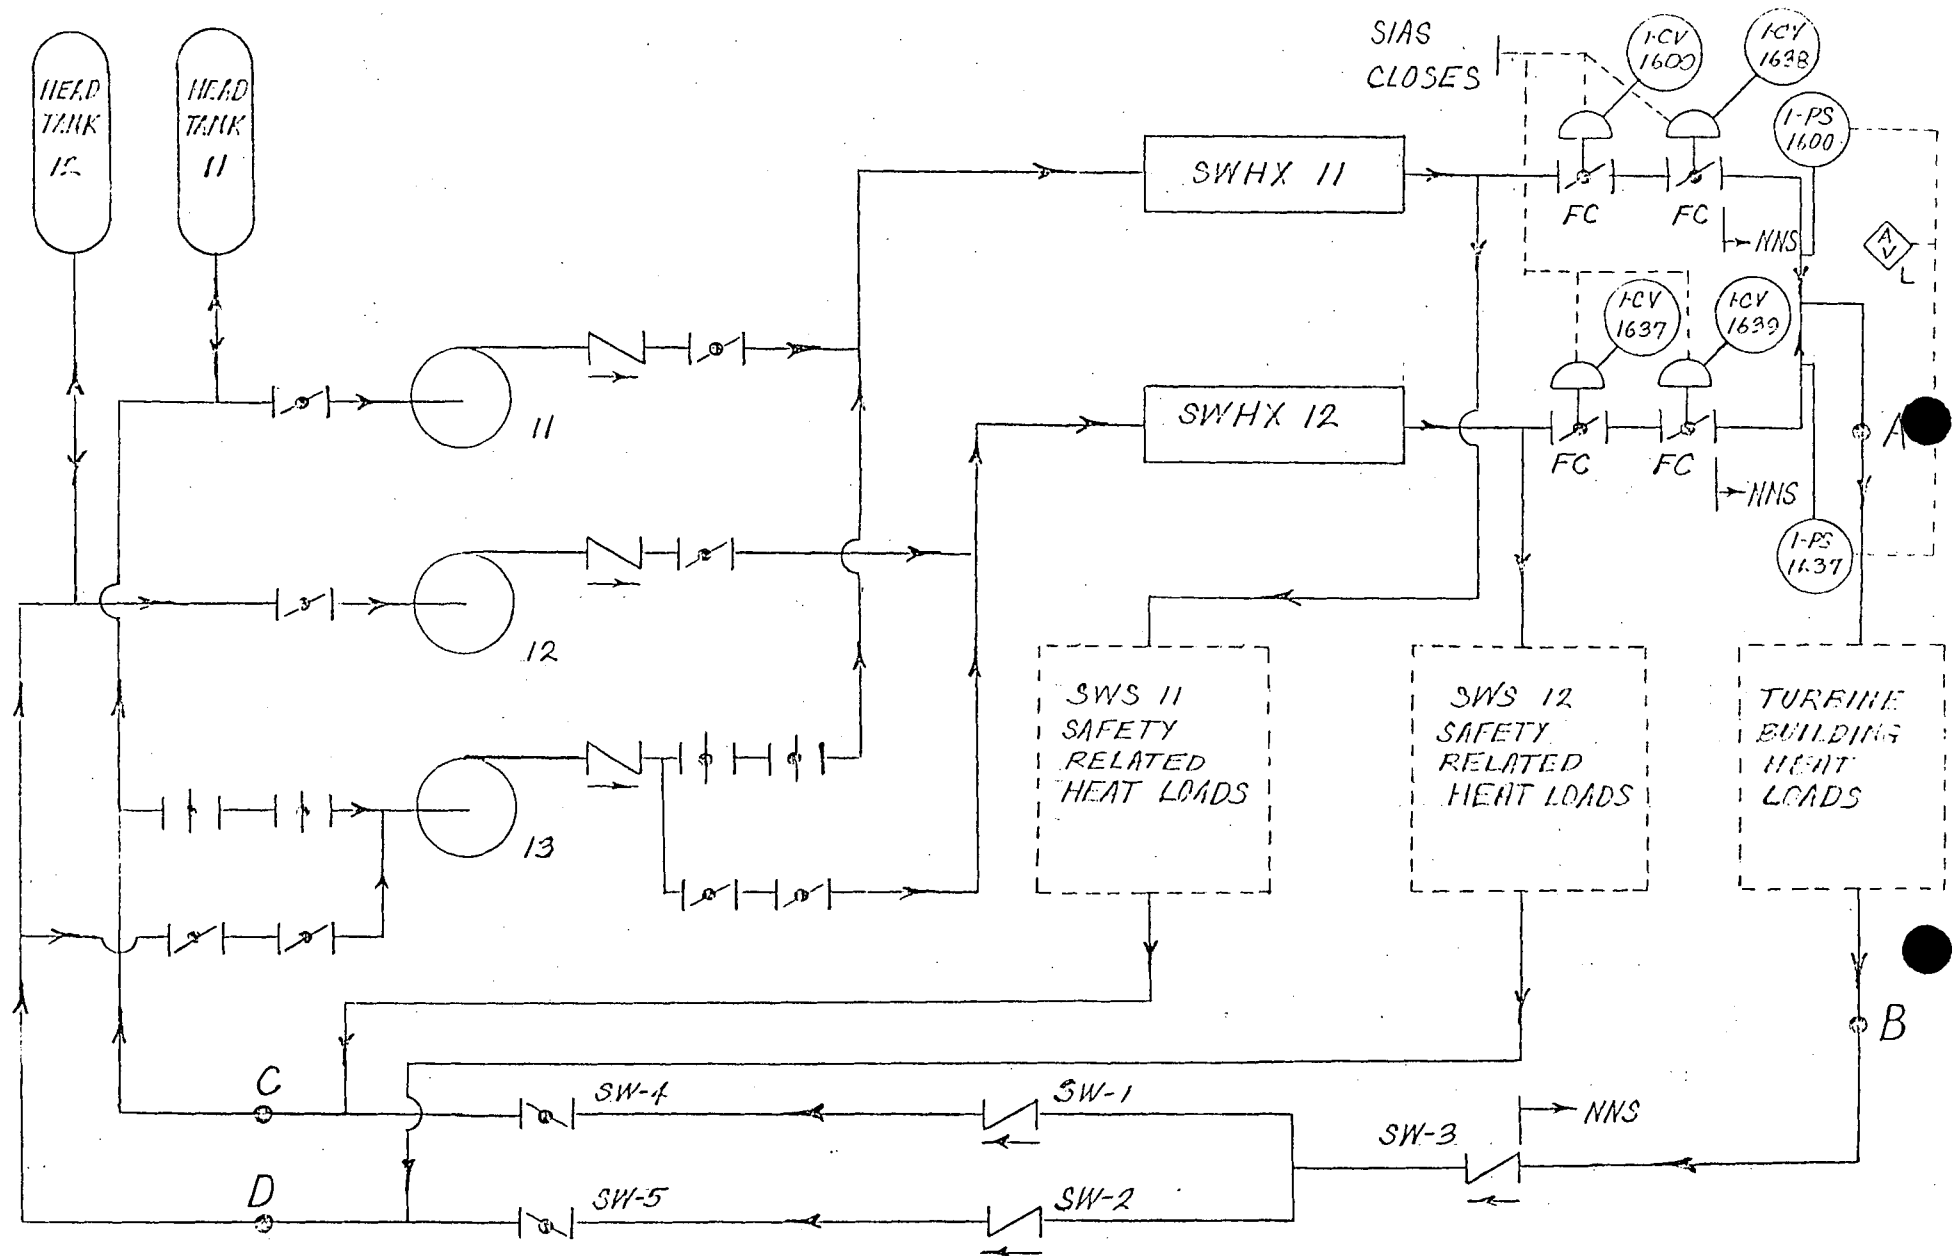
FIGURE 1 SIMPLIFIED SERVICE WATER SYSTEM PIPING DIAGRAM

header. Isolation of the safety and non-safety-related systems is accomplished by four redundant air-operated valves in the supply to the turbine building (two for each redundant subsystem) and by three check valves on the return side (one check valve in the common header and one in each of the redundant subsystems). The air-operated isolation valves on the supply to the non-safety-related part of the system close automatically on an SIAS. On loss of instrument air these isolation valves fail in the closed position.

During the time the SWHX 12 was out of service, air accumulated on the shell side due to the fact that the heat exchanger outlet valve was closed. (The source of air, as later determined, was a tube failure in the instrument air compressor 11 aftercooler.) When the heat exchanger was brought back on line, the trapped air was swept into the system, and due to the common header in the turbine building, disabled both safety-related subsystems. Although the SWS is provided with a number of constant vent valves, their relieving capacity was exceeded by the sudden influx of the large quantity of air that had accumulated in the SWHX while it was out of service. In addition, because the Unit 1 instrument and plant air compressors tripped after losing service water, the Unit 2 plant air system began supplying the total Unit 1 compressed air demand, both plant air and instrument air.

- (2) It is recommended that the four check valves and the four solenoid operated three-way valves in the instrument air lines that provide control air for the four diesel generator 12 service water supply and return valves be added to the IST program. (Refer to Figure 1.) These check valves are necessary to prevent the control air stored in the

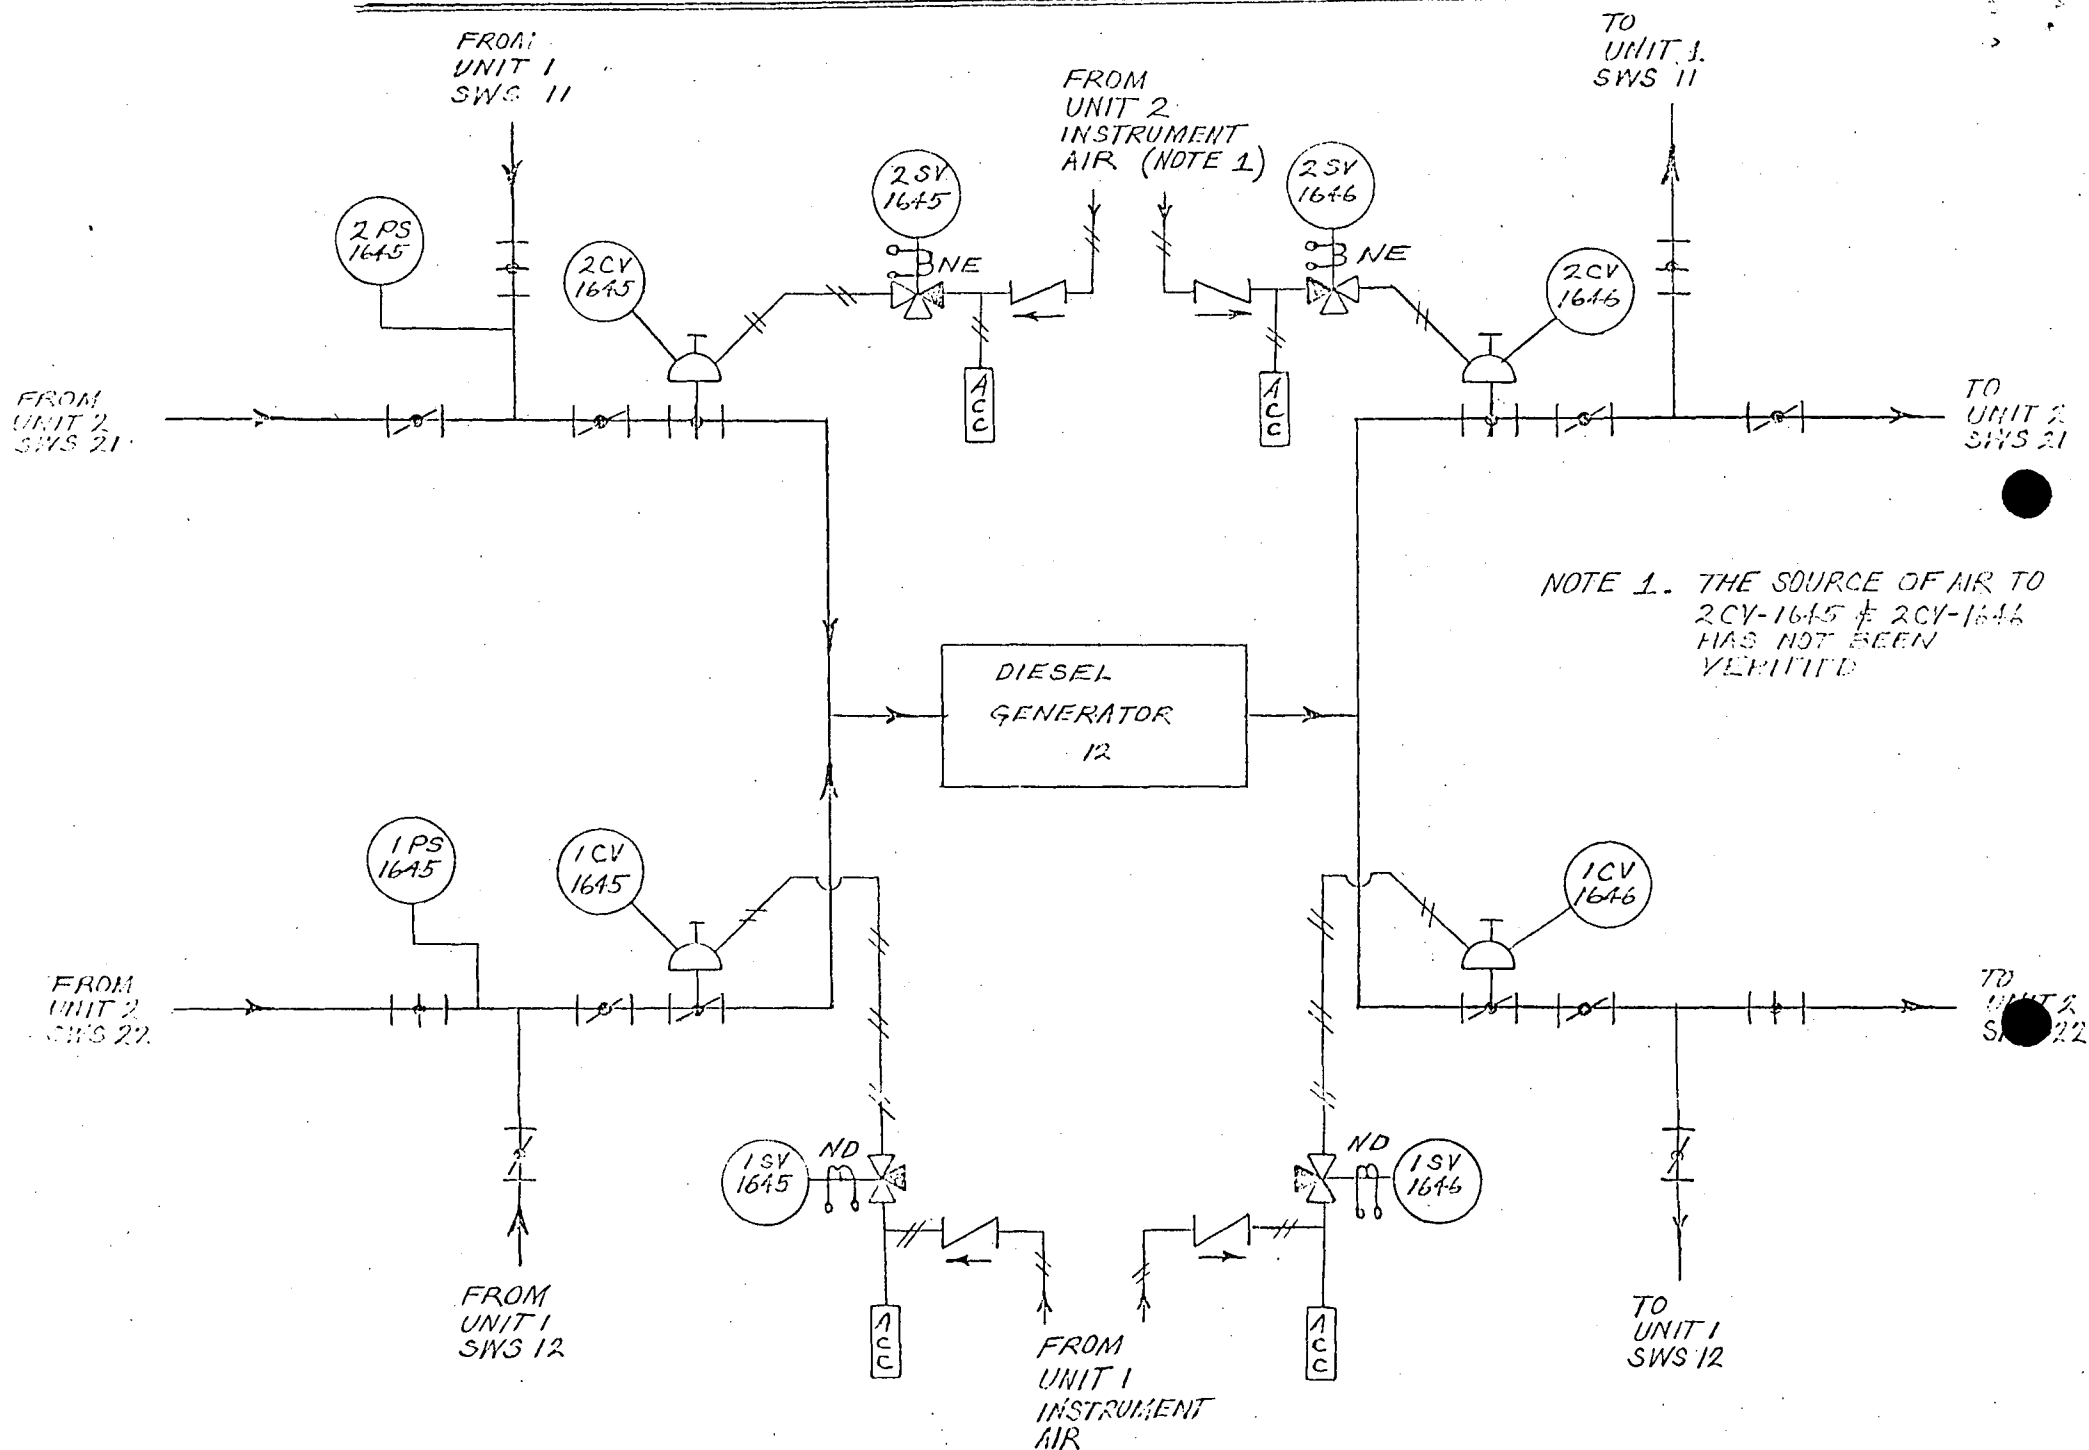
FIGURE 2 SERVICE WATER SUPPLY TO DIESEL GENERATOR 12

As shown in Figure 2, diesel generator 12 can also be supplied with service water from either Unit 1 or Unit 2. Usually, diesel generator 12 is supplied with service water from subsystem 12 on Unit 1. Referring to Table 3, it can be seen that if the pressure in service water subsystem 12 decreases below the setpoint of the installed pressure switches (45 psig), the service water supply to diesel generator 12 would automatically transfer to subsystem 21 on Unit 2. This transfer is accomplished by the automatic repositioning of four air-operated butterfly valves. All four of these valves fail closed on loss of instrument air and fail open on loss of DC. Since the instrument air is not a safety-related system, and two of the four valves must remain open to allow service water from either Unit 1 or Unit 2 to be supplied to diesel generator 12, safety-grade air accumulators have been provided to permit valve operation or maintenance of valve position on loss of the instrument air system. Check valves on the instrument air lines to each of the valves prevents blowdown of the accumulators through a break in the instrument air system.

The four service water inlet and outlet valves to diesel generator 12 are air operated and fail closed on loss of instrument air. Since air is required to keep the valves open, safety-grade air accumulators and check valves have

been provided to maintain a limited air supply following a loss of the instrument air system. If these check valves leak or there is leakage across the vent ports of the solenoid operated 3-way valves allowing the air to escape, the service water valves will drift closed causing diesel generator 12 to trip.

g. Leaking check valves or leakage of the solenoid operated 3-way valves in the instrument air supply to diesel generator 12's air-operated service water supply and return valves would cause these valves to go to their fail closed position if initially open or remain closed on loss of instrument air. This would isolate all service water from diesel generator 12, making it inoperable until operators manually opened the appropriate valves, aligning the diesel to Unit 1 or Unit 2, by means of the handwheels provided.

seismically designed accumulators from being lost through a break in the non-seismically designed instrument air system. The solenoid operated three-way valves are also part of the same seismically designed pressure boundary as the check valves described above. The service water supply and return valves fail closed on loss of instrument air. Therefore, the inability of these check valves or the solenoid operated three-way valves to maintain a leak-tight pressure boundary will result in service water isolation to the 12 diesel generator. Handwheels are provided for the service water supply and return valves and valve position is indicated in the control room by open/close status lights; therefore, these valves can be manually repositioned, allowing for some delay due to operator action, following a loss of instrument air.
