VIRGINIA ELECTRIC AND POWER COMPANY
NORTH ANNA POWER STATION UNITS 1 AND 2
POST-EARTHQUAKE RESTART READINESS DETERMINATION PLAN
STATUS UPDATE

Status Update of Near-Term Restart Actions
North Anna Power Station Units 1 and 2

Root Cause Evaluation of the Dual Unit Trip Following Magnitude 5.8 Earthquake

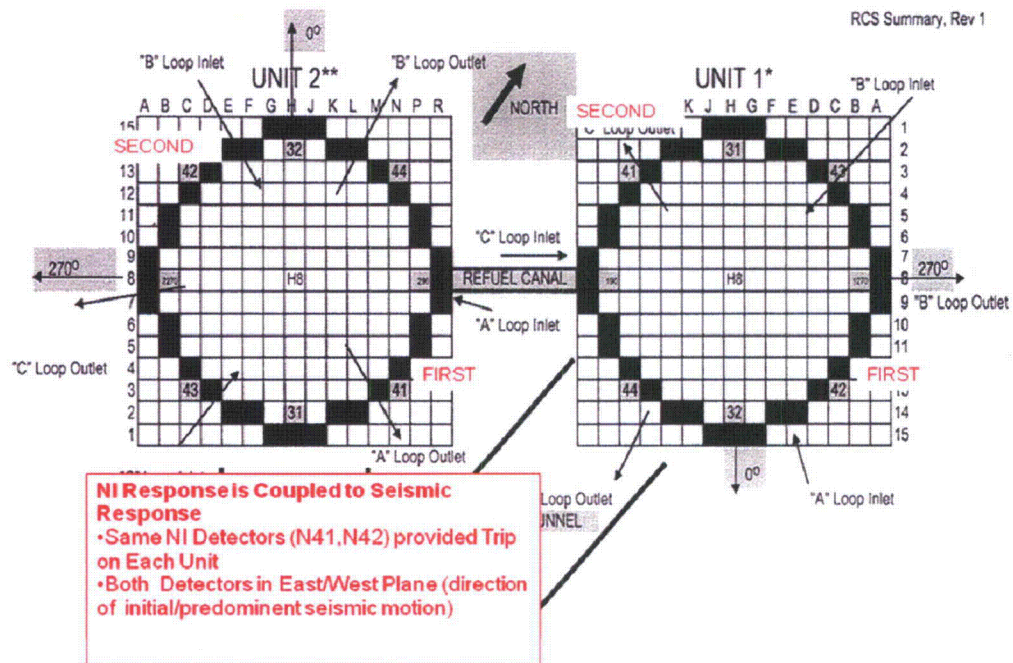
The direct correlation of the reactor trips and the earthquake motion is illustrated in the figures below. Figure 1 provides a schematic showing the location and orientation of the PRNIs which made up the 2 out of 4 reactor trip logic. The figure is labeled with the sequence and location of PRNIs N41 and N42 which tripped the units. As shown below, the nuclear instruments (NIs) on each unit are identical and are located in identical locations. It is also noted that the initial seismic motion at the time of the trip was in the East-West direction.

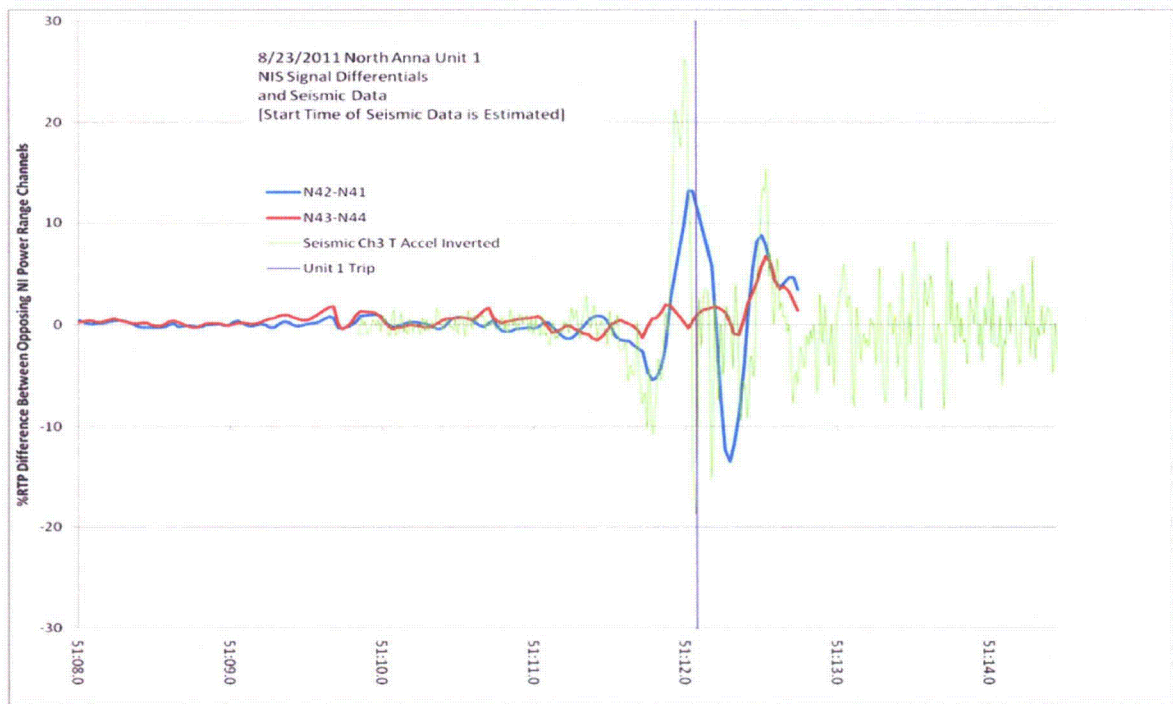
Figures 2 and 3 below demonstrate how the PRNIs closely correlate with the seismic response.
