UNITED STATES
NUCLEAR REGULATORY COMMISSION
OFFICE OF INSPECTION AND ENFORCEMENT

IE Circular No. 79-02

FAILURE OF 120 VOLT VITAL AC POWER SUPPLIES

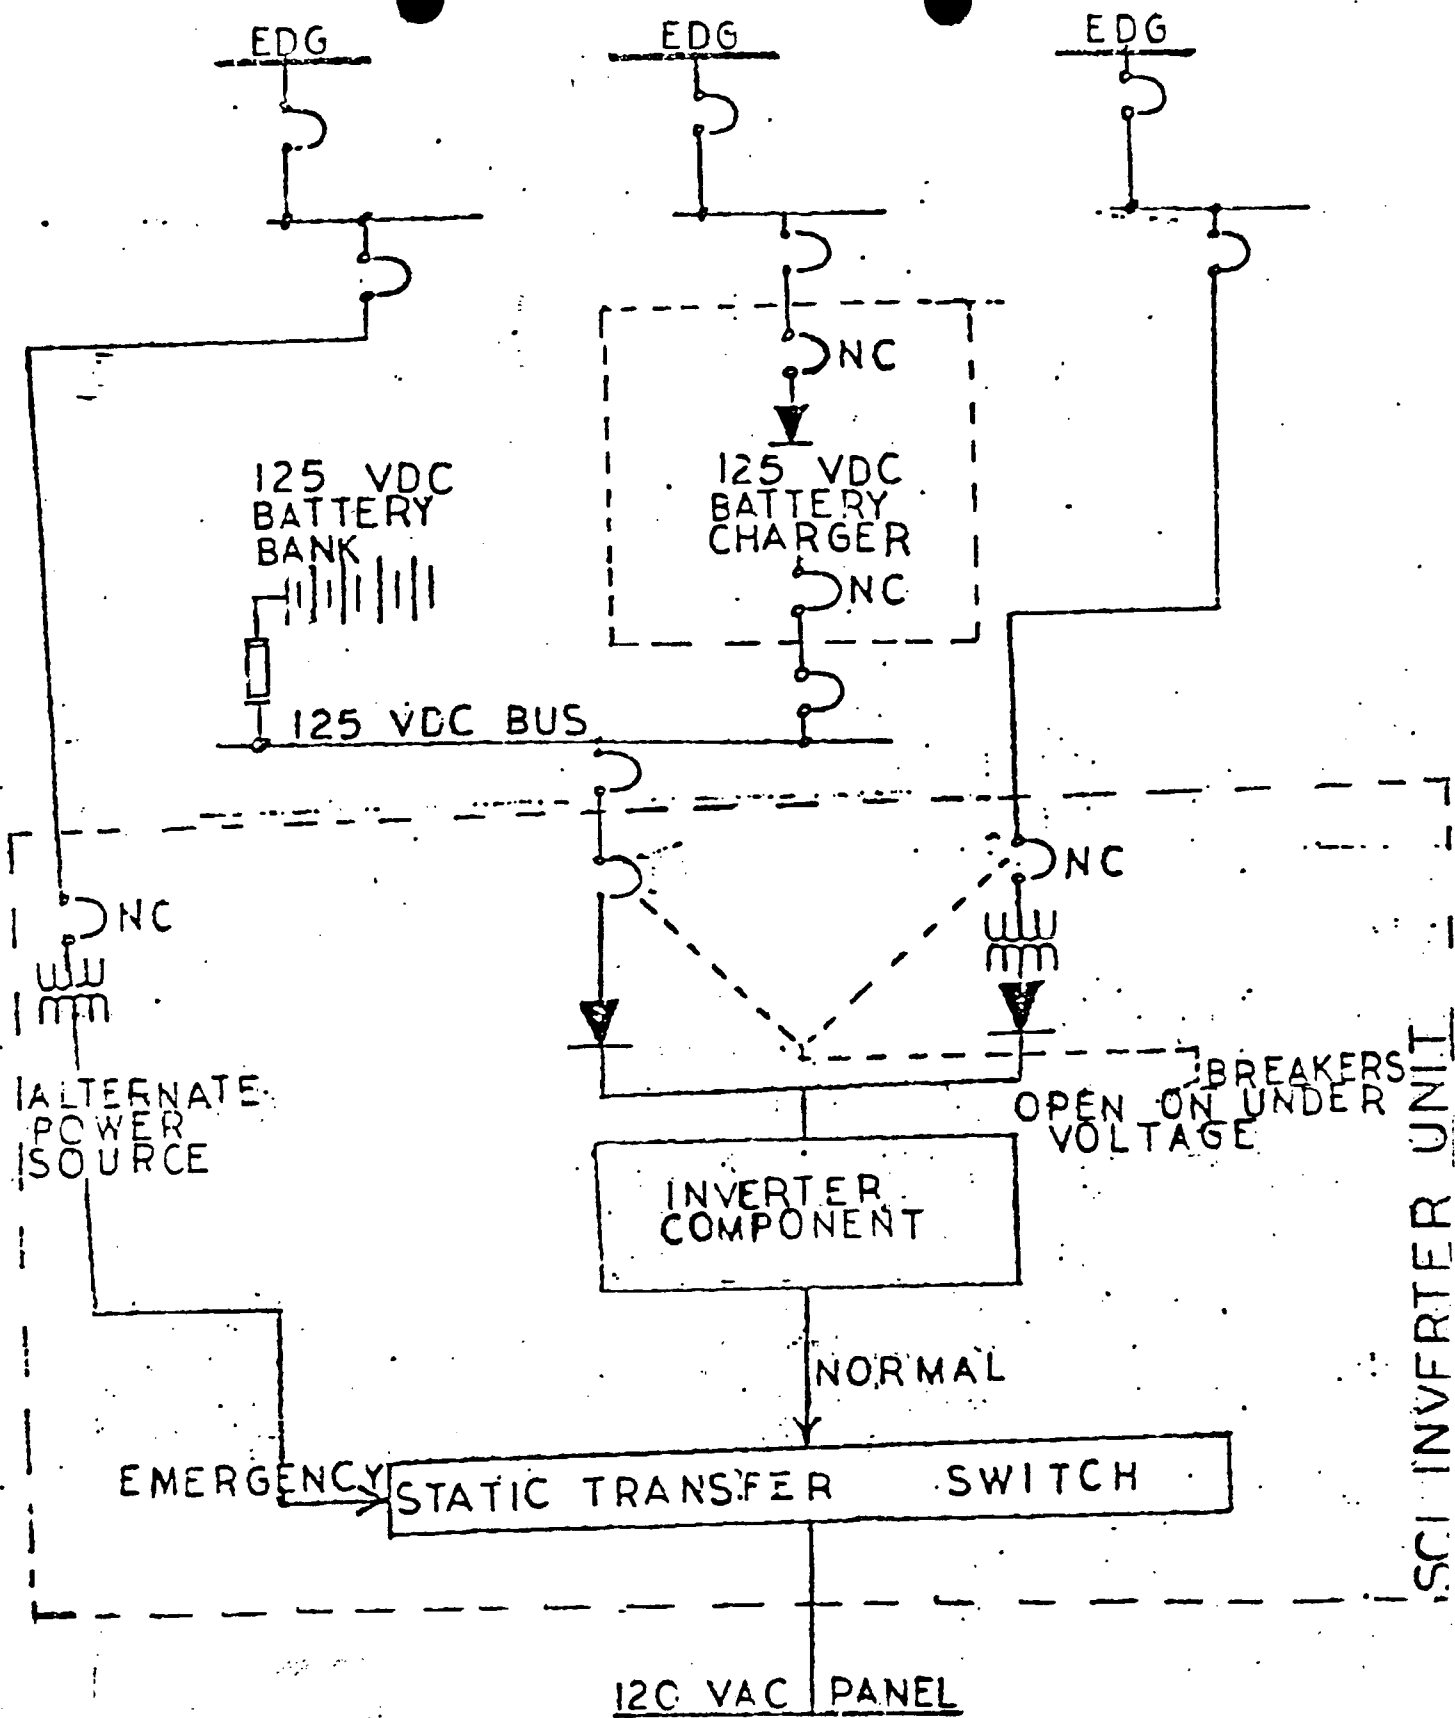
FIGURE 1
SINGLE LINE DIAGRAM-120 VAC

On September 16, 1978, Arkansas Nuclear One - Unit 2, while in hot functional testing preceeding initial criticality, suffered a degradation of both of the independent off-site power sources. This produced an undervoltage condition on the Engineering Safety Features (ESF) Buses and caused an inadvertent ESF actuation. The licensee determined that the ESF actuation occurred on a loss of at least two of the uninterruptable 120 volt vital AC power sources. Immediate investigation revealed that all four of the Solidstate Controls, Inc., (SCI) inverter static switches had automatically transferred to the alternate power supply (the 120 volt AC being supplied by transformers directly off the ESF buses rather than from the inverter output.) Figure 1 (attached) shows the functional interconnection of the 120 volt AC power supply system.

A single conclusive cause of the undesired SCI inverter static switch transfer could not be identified. However, the following problems were discovered during subsequent investigation.

- (a) The SCI inverters have circuitry to monitor the incoming DC voltage level which, on sensing a low voltage (nominally 104 DC volts for these inverters) will trip both input breakers to the inverter component after an adjustable time delay.

The setting of these time delay relays were not verified during either preoperational testing or subsequent maintenance. The time delay is necessary in order to accommodate transient loading conditions which may be encountered.

- (b) On one SCI inverter, a DC fuse within the inverter component was found blown. The vendor indicated that this fuse will blow due to an excessive DC voltage to the inverter component caused by a transient on the 480 AC input. The licensee has subsequently reset the taps on the 480V to 120V three-phase AC input transformer to limit the DC voltage to the inverter to less than the nameplate maximum rating in the event of a high AC input voltage transient.

- (c) The SCI inverter static switch is designed to transfer to an alternate source on inverter output overcurrent or undervoltage. Initially, these trips were set at 125 percent overcurrent and 80 percent undervoltage. An explanation for the transfer of two of the inverter static switches is that during one of the transfers of site loads, the instantaneous inductive load caused these trip set points to be exceeded. The licensee has subsequently adjusted the transfer sensing circuitry to higher overcurrent and lower undervoltage trip settings to assure that the inverter will maintain load over the widest possible range of voltage and current. (Note that in this case, once the SCI inverter transfers to the alternate source, it will not automatically transfer back to normal source.)

1. Determine whether or not time delay circuitry is used in your inverter units. If so, have they been adjusted to the appropriate set point as required by equipment and the integrated system designs?

2. Determine if the AC input voltage and transformer tap settings are optimized to prevent exceeding the inverter component nameplate maximum rated DC input voltage in the event of a high AC input voltage transient.

3. If an alternate 120 volt source is used in your design, determine if the protection transfer circuitry of the inverter has been optimized within design limits to ensure maximum possible availability of the inverter system during transient loading conditions. An operating history of inexplicable transfers may be indicative of the above.

4. Determine if the administrative controls employed by your facility ensures operability of safety systems after its subcomponents (e.g., time delay relays, switches, etc.) have been subjected to maintenance or testing.
