U.S. NUCLEAR REGULATORY COMMISSION  
OFFICE OF INSPECTION AND ENFORCEMENT  
REGION III

IE Circular No. 78-18  
November 6, 1978

UL FIRE TEST

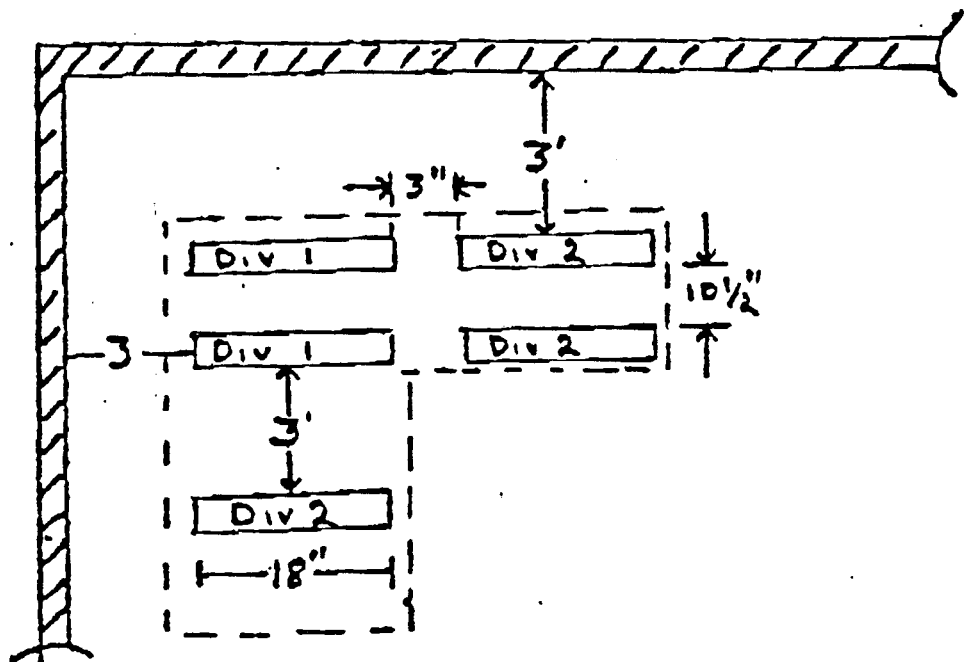
Figure 1

--- approximate boundary  
of pan for liquid  
spill fire

Vertical Tray Corner Test
