November 8, 1977
IE Bulletin 77-05

ELECTRICAL CONNECTOR ASSEMBLIES

TRIP REPORT
by
W. R. Rutherford

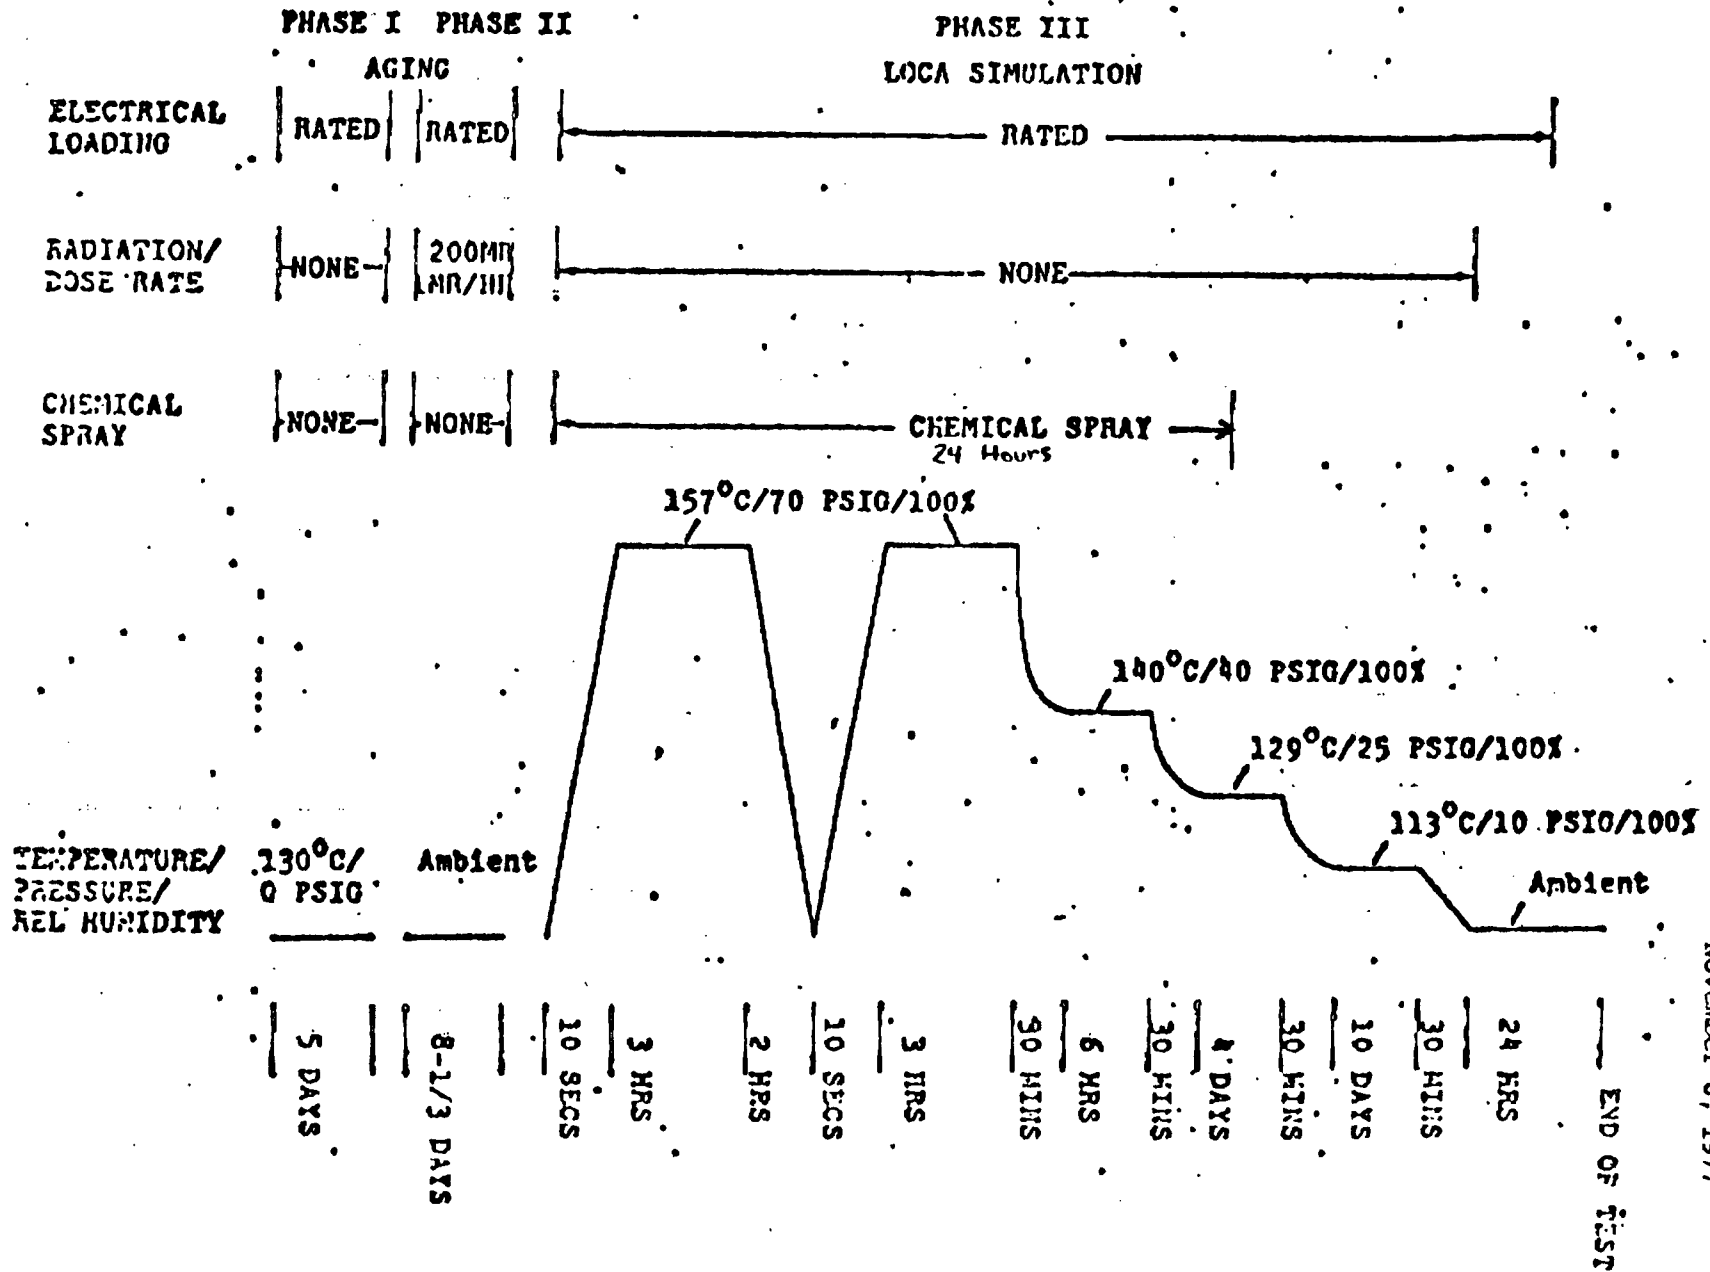
Figure 1

The three tests performed by Sandia were composed of two sequential and one simultaneous exposure to LOCA environments. In each case the equipment was exposed to radiation and thermal aging prior to operating under the simulated LOCA conditions. Figures 1 and 2 describe the test profiles for sequential and simultaneous tests respectively (Sandia tests were designed to study synergistic effects). Each of the tests satisfy the intent of IEEE 323-1974. The assemblies were electrically loaded to 20 amperes and 600 volts at the start of the tests. Insulation resistance and capacitance measurements were recorded during the tests to indicate damage.
