Enclosure: IE Circular
 No. 77-06, "Effects of
 Hydraulic Fluid on
 Electrical Cables"

EFFECTS OF HYDRAULIC FLUID ON ELECTRICAL CABLES

Reference: Quad-Cities Nuclear Power Station
Docket No. 50-265, DPR-30, Unit 2

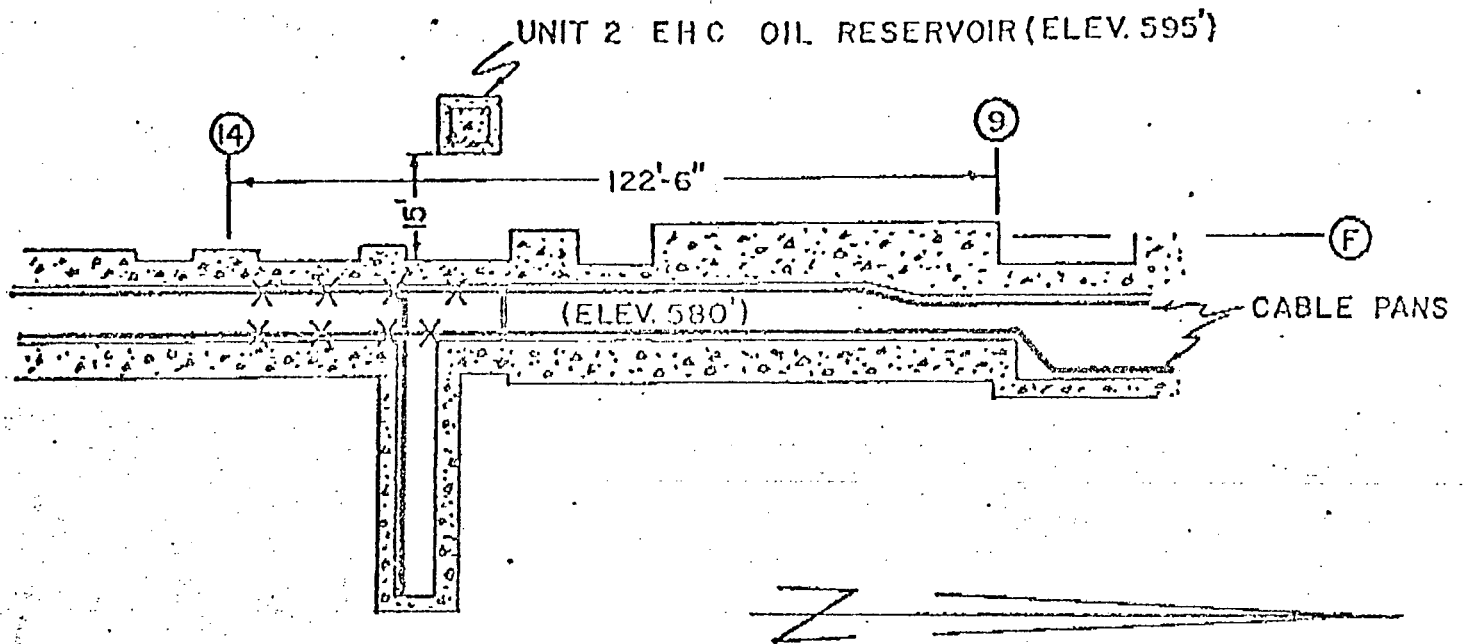
FIGURE. 1

Figure 1 shows the approximate locations where EHC fluid accumulated. Figure 2 illustrates the postulated path of EHC fluid migration from the EHC fluid reservoir to the Unit 2 cable tunnel area. The accumulation of EHC fluid around the EHC fluid reservoir foundation, and subsequent migration between the finish floor and rough slab, via small cracks in the concrete, is the postulated cause of the EHC fluid problem.

The rough slab serves as the ceiling in the Unit 2 cable tunnel and minor small cracks in the ceiling served as a leak path out of the concrete and onto the cable trays and floor. Portions of cables within these trays thus became saturated with the EHC fluid.

The upper cable trays did not contain all of the EHC fluid, even though the pans in the cable tunnel were of solid bottom construction. This was because the EHC fluid had leaked through the cable pan connecting joints and thus all the cable pans below were subjected to the EHC fluid. The cables closest to the bottom of the cable pans were most affected by the EHC fluid because these cables were in constant saturation with EHC fluid.

UNIT 2 CABLE TUNNEL
PARTIAL PLAN

X- DENOTES AREAS WHERE THE EHC OIL HAD ACCUMULATED
REFERENCE DRAWING - SARGENT & LUNDY M-5

At the present time, all the cables in the affected area of the Unit 2 cable tunnel are being protected from the continuing EHC fluid leakage. The leakage has subsided and once it has stopped the ceiling area will be cleaned and a protective sealer will be applied to prevent any possible leakages.

The EHC fluid reservoir foundation must also be sealed with the same protective sealer once leakages have been resolved. The sealer has been ordered from the Carbolite Company, type 187 HEP, which is a recommended EHC fluid sealant.

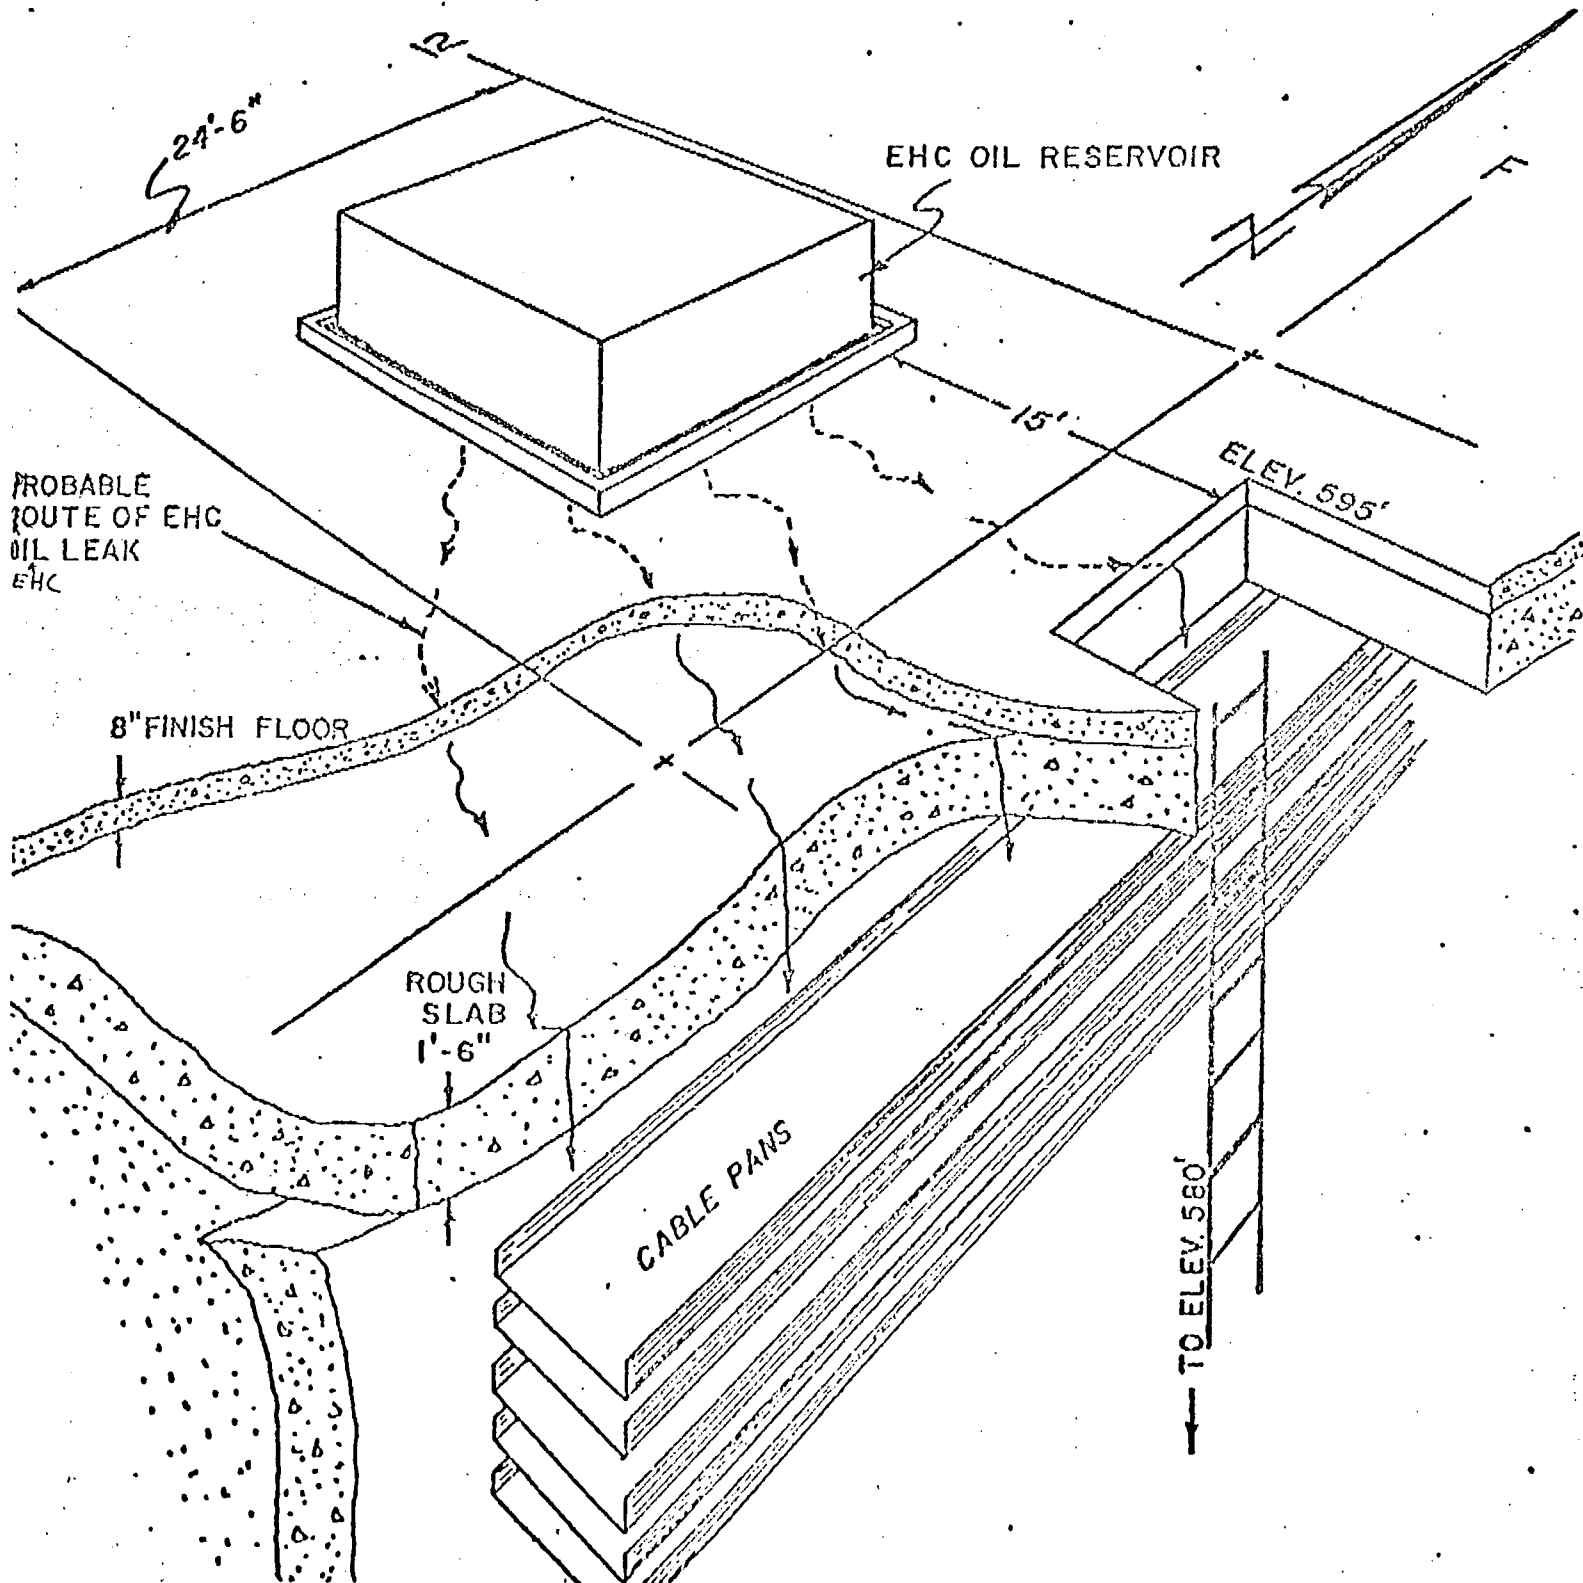
FIGURE. 2

UNIT 2 CABLE TUNNEL
CUT-AWAY
