RE: Willow Creek ISL Operations Spill Investigation Inspection Report, Permit No. 478

SPILL INSPECTION REPORT

SUBJECT: Uranium One's Willow Creek In Situ Uranium Mine

DATE of INSPECTION: August 24, 2011

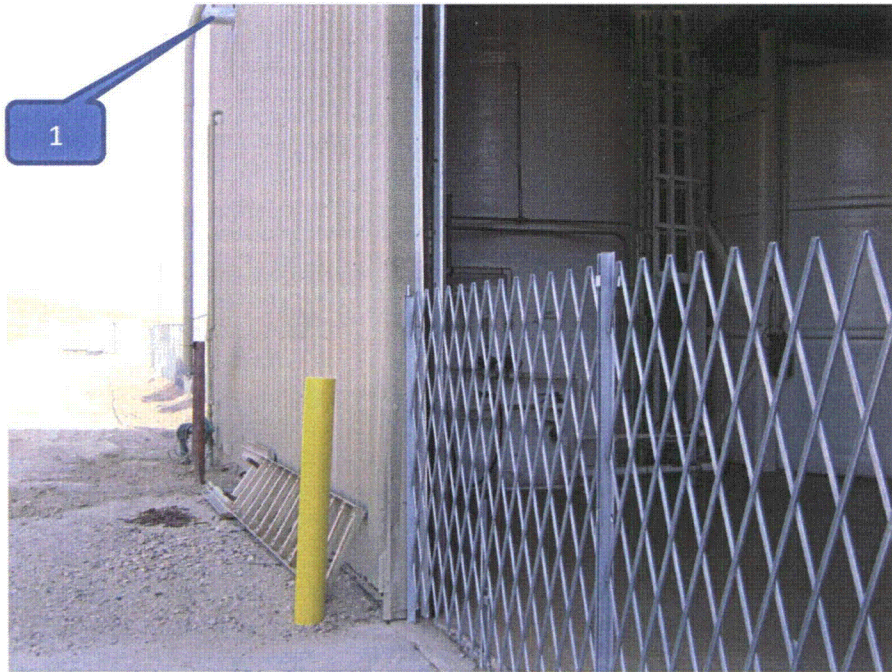
I arrived at the Irigaray site about 9:30 AM, August 24, 2011. I was shown the tank inside the plant annex building which holds the brine that spilled. It had overflowed through a vent near the top which ran outside through the adjacent wall (Photo No. 1). On the ground below the vent was a culvert opening built to convey water from roof runoff away from the building (Photo No. 2). The culvert runs southwestward under a graveled pad to link up with another culvert running southeast that carries run-off to a drainage that runs northeastward along the south-eastern side of the plant building (Photo No. 3). The spilled brine went through these culverts and down the drainage for a distance of about 110 yards. The maximum width of the affected area was about five feet (Photos Nos. 4 and 5).

Larry Arbogast said the apparent cause of the spill was a valve that had been left partially open when the tank was filled. The tank is periodically filled with dry sodium chloride which is converted to brine by the addition of water to the tank. There are no figures available on the number of pounds of salt lost. Since the water is introduced to the salt tank at the bottom and the vent which overflowed is at the top of the tank, the fluid which overflowed could be expected to be the least dense and contained the least salt of the fluid in the tank.

Photo No. 1
Looking northwest at southwest plant door with brine tank partially visible at center. The brine tank's outside vent is indicated by arrow.

A repeat of this problem will be prevented by rerouting the vent so any overflows will remain inside the building where they will flow to the building sumps. Any fluids in the building sumps are routed to an evaporation pond.

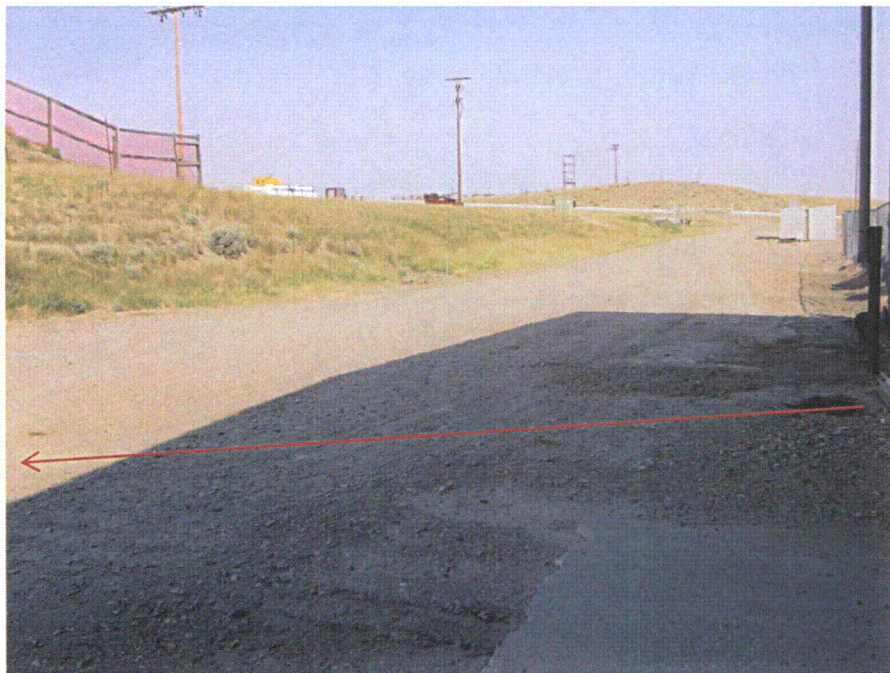
Photo No. 2
Looking northwest at area outside southwest plant door with route of buried culvert shown approximately by line and arrow. The leaking brine flowed through this culvert.

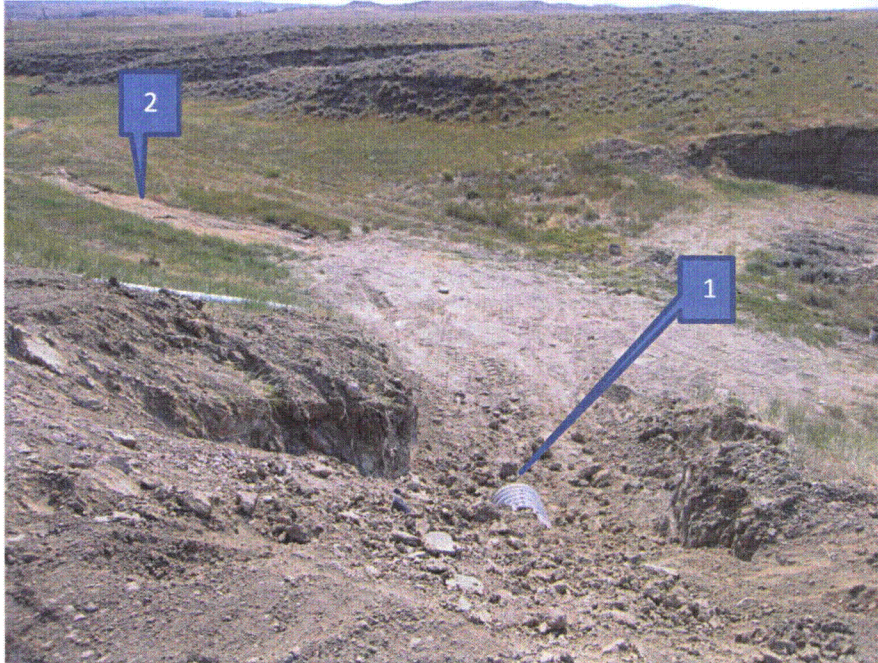
Photo No. 3

Following the spill, the drainage culvert leading to the channel (Photo No. 3) was replaced, resulting in equipment track over and alongside the spill area (Photo No. 4). No cleanup work had been attempted by the day of the inspection.

Looking northeast from top of slope above culvert (No. 1) which discharges runoff from southern plant area and plant roof to drainage east of plant area. Disturbance from work replacing the drainage culvert can be seen in the foreground.

The grass killed by the brine can be seen in the area indicated by Arrow No. 2

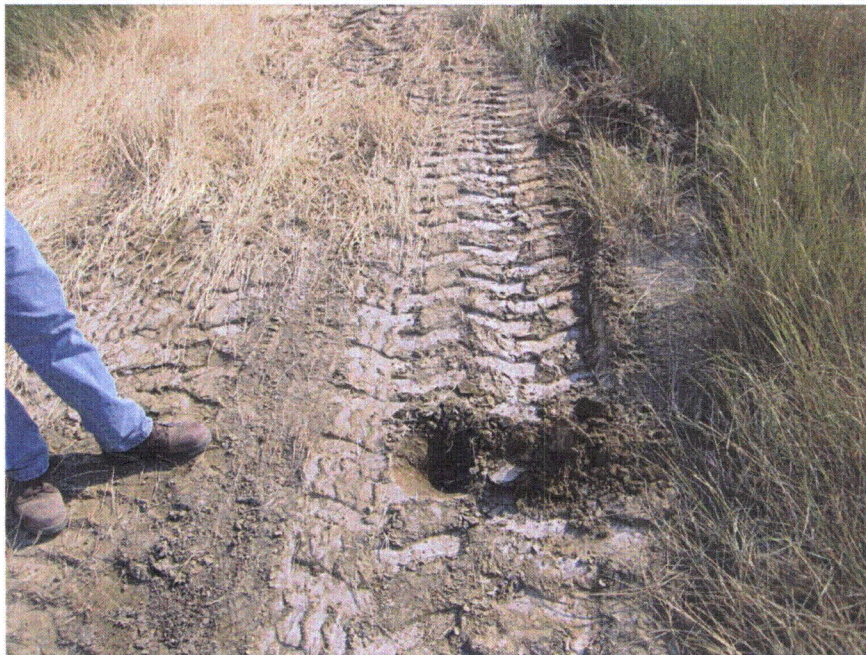
Photo No. 4

Close up view of area where sodium, chloride brine has killed the grass and impacted the soil.

The equipment tracks were caused by equipment replacing the drainage culvert seen in Photo No. 3 above.

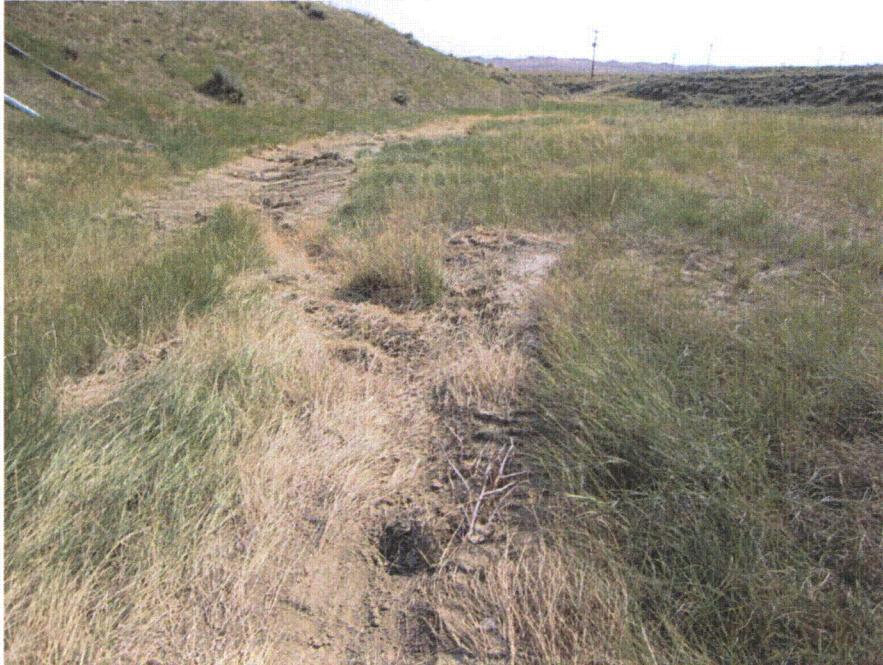
Photo No. 5

The visual effects of the spill are limited to the grass in the affected channel turning brown and presumably dead and a thin salt crust (Photos Nos. 5 and 6).

Looking northeast down drainage affected by brine spill. The brown grass has been killed by the salt. Some white salt crust is visible at center. The plant building is located at the top of the slope at left. This slope was heavily impacted by a yellowcake spill and cleanup in 1994.

Another option would be to allow the area to heal through natural attenuation. The highly soluble salt would likely leach out the soil in just a few years. This is my recommended option.

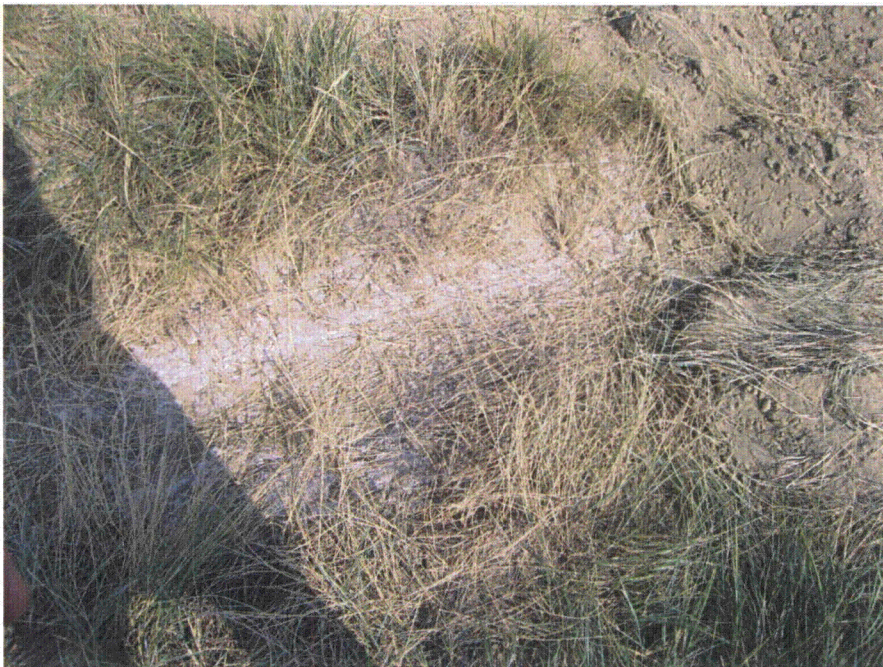
Photo No. 6

Close-up of sodium chloride salt crust remaining in channel bottom.

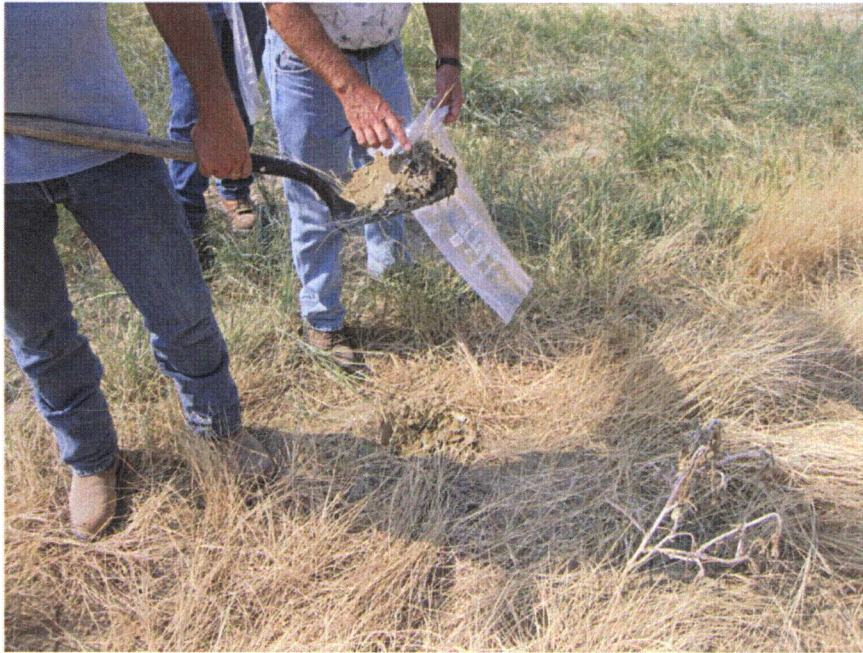
Photo No. 7
Sample No. 1 being taken
from location near lower
(northern) end of channel area
affected.

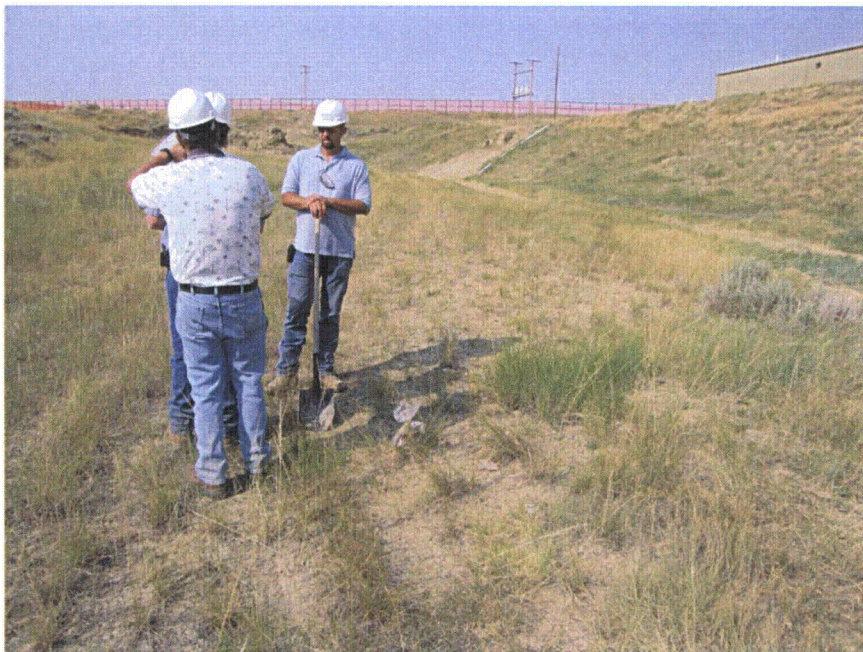
Photo No. 8
Location of Sample No. 2
taken in location away from
spill area as a control sample.

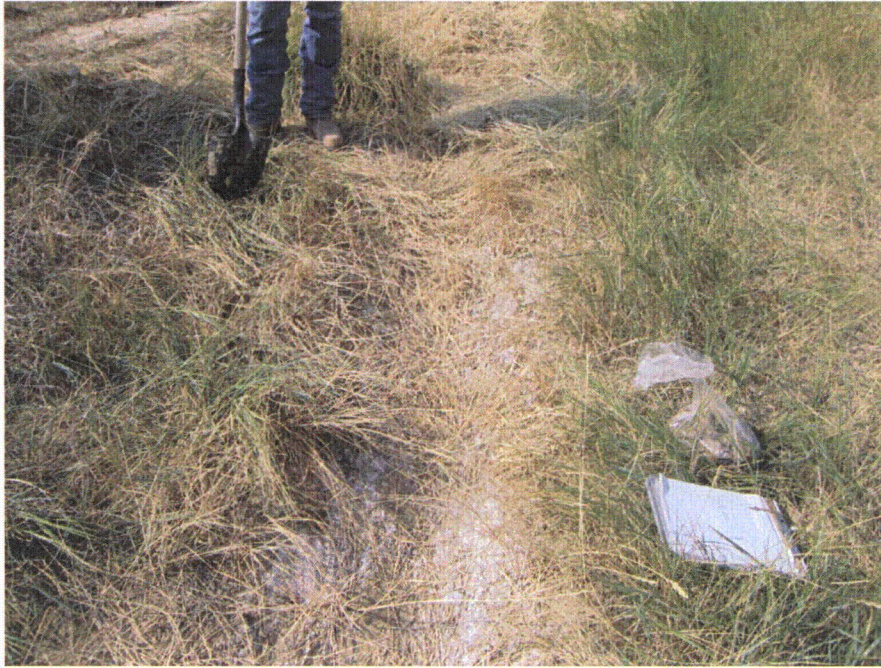
Photo No. 9

Location of Sample No. 3 which was taken in the bottom of the channel where the salt crust is present. Location is about midpart of affected channel.

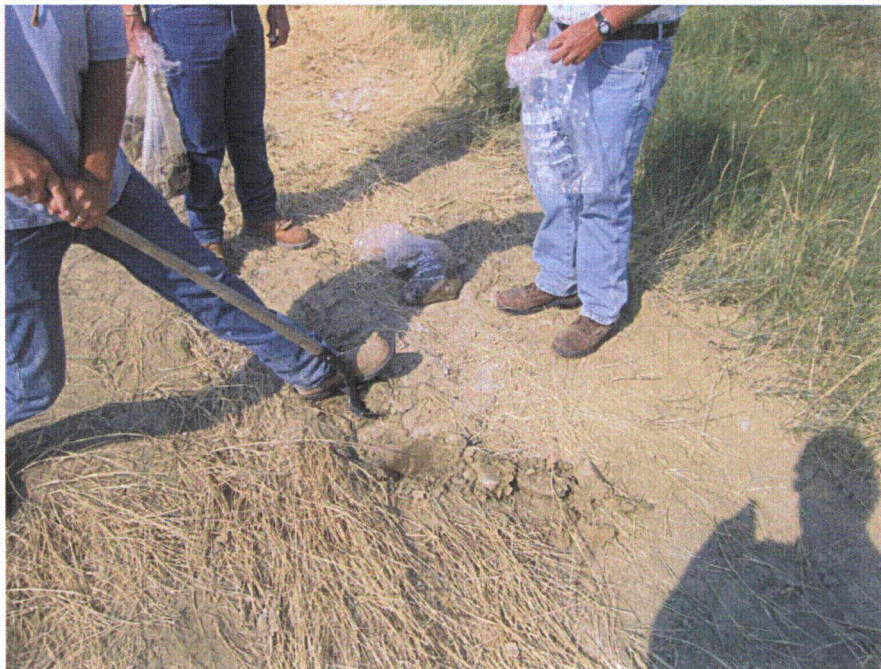
Photo No. 10

Sample no. 4 being taken from near upper part of spill area in channel.
