VIRGINIA ELECTRIC AND POWER COMPANY (DOMINION)
NORTH ANNA POWER STATION UNITS 1 AND 2
RESPONSE TO REQUEST FOR ADDITIONAL INFORMATION
RESTART READINESS DETERMINATION PLAN

**Response to Request for Additional Information
Restart Readiness Determination Plan**

**Virginia Electric and Power Company
(Dominion)
North Anna Power Station Units 1 and 2**

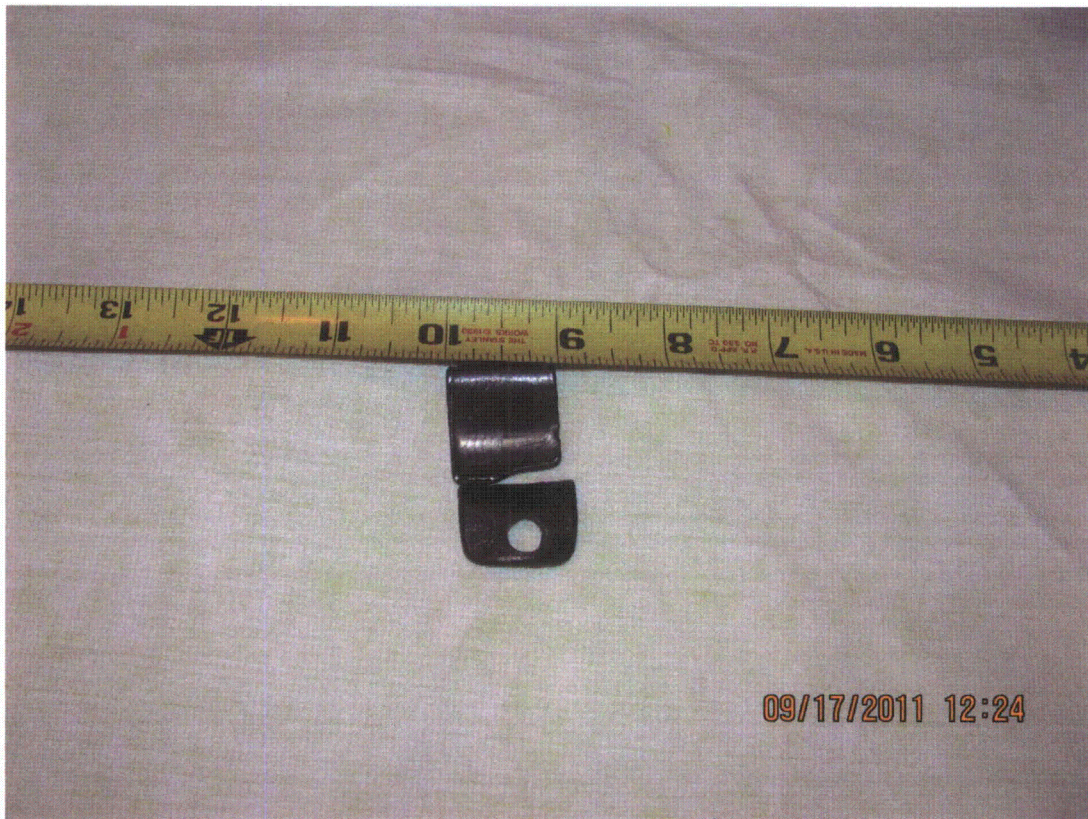
Although the cause evaluation is not yet complete, the available data indicates that the parts found in the Unit 1 "A" Steam Generator, see picture below, are not components from within the Reactor Vessel or the Reactor Coolant System. Material analysis has concluded that the material is 300 series stainless steel. The material appears to be some kind of conduit clip; however based on size and shape, it does not match any parts that are stocked at North Anna. It does not appear to come from any components in the RCS, Reactor Vessel, Safety Injection, or RHR systems. Comparison against parts associated with the equipment used for the last 10-Year Vessel ISI Inspection (from inspections performed in 2009) and refueling equipment has not identified a

suspect part. The pieces are too large to have flowed backwards through the S/G tubes to get into the hot leg bowl. Therefore, the only credible source of the foreign materials is that it was introduced through the refueling cavity to the "A" S/G hot leg. Review of the loose parts monitor data indicates that the part may have been introduced during the 10-year Vessel ISI Inspection performed in 2009 refueling outage; however this data is not conclusive. Dominion is continuing to work towards identifying the source of the foreign material and will address any generic issues that may be identified.
