VIRGINIA ELECTRIC AND POWER COMPANY
RICHMOND, VIRGINIA 23261

VIRGINIA ELECTRIC AND POWER COMPANY (DOMINION)
NORTH ANNA POWER STATION UNITS 1 AND 2
RESPONSE TO REQUEST FOR ADDITIONAL INFORMATION
RESTART READINESS DETERMINATION PLAN

Response to Request for Additional Information – North Anna Restart Readiness
Determination Plan

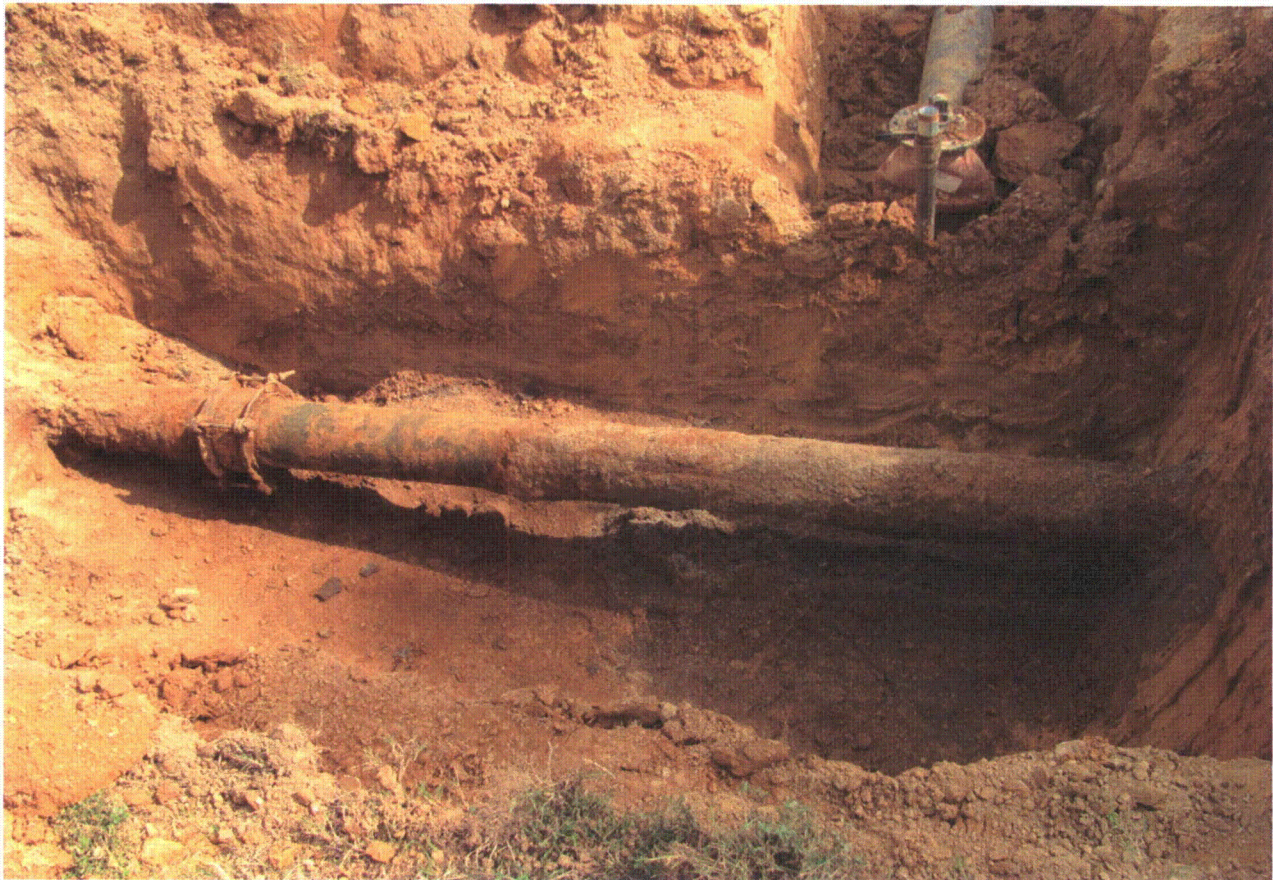
- Indirect inspection for leakage by review of detailed pictures of the FP main loop near the West Security Gate within a few days following the seismic event. (Excavation area has since been backfilled due to outage activities.)
- Direct inspection of FP piping going to the North Anna Nuclear Information Center.

FP Piping to the North Anna Nuclear Information Center
(Pipe in the top right corner is for North Anna 3 Site Separation)

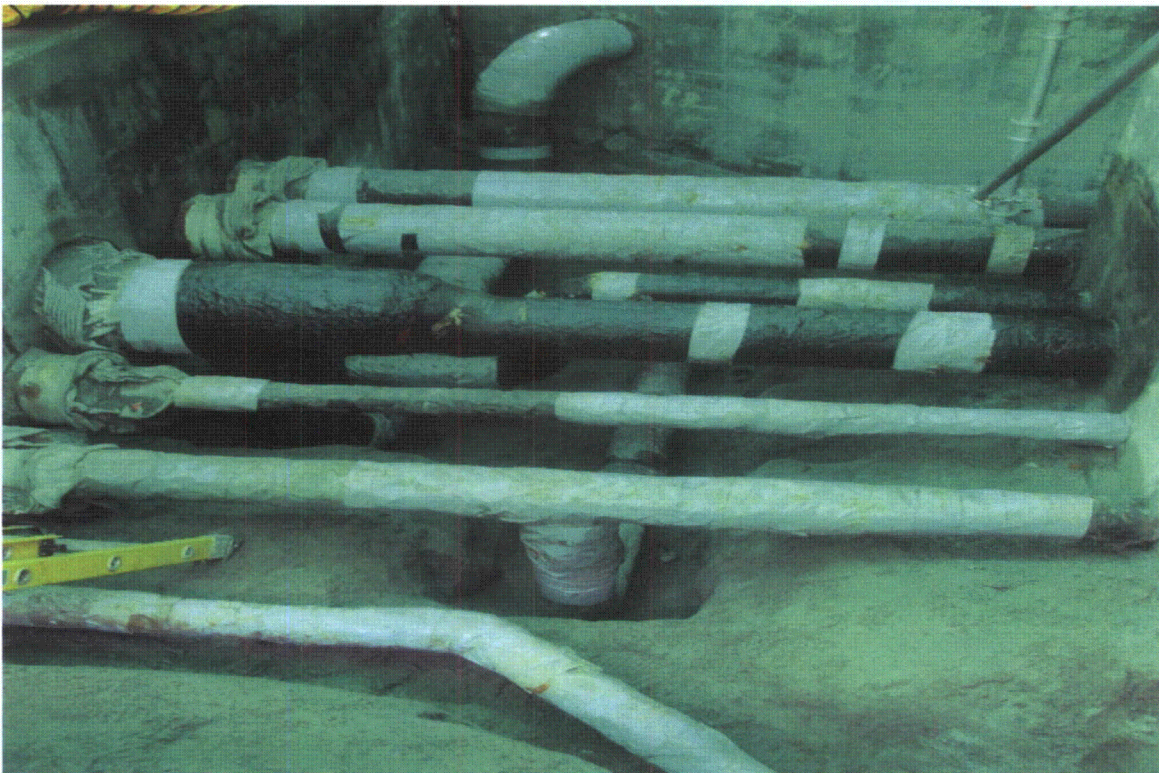
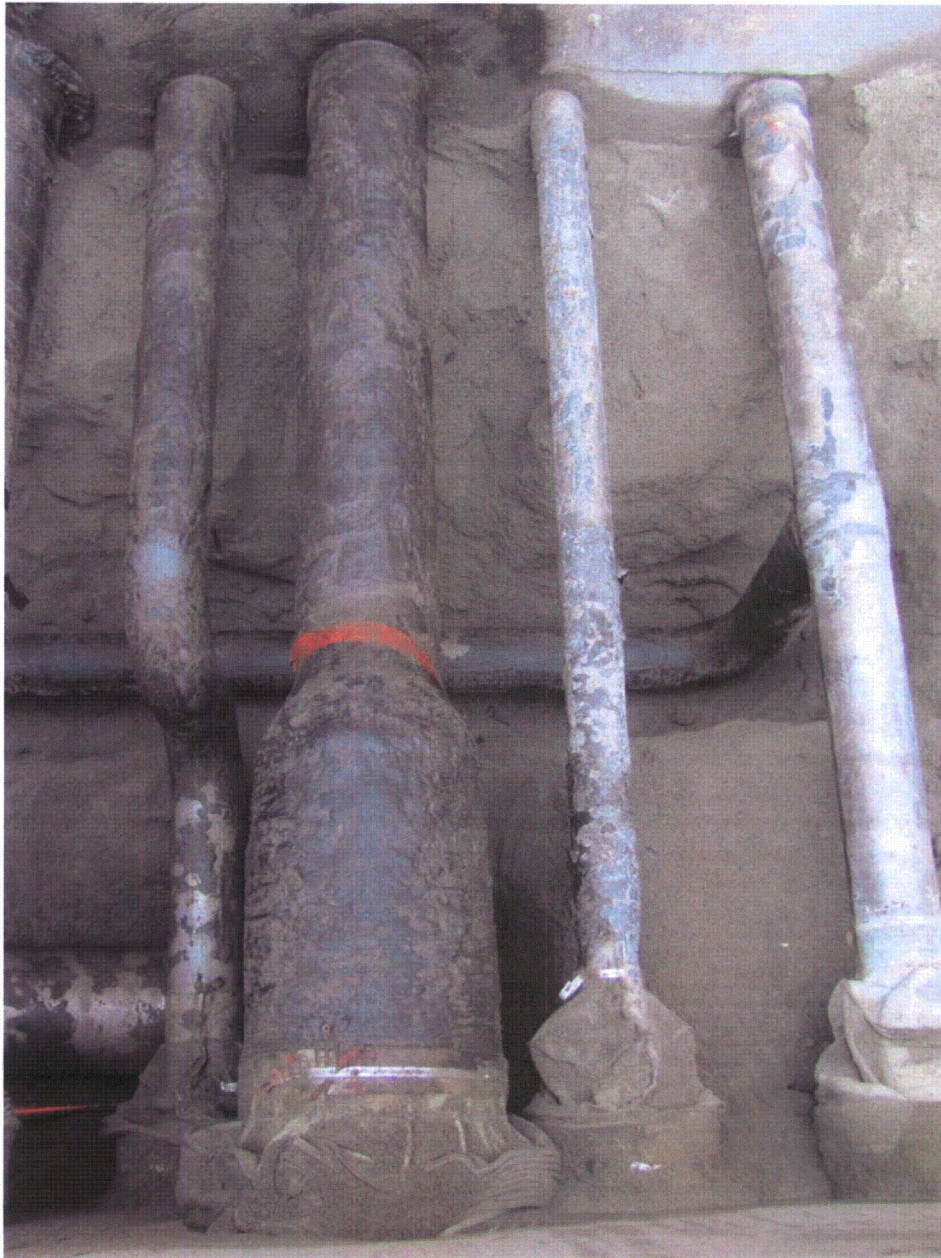
Excavated Unit 1 RWST Piping

Safety related buried piping associated with the Unit 1 RWST was excavated and formally inspected, and no issues were found. Several individual pipes were inspected, including ultrasonic testing (UT) of the pipe wall thickness. Areas where the pipes were anchored through wall penetrations were also examined, and there were no indications of high stress at the penetrations nor were any cracks present. This piping was inspected since it is considered to be high risk consequence piping by the Underground Piping and Tank Integrity Program. Piping inspections included:

- Direct inspection of the Unit 1 Refueling Water Storage Tank (RWST) piping located between the Auxiliary Feedwater tunnel and Quench Spray Pump House (see pictures below). Inspected piping sections included the following systems:
 - Quench Spray piping to the Quench Spray pumps' suction,
 - Quench Spray pump recirculation piping,
 - Safety Injection system piping to the High Head and Low Head Safety Injection pumps' suction,
 - RWST recirculation pumps' suction and discharge piping, and
 - Refueling Purification and blender make-up piping to the RWST.
