MONTICELLO NUCLEAR GENERATING PLANT
Docket No. 50-263 License No. DPR-22

Licensee Event Report to the NRC
Crack Indications in Recirculation Bypass Piping

SUPPLEMENT TO LICENSEE EVENT REPORT TO THE NRC

1. Report Number: AO 263/75-03
- 2a. Report Date: January 30, 1975
3. Facility: Monticello Nuclear Generating Plant
Monticello, Minnesota 55362
4. Identification of Occurrence:

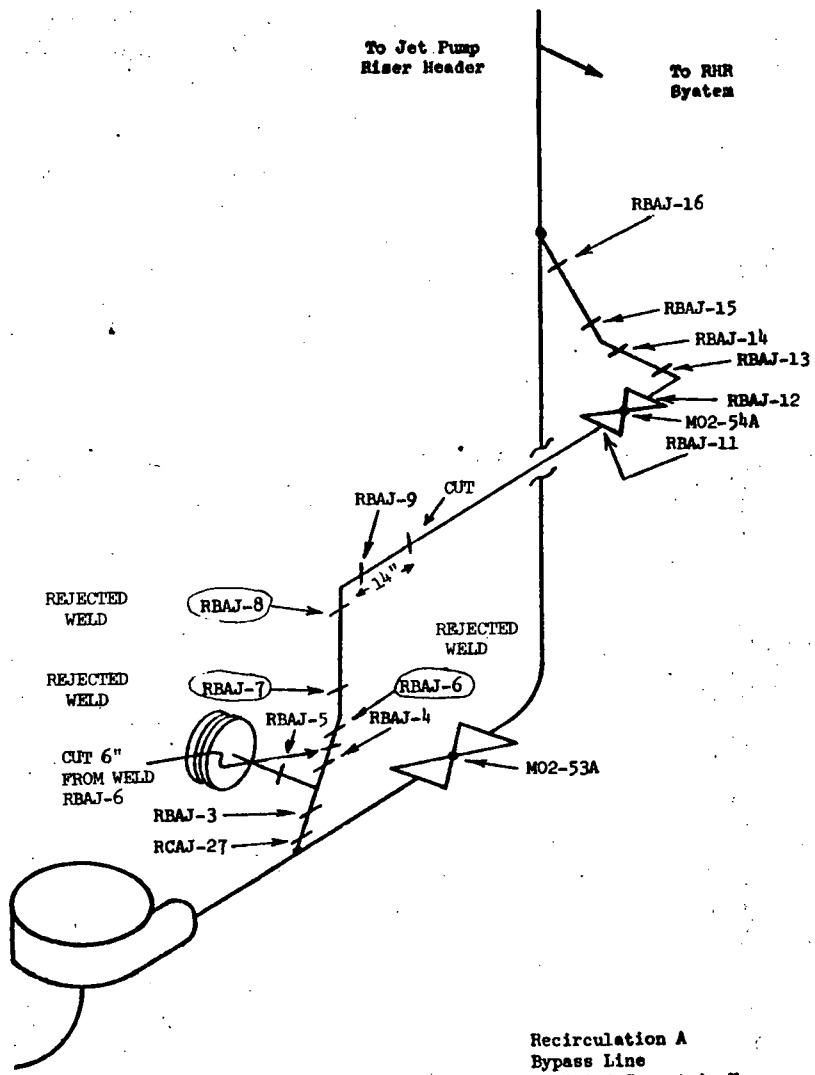
Recirculation A
Bypass Line
Modified Isometric U
Ref. FSK 382-1

On January 20, 1975, during the inservice inspection of the reactor coolant system, linear indications were detected by ultrasonic examination in two welds in loop A and one weld in loop B of the reactor recirculation system 4-inch diameter bypass lines. Radiographic examination of these three welds definitely verified the presence of a linear indication in one of these welds. The radiograph showed the indication to be located in the weld heat-affected zone.

After a thorough review and study of all of the ultrasonic recordings and comparing inspection results obtained in November, 1974, with the present results, a fourth weld became a suspect. This weld was located in loop A. Although the amplitude of the ultrasonic signal for this weld was relatively low, the signal pattern was similar to the three welds that were rejected; therefore, this weld was also rejected (see attached Figure).

The cause is unknown. It appears to be a generic problem similar to problems experienced at other BWR facilities. Identical inspections performed in November, 1974, revealed no unacceptable indications in these same welds. Indications which were detected in the November inspection were of a magnitude and nature such that they were indiscernible from the weld root I.D.

Segments of both pipe loops which contain the four rejected welds are being removed and replaced. This piping (schedule 80, type 304 stainless steel) will be sent to a laboratory for metallurgical examination.
