PLANT NAME: MONTICELLO

ABNORMAL OCCURRENCE REPORT TO THE AEC
Failure of HPCI Turbine Stop Valve to Open

1. Report Number: AO 263/74-22
- 2a. Report Date: August 16, 1974
- 2b. Occurrence Date: August 6, 1974
3. Facility: Monticello Nuclear Generating Plant
Monticello, Minnesota 55362
4. Identification of Occurrence:

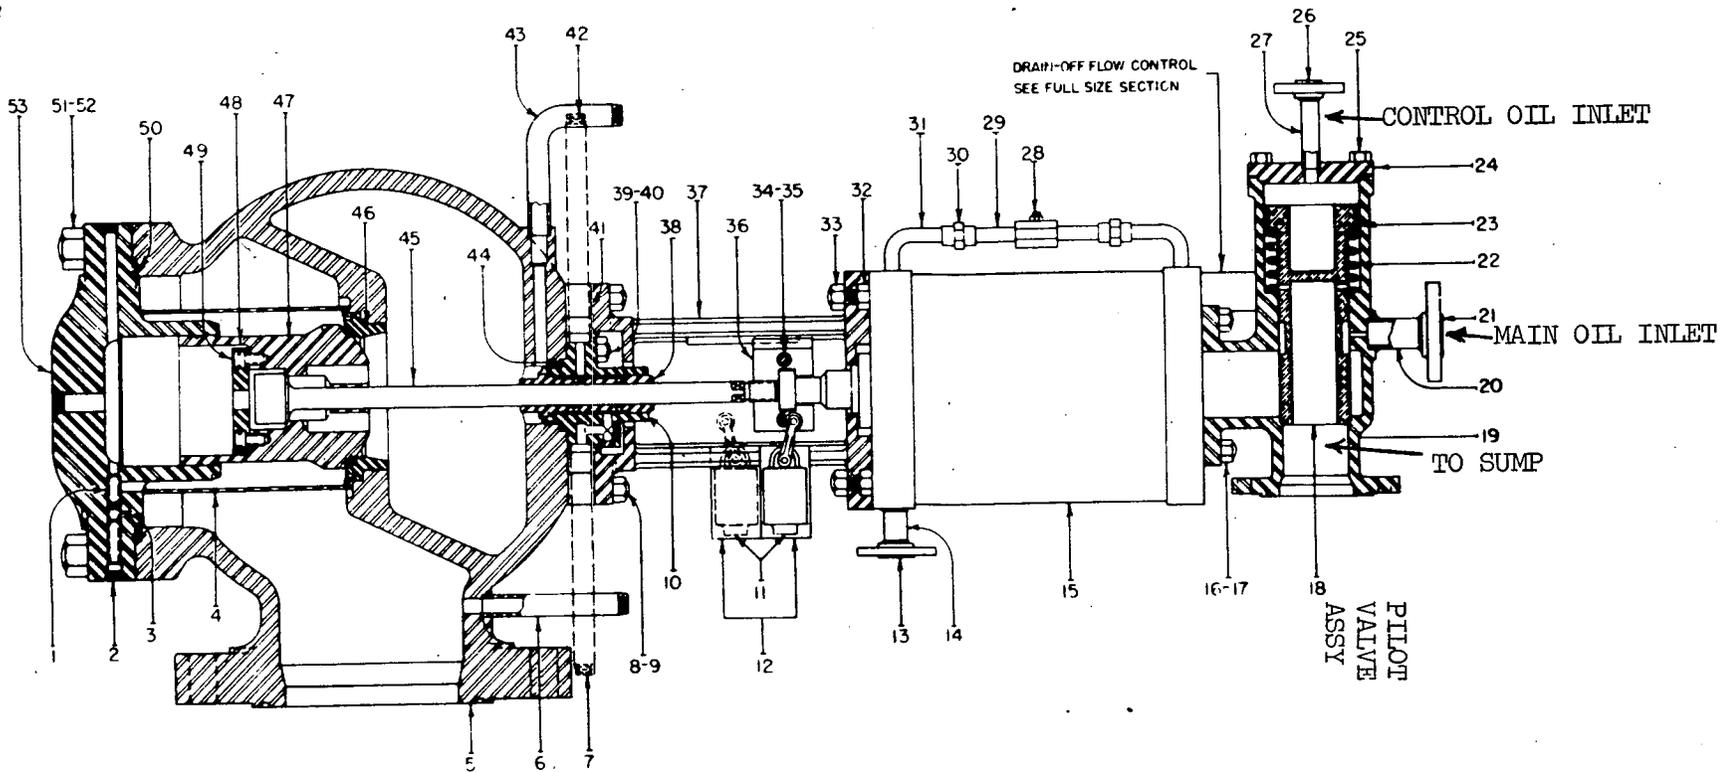
FIGURE 2. HPCI TURBINE STOP VALVE ASSEMBLY.

2. Inspection revealed that the condition of the pilot valve (see Figure Two) plug, seat, piston rings and cylinder surface was satisfactory. The possibility of a defective pilot valve was therefore ruled out.
3. Discussions with a representative of the General Electric Company revealed that a similar HPCI Stop Valve failure had occurred at an overseas BWR facility. The cause of that failure was attributed to a relaxed trip reset spring and trapped air in the oil system.

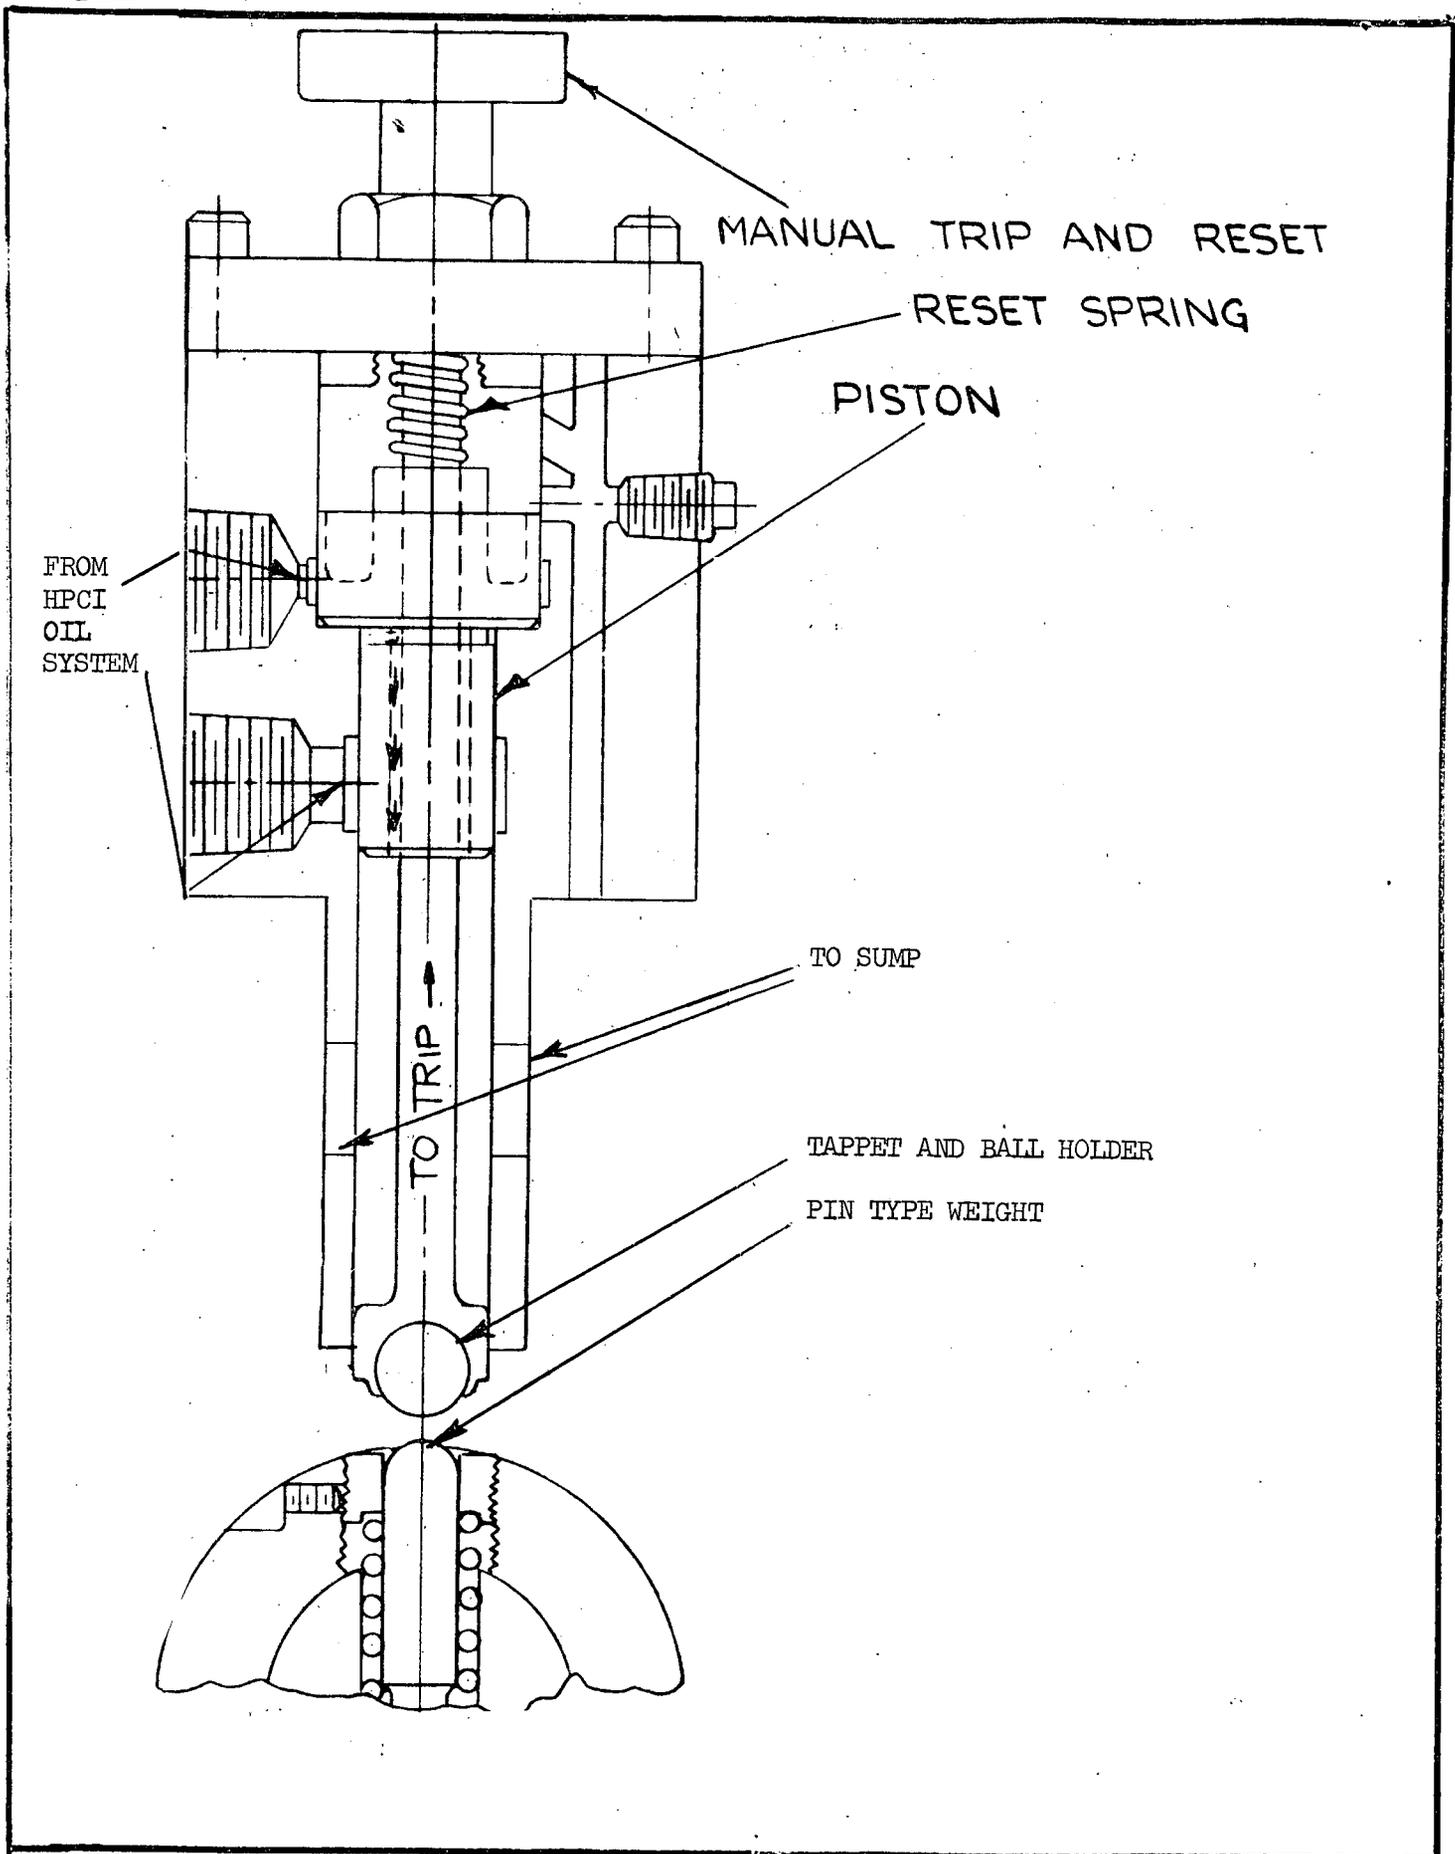
FIGURE 1. OVER-SPEED TRIP MECHANISM

Component Failure - Because of the intermittent nature of the problem it was not possible to determine a definite cause. However, it is postulated that the turbine overspeed trip reset spring (see Figure One) relaxed so that slight pressure surges in the oil system were sufficient to lift the trip piston and vent control oil pressure. It is believed that air trapped in the oil system contributed to propagation of pressure surges into the overspeed trip mechanism. The above conclusions were based on the following considerations:

The tension of the overspeed trip piston spring was increased and the oil system was vented. Leaking pipe fittings were located and tightened. Until it is determined that the problem has been satisfactorily resolved, surveillance of the auxiliary oil pump will be performed at times when operation of the stop valve and associated oil system controls can be closely observed.

It is planned to replace or retension the trip reset spring on a regular basis in the future.
