MONTICELLO NUCLEAR GENERATING PLANT Docket No. 50-263 License No. DPR-22

Cracked Tee in Standby Liquid Control System

Broken Stem on RHR Service Water Control Valve, CV-1728

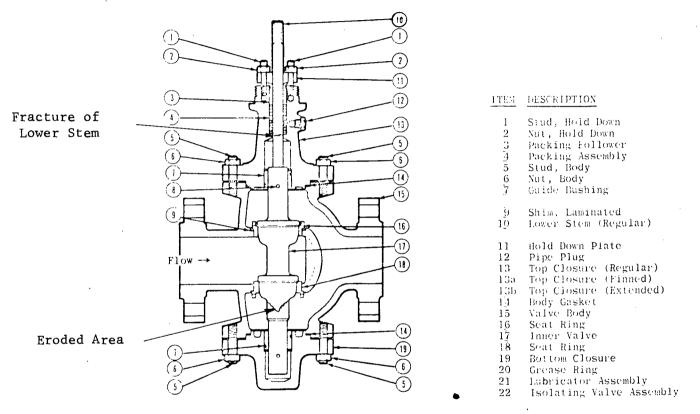
Figure 1. Typical Double Port Valve

On April 10, 1974, an inspection of the RHR Service Water Control Valve, CV-1728, revealed that the lower valve stem was broken. Further inspection revealed significant metal erosion below the lower port disc. (See attached figure) The nature of these failures and the design of the valve are such that the valve was still able to perform its function of controlling differential pressure between the RHR and RHR Service Water. The valve operator withdraws the stem to a given position and maintains that position through a position feedback device. The inner valve is designed to open when either normal flow or normal differential pressure forces are appled across the valve ports. Consequently, the inner valve will be forced open by hydraulic forces until it is restrained at the required position by the severed lower stem.

This is the first failure of this type which has been experienced. Metallurgical and mechanical investigations to determine the cause of the stem fracture and the erosion are continuing. The control valve in the redundant system will be inspected during the current outage. Following the completion of the metallurgical and mechanical tests and the inspection of the redundant system, a report on the final resolution of the problem will be submitted.
