SUBJECT: NRC INSPECTION REPORT 040-00299/11-001

Facility: Gas Hills facility

Location: Natrona County, Wyoming

Umetco Minerals Corporation Gas Hills Facility NRC Inspection Report 040-00299/11-001

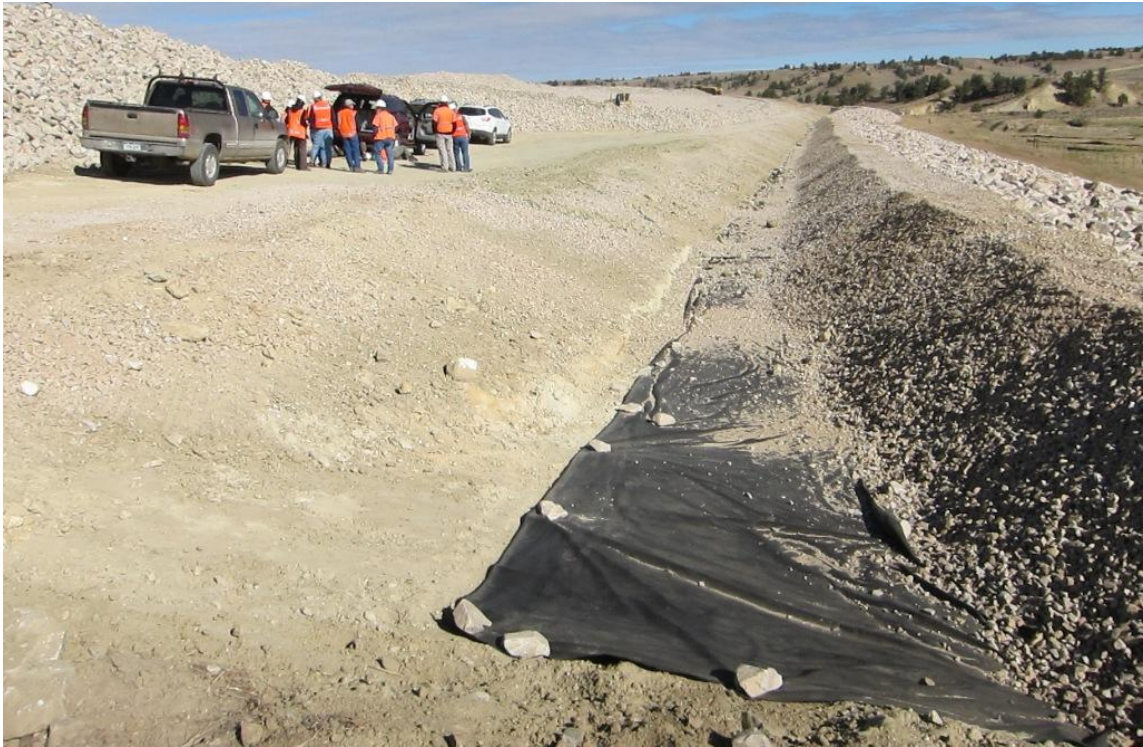
Repair of launch rock structure

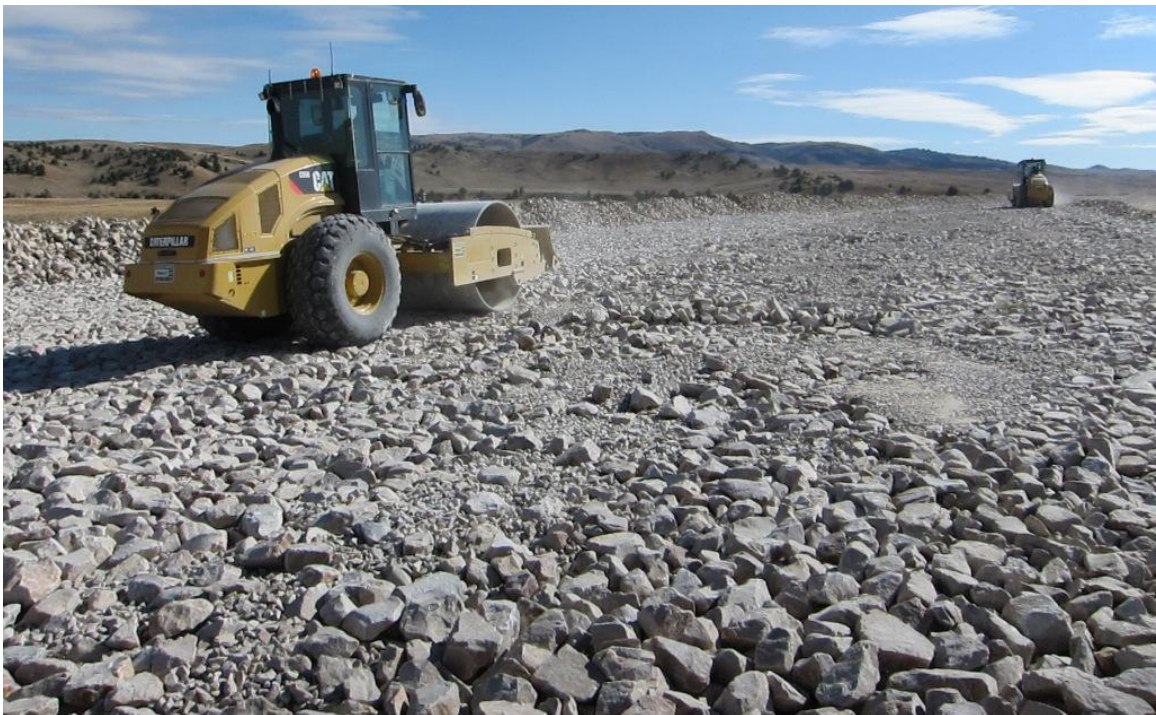
Mechanical vibrators in operation to “shake” bedding layer material under Type C rock

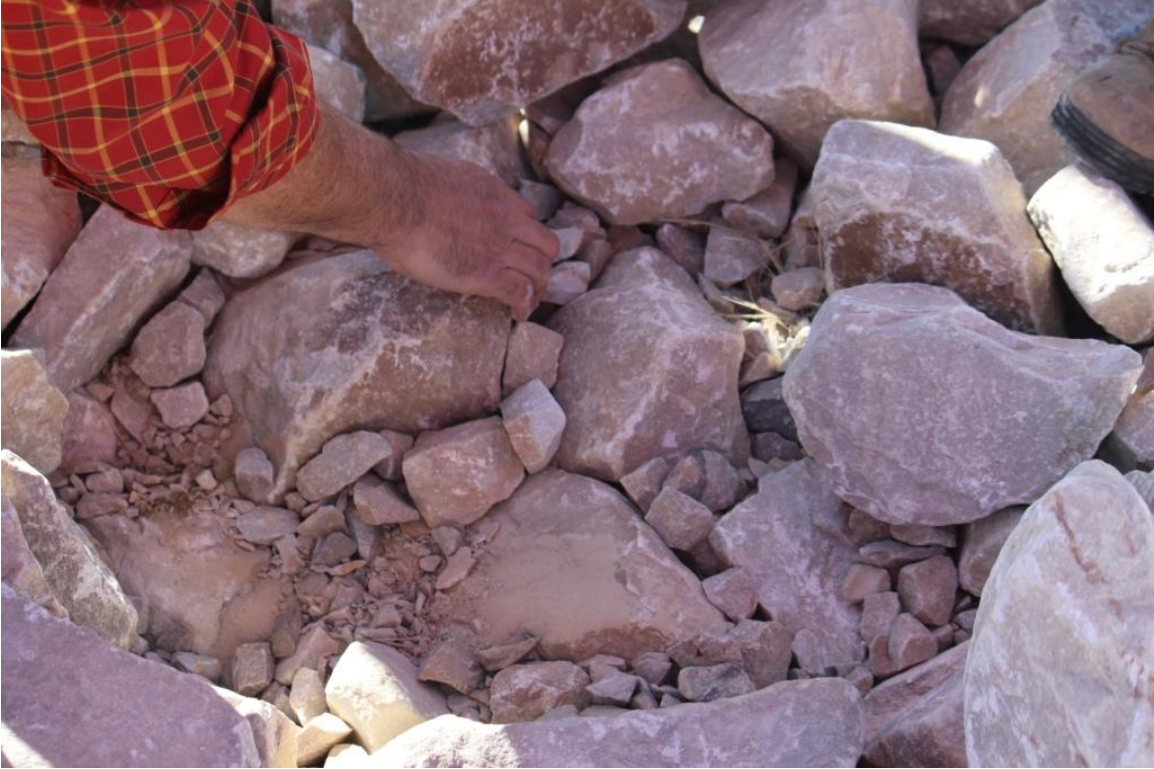
Visual inspections of the completed work indicated that the licensee was accomplishing the filter addition in a satisfactory manner. The licensee was placing the filter to the required minimum depth, and the rock voids in the larger rock were filled satisfactorily to prevent high-velocity flows from occurring in the rock voids. The licensee was using two acceptable techniques to place the bedding layer filter into place: (1) removal of the large rock, placement of the filter, and replacement of the large rock; and (2) distributing the filter material into the rock voids by placing the material directly on the cover and vibrating it through the cover to the frost protection layer. Based on several hand excavation examinations of random spots on the completed cover and visual inspection of a test trench opened by the licensee during the inspection, the filter layers were found to be in place and of an acceptable thickness.

Visual inspection of bedding layer material under Type C rock

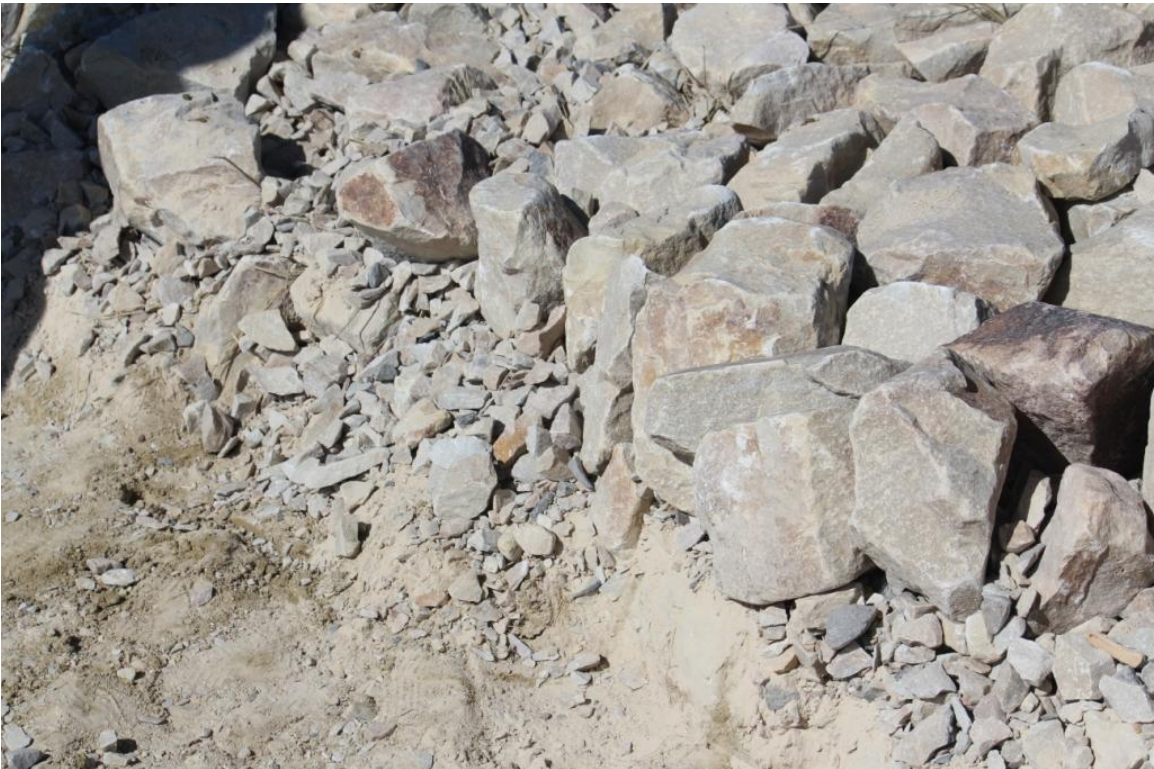
Bottom of test trench showing results of bedding layer emplacement using vibration method
