IE Inspection Report No. 050-263/75-16

Monticello Nuclear Generating Plant
Monticello, Minnesota

IE Inquiry Report No. 050-263/75-01Q (CDR)

Rework and Repairs - Feedwater Nozzles and Sparger Units

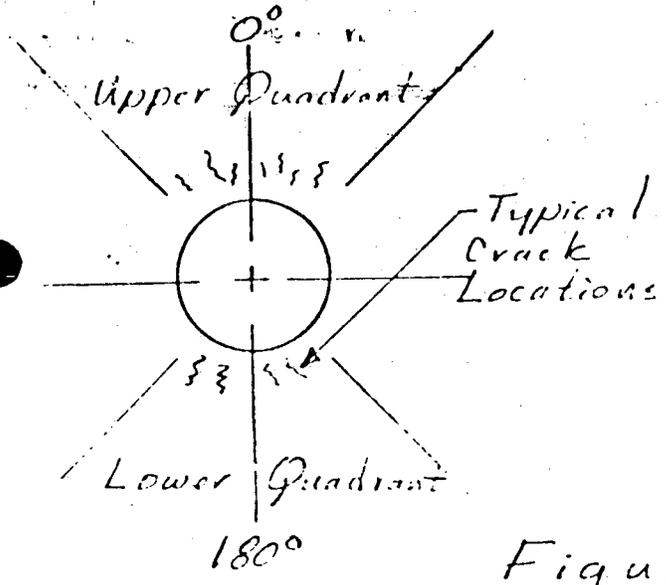
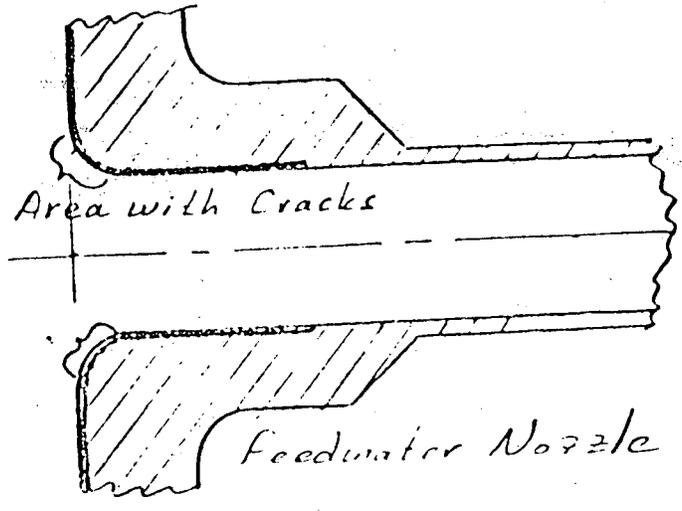
Figure 1

Approximately 200 crack indications have been found on the inside of the vessel where the four horizontal ten-inch feedwater nozzles merge into the vertical wall of the reactor vessel. The indications were generally concentrated in the upper and lower quadrants as shown on the attached drawing (figure 1). The locations of the cracks as marked by crayon for grinding are shown on the photograph of the 60° nozzle (figure 2). The vertical axis is represented by the 0-180° line. All four nozzles had some indications, but the nozzle at 60° appeared to show more indications. The indications were parallel or nearly parallel to the axis of the pipe as shown on the photograph with penetrant applied, of the 60° nozzle at 330° orientation (figure 3).
