UNITED STATES
NUCLEAR REGULATORY COMMISSION
REGION IV
612 EAST LAMAR BLVD, SUITE 400
ARLINGTON, TEXAS 76011-4125

October 18, 2011

SUBJECT: WOLF CREEK GENERATING STATION - NRC EXAMINATION REPORT
05000482/2011301

ER05000482/2011301; August 26, 2011 - September 22, 2011; Wolf Creek Generating Station; Initial Operator Licensing Examination Report; Examination Development

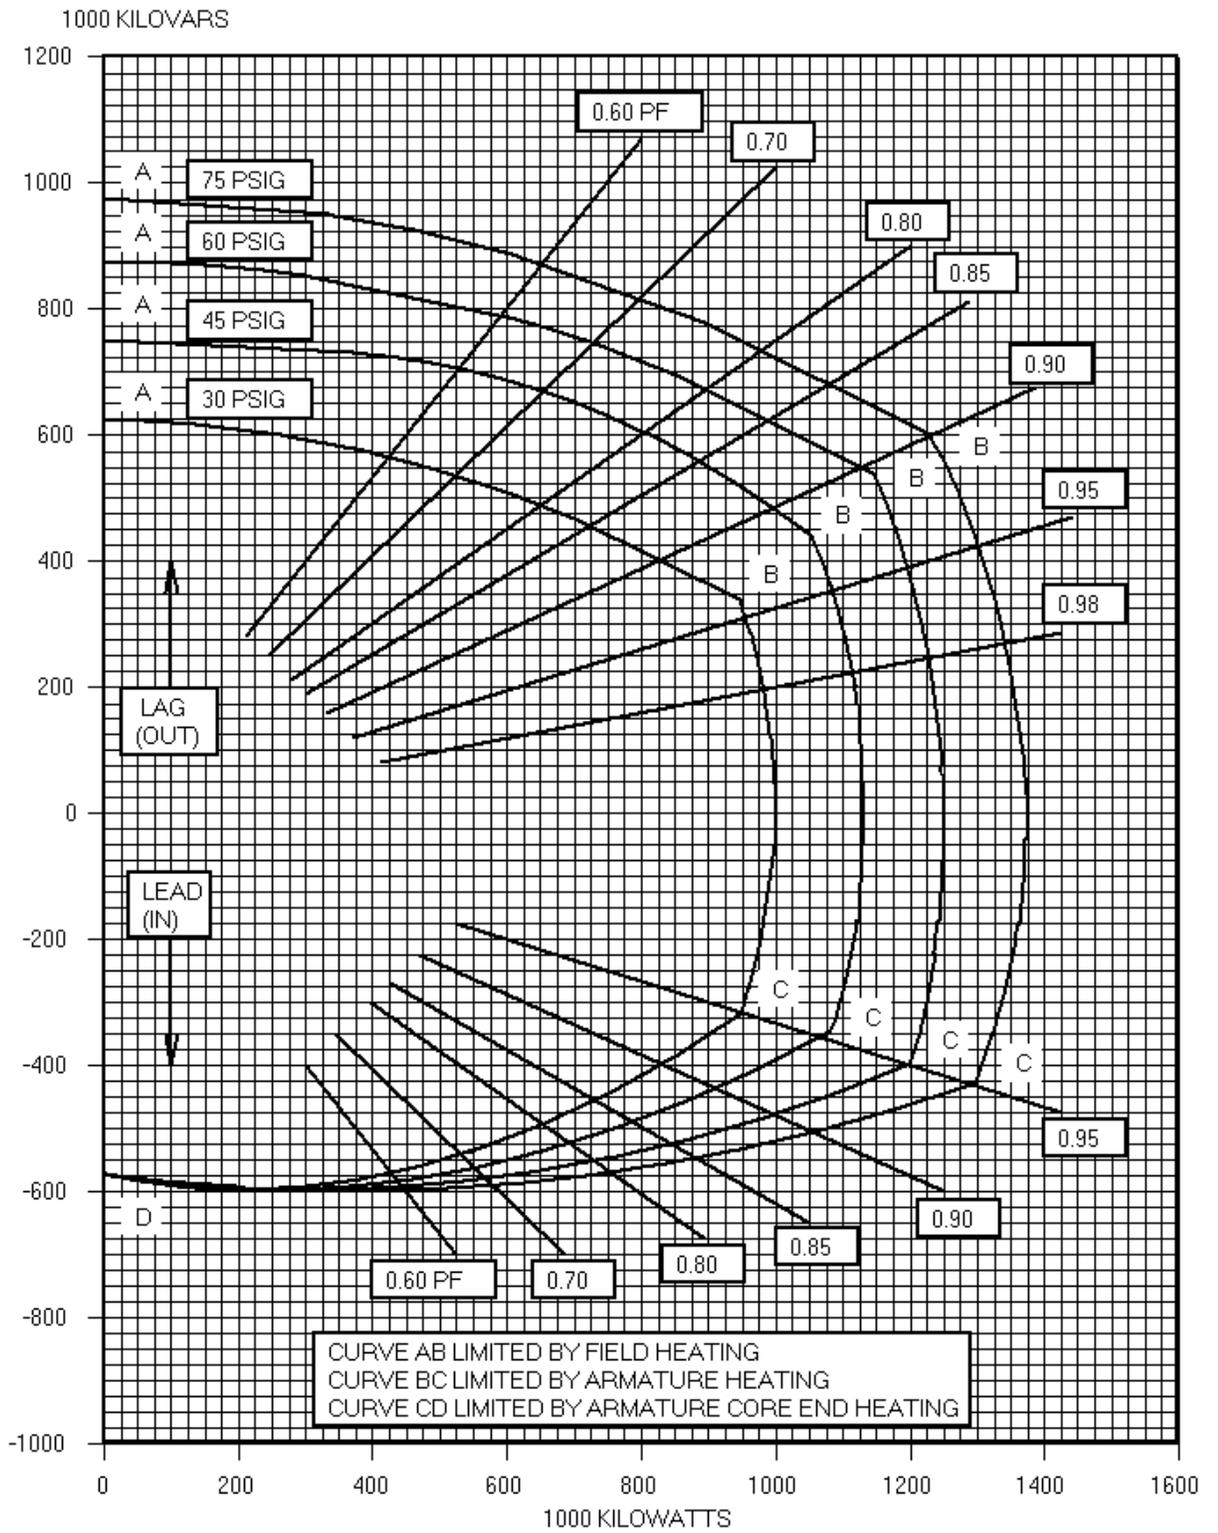
(Provided reference on next page)

The question is two parts, the first part assesses main generator limitations and the second the required course of action to place the unit in a safe configuration. The applicant must find four points on the main generator spider curve and assess whether they are inside or outside of an acceptable pressure curve. This was first done with pressure versus power factor then later revised to pressure versus reactive load. The second part tests the applicant's knowledge of the required remedial actions contained in ALR vice OFN procedures.

Review of the associated points indicates there is no correct answer to this question since all points are outside their respective power curves on the figure. The question prior to the final version did have a correct answer with reactive load in Answer D at 400 MVAR. This was changed to 500 MVAR in the final version by a validator comment. This change was made in error without sufficient final review.

Answer B is closest to the curve but still outside. The procedural flowpath is incorrect since the OFN does not isolate the leak. The leak is isolated by the local ALR, which then sends the performer to a system operating procedure to emergency depressurize the generator.

The examiners concurred with the licensee's assessment. When the question was converted to have the distracters read in MVARs rather than power factor, an error was incorporated into the question that rendered none of the distracters correct.

The question requires repair. The original question may not have been discriminatory enough, but performed well in validation. If MVAR is to be used in the answer then the current MVAR loading statement needs to be removed from the stem. A correct answer must be provided.

This question is recommended for deletion from this exam because no correct answer is provided. For this question, an error occurred when changes were incorporated from validation without sufficient technical review.

Since there is no correct answer, the final answer key has been revised to indicate that this question has been deleted from the examination.
