MONTICELLO NUCLEAR GENERATING PLANT
Docket No. 50-263 License No. DPR-22

Supplemental Evaluation Report on
Feedwater Nozzle Cladding Cracks

MONTICELLO
FEEDWATER NOZZLE CLADDING CRACK
REPAIR REPORT

NUCLEAR ENERGY SYSTEMS DIVISION
GENERAL ELECTRIC COMPANY
FOR
NORTHERN STATES POWER COMPANY

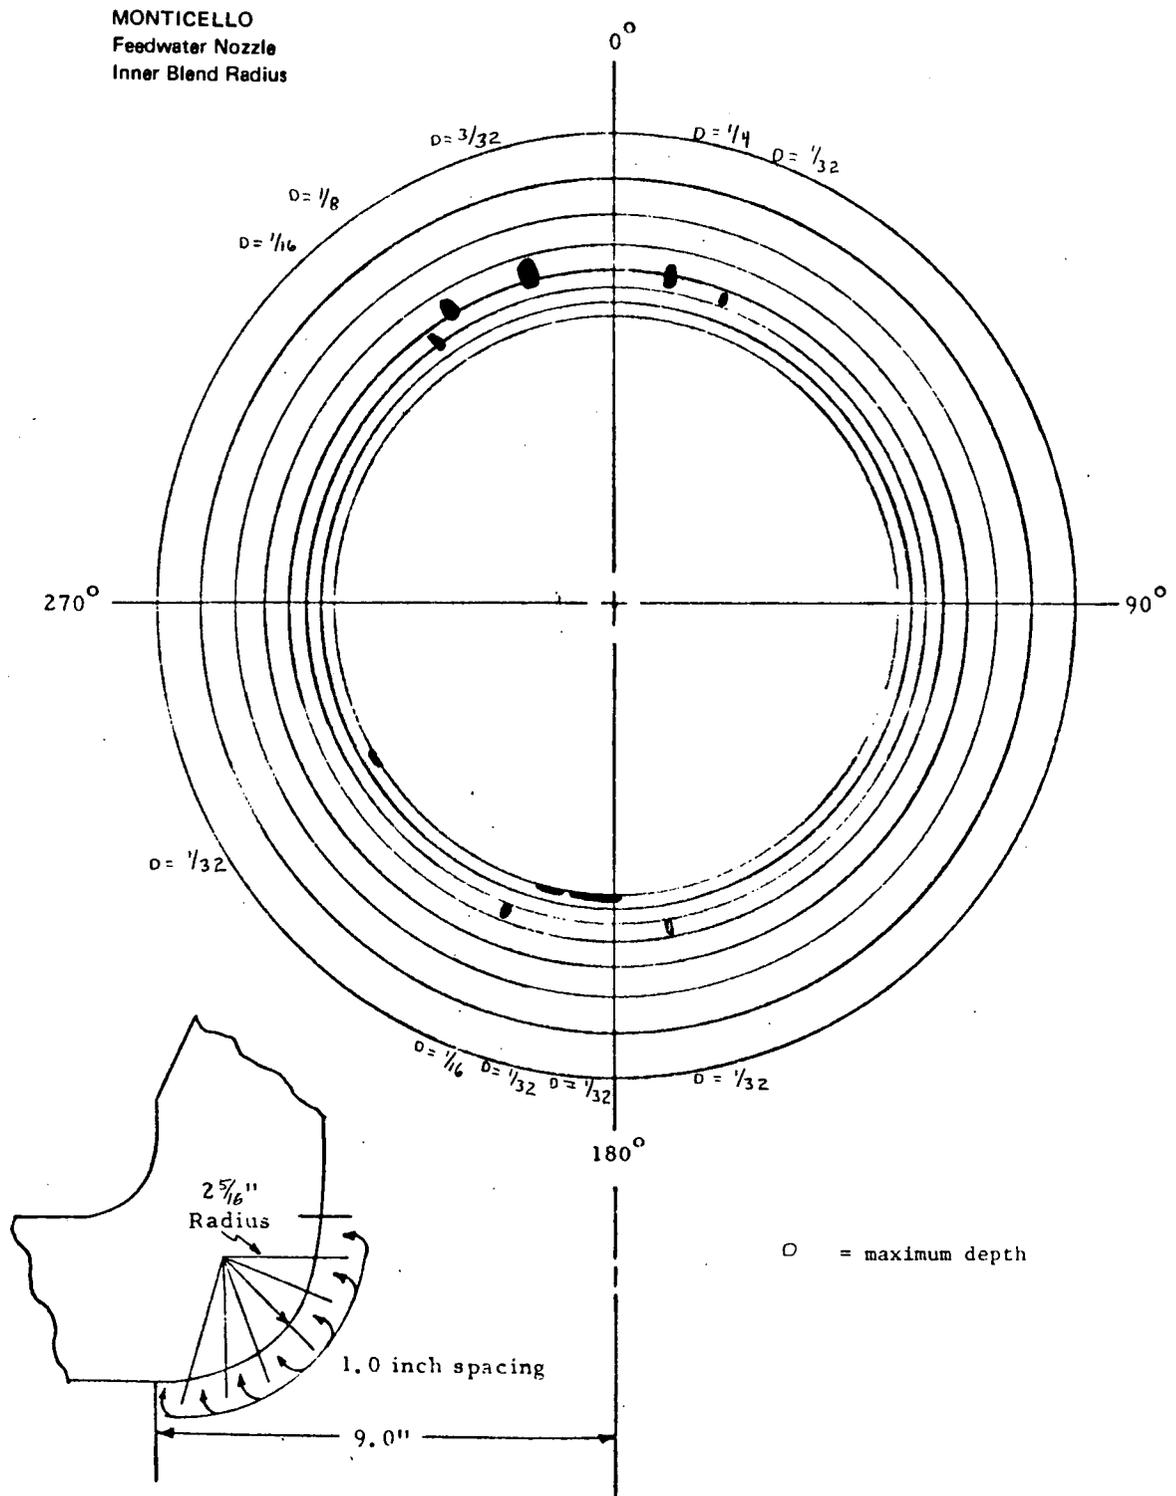
Figure 1. 45° Nozzle Base Metal Grindouts

All base metal ground areas were measured and mapped as shown in Figures 1 through 4.

After the indications were removed the bottom of the cavity was ground to a radius of twice the total depth of the cavity, and the sides of the grind cavities were ground to blend smoothly with the surrounding cladding metal surface with a minimum slope of 4 to 1 in base metal 2 to 1 in the cladding. A PT was performed on the blended cavity and final determination of clad base metal interface was made using demineralized water.

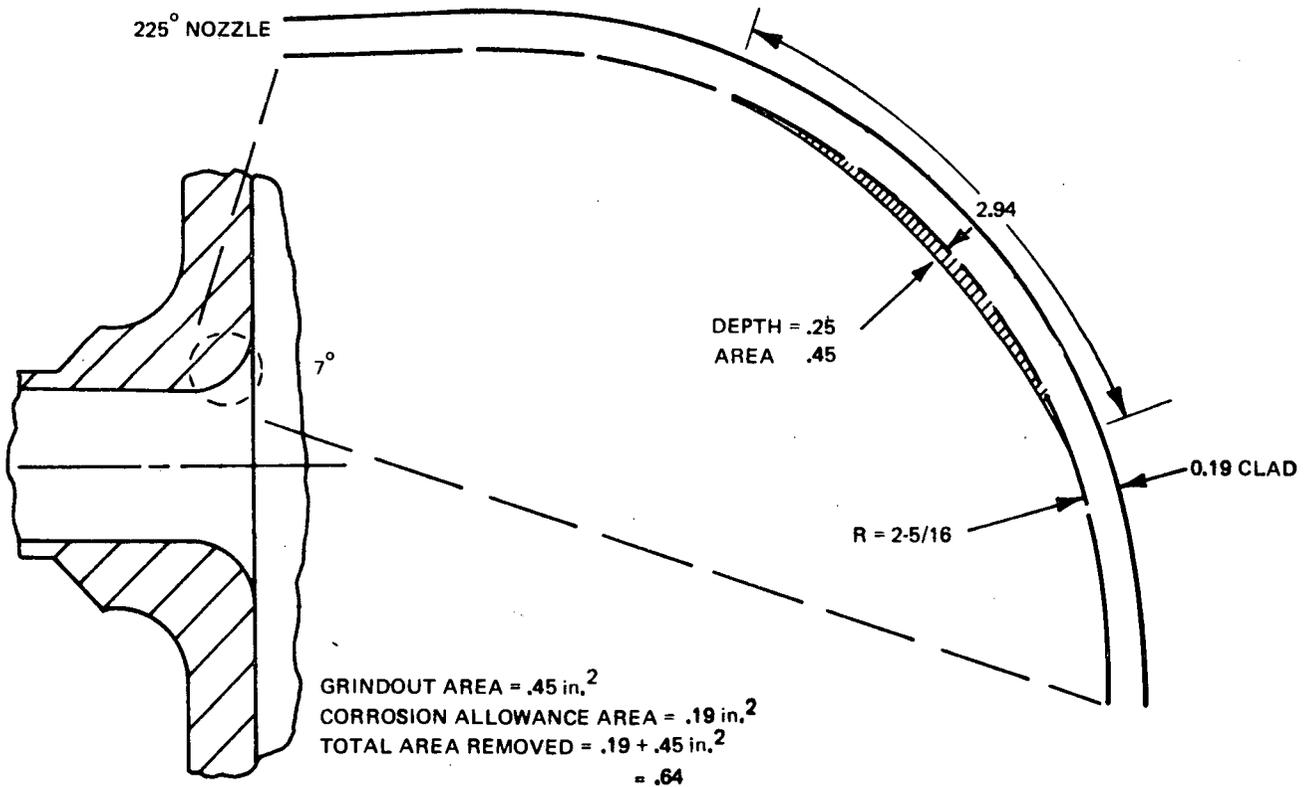
Figure 5. Largest Base Material Removal

Removal of base metal from the nozzle corner increases the required reinforcement area by the amount of low-alloy base material removed, measured as the largest cross-section area of removed metal lying in a plane through the nozzle centerline. Additionally, as the low-alloy steel is no longer clad at this location, 1/16-in. depth more than was actually removed is assumed non-existent for corrosion allowance, as above. All 53 grindouts that penetrated into base metal were mapped. The nozzle corner radius location with the largest base material removal is shown in Figure 5. As indicated, the additional required reinforcement area is approximately 0.64 in.². Since the available excess reinforcement area is $(31.20 - 28.30) = 2.90\text{-in.}^2$, the additional reinforcement area required as a result of this repair is approximately 22% of that which could be removed without violation of the original code calculation and $0.64/2.9 + 2.2 = 13\%$ of actual.

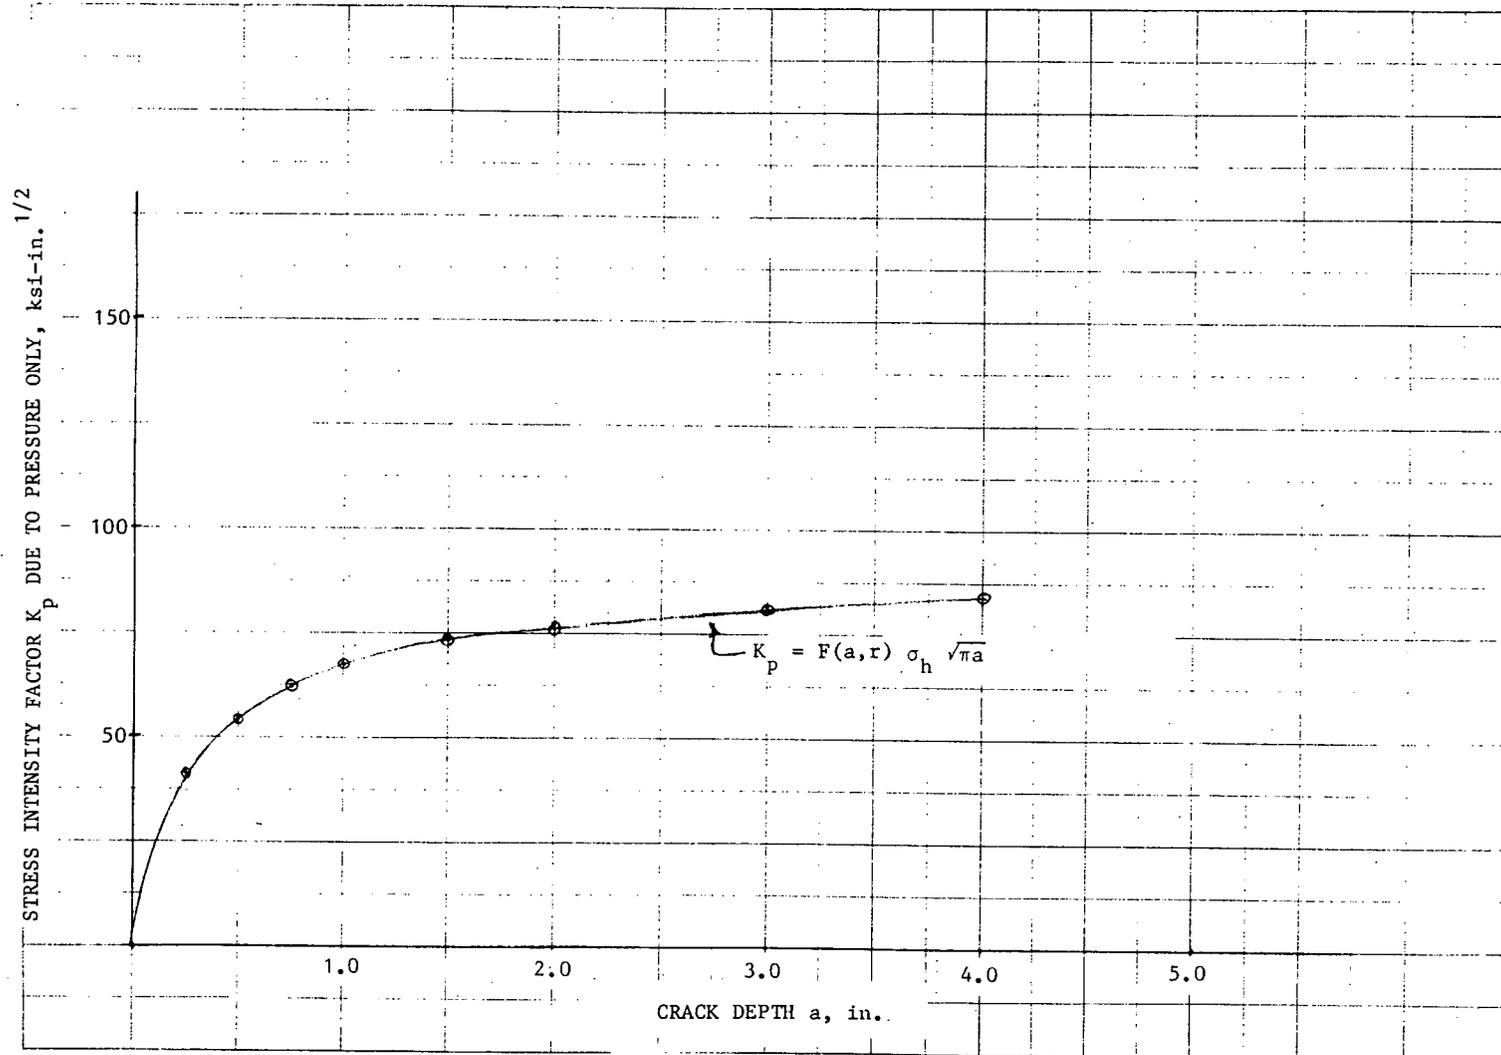
Figure 6. Pressure Stress Intensity Factor

The stress intensity factor K_p due to pressure is plotted in Figure 6.

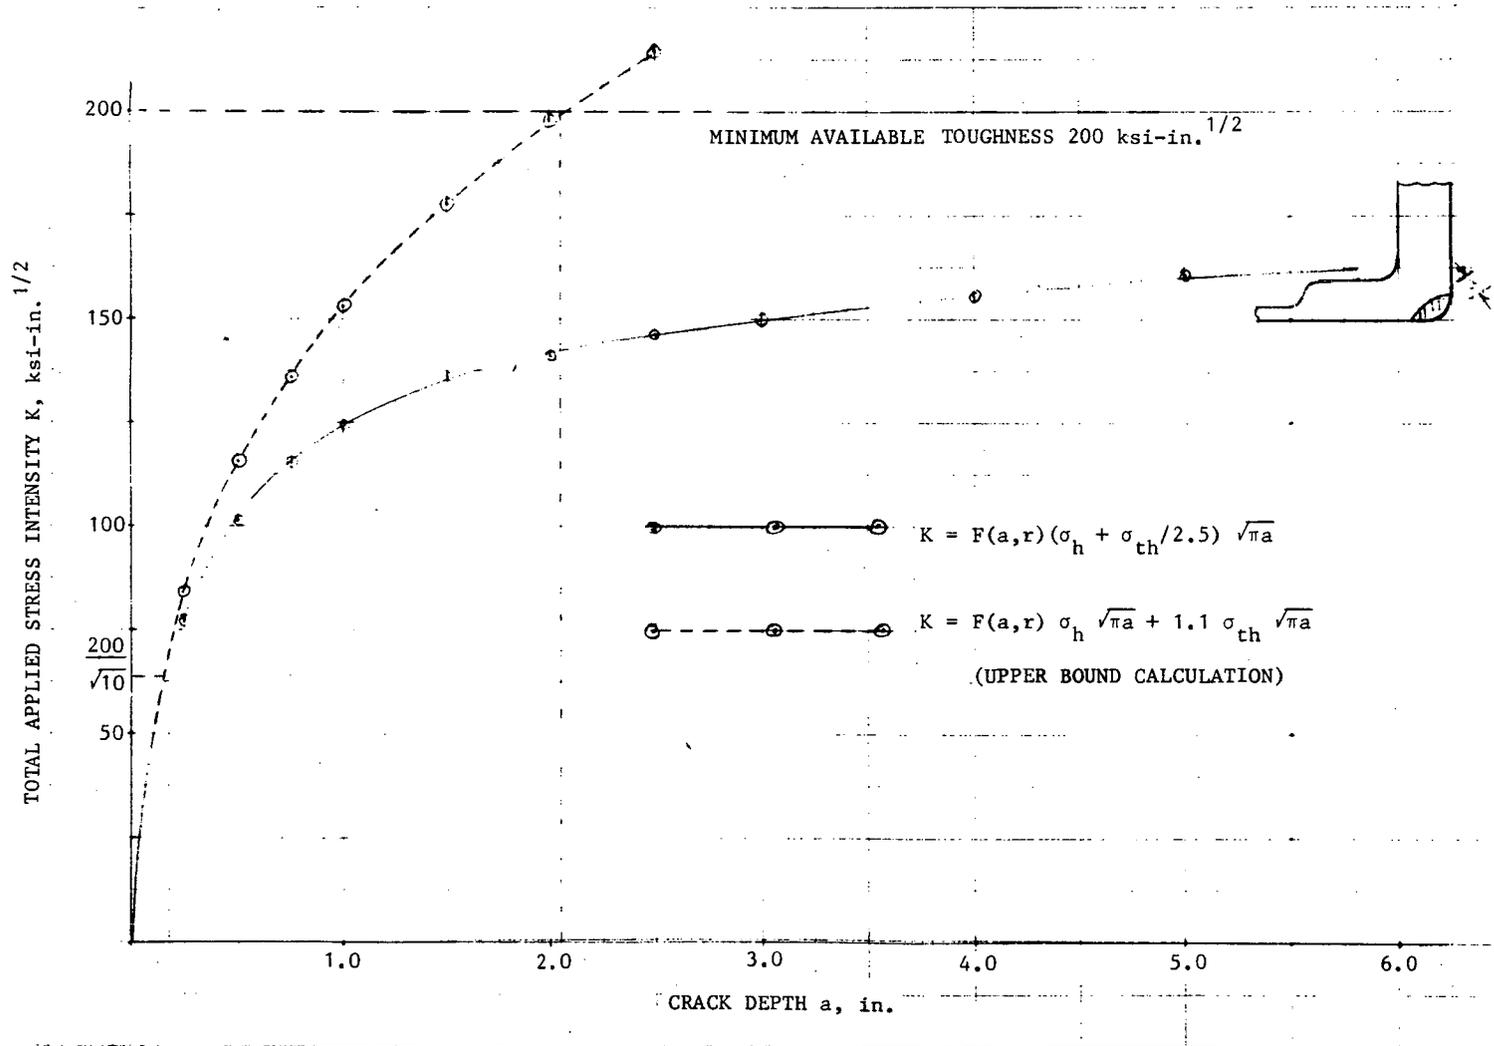
Figure 7. Total Stress Intensity Factor

Figure 7 also shows that for the second method based on the equivalent hoop stress technique the critical flaw does not occur (i.e., the crack would penetrate the wall and leak without growing unstably).

It can therefore be concluded that the critical flaw size is not less than 2 in. and is probably closer to 8 in. The exact value can be determined only by detailed stress analysis.

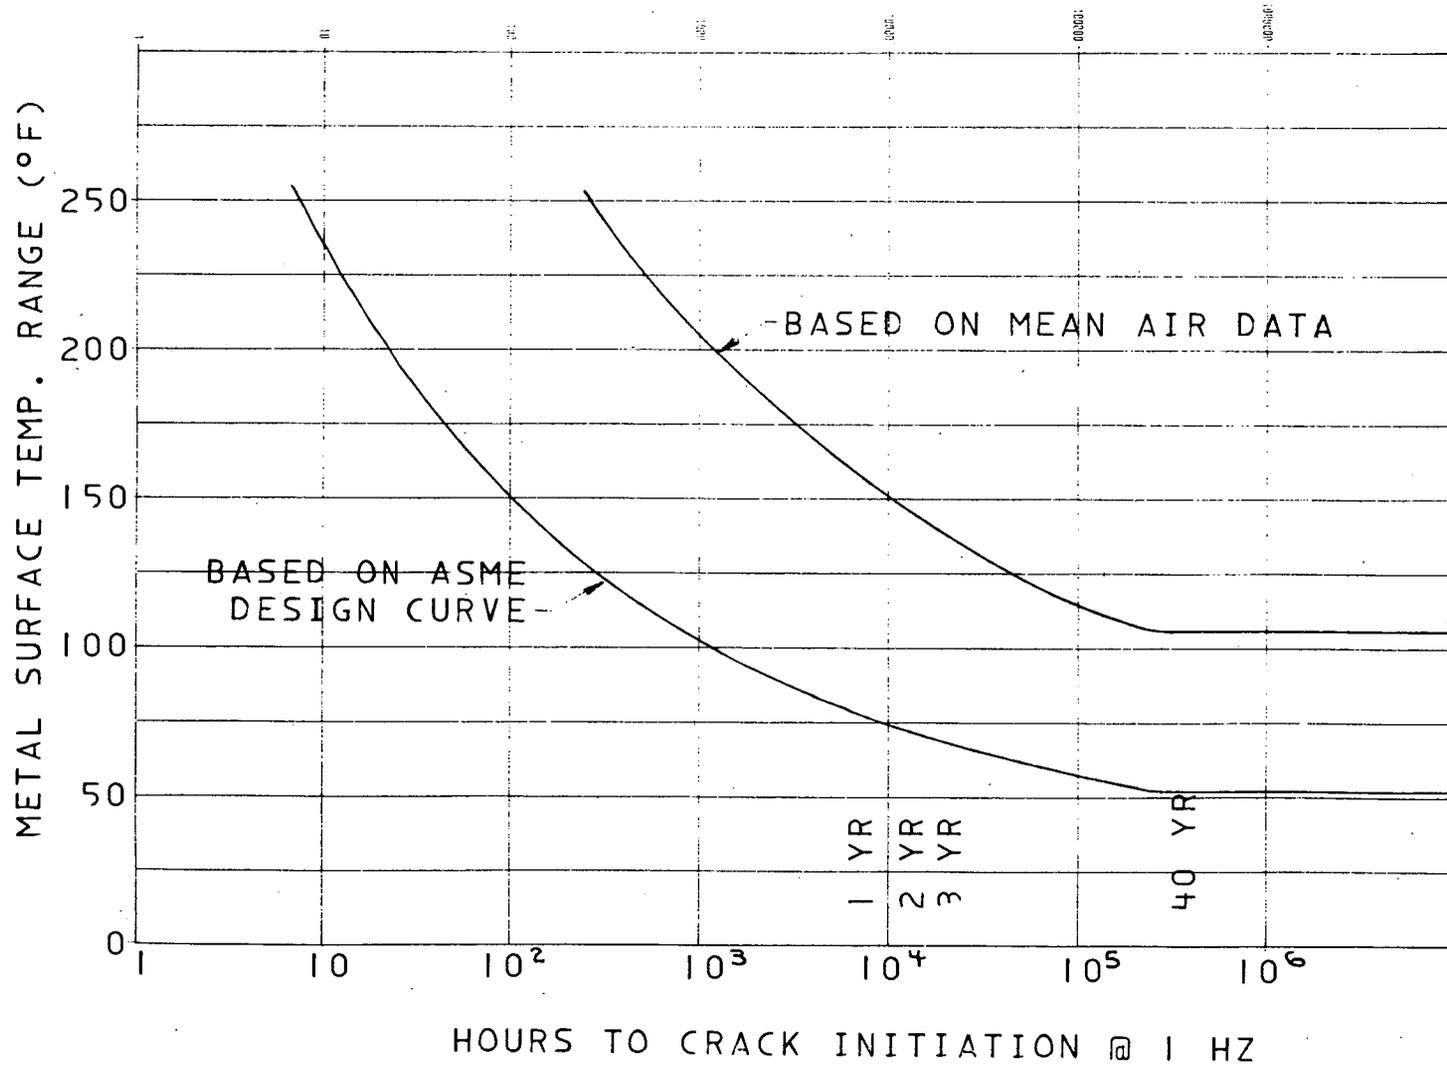
Figure 8. Fatigue Crack Initiation

Figure 8, which is based on ASME Section III fatigue curve extrapolated to 10¹⁰ cycles and on temperature fluctuations of 1 Hz, shows that 125°F cycling at rated conditions would begin initiating cracks between 300 and 45,000 hours. It is expected that some cracks would initiate in less than one year of rated operation. Thermal cycling during startup and other conditions can be significantly higher than 125°F thus decreasing the time required to initiate cracks.

Based on the frequency and amplitude of the thermal cycling it is concluded that the high cycle thermal stresses would drive the cracks to a depth of approximately 0.1 inch. Further growth must be attributed to another cause.

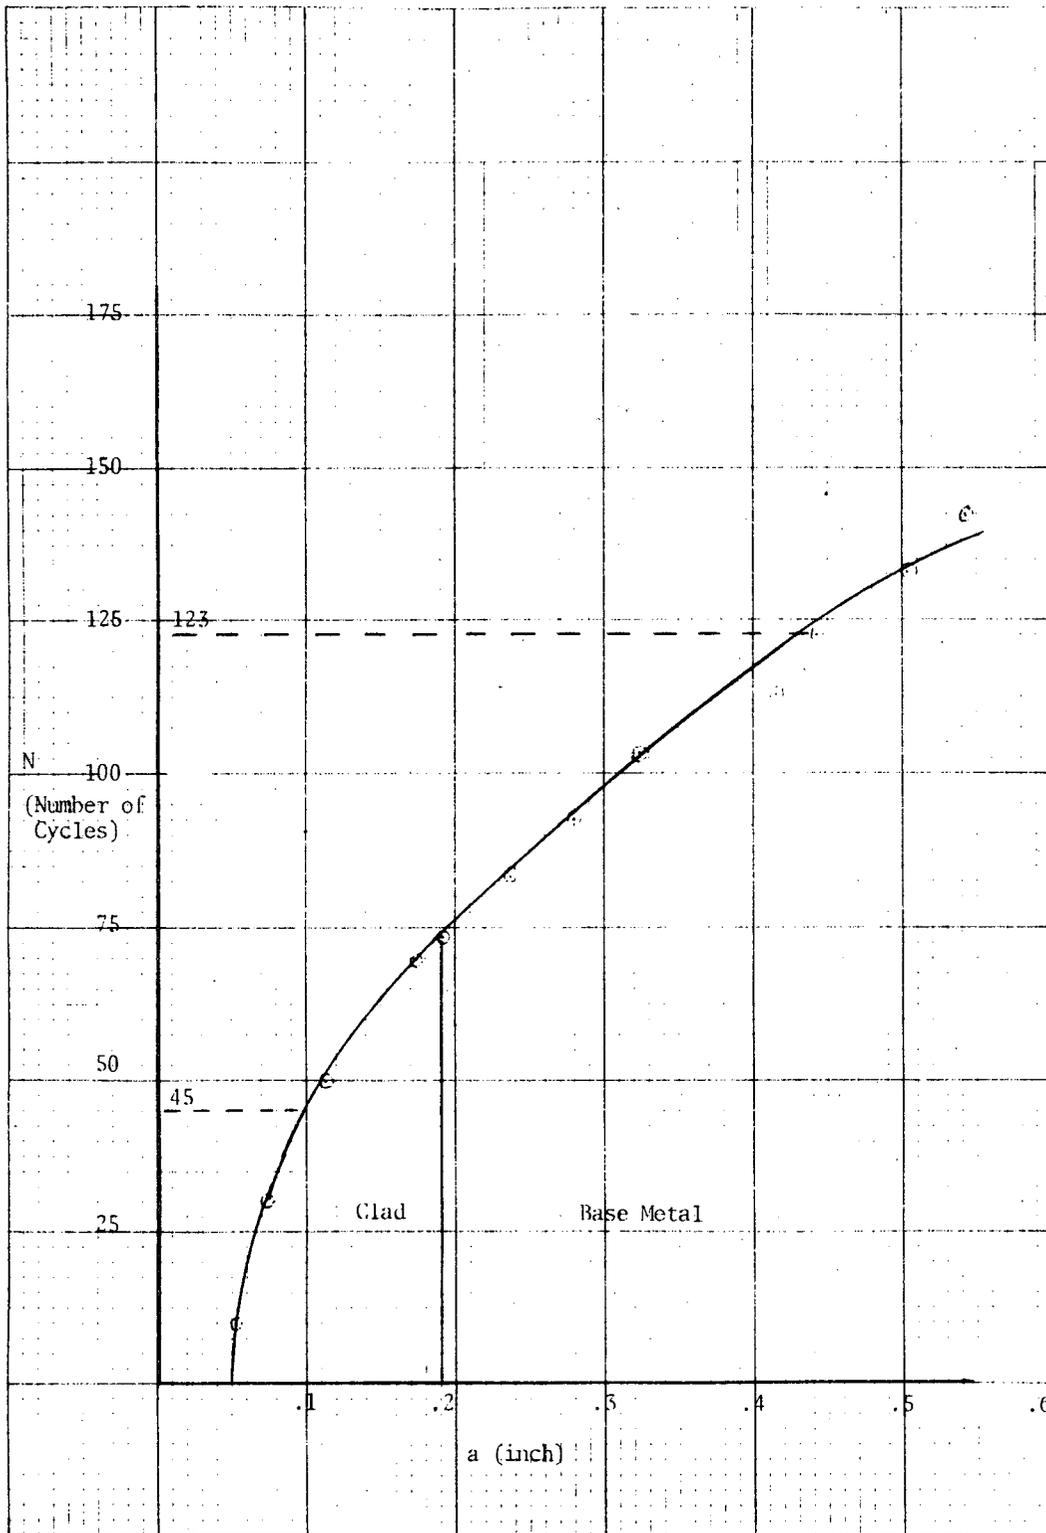
Figure 9. Crack Growth

Crack growth is plotted on Figure 9 using the values in Table 1. Each startup cycle consists of one cycle of pressure plus thermal, and five thermal cycles. The data points do not all lie on a smooth curve as the geometrical factor was changed in a stepwise manner. Figure 9 shows that a 0.1-inch crack will grow to a 0.44-inch crack in 78 cycles and to a 0.50-inch crack in 88 cycles.

Thus the existence of cracks up to a total depth of 0.5 inch is attributed to initiation by high cycle fatigue and growth by pressure plus thermal cycling.
