PART 21 NOTIFICATION - EMERGENCY DIESEL GENERATOR PISTON DELAMINATION

Report No. 10CFR21-0103

**10CFR21 REPORTING OF DEFECTS
AND NON-COMPLIANCE**

COMPONENT: Piston Assembly – Delamination of Tin Plating on Refurbished Piston Skirts

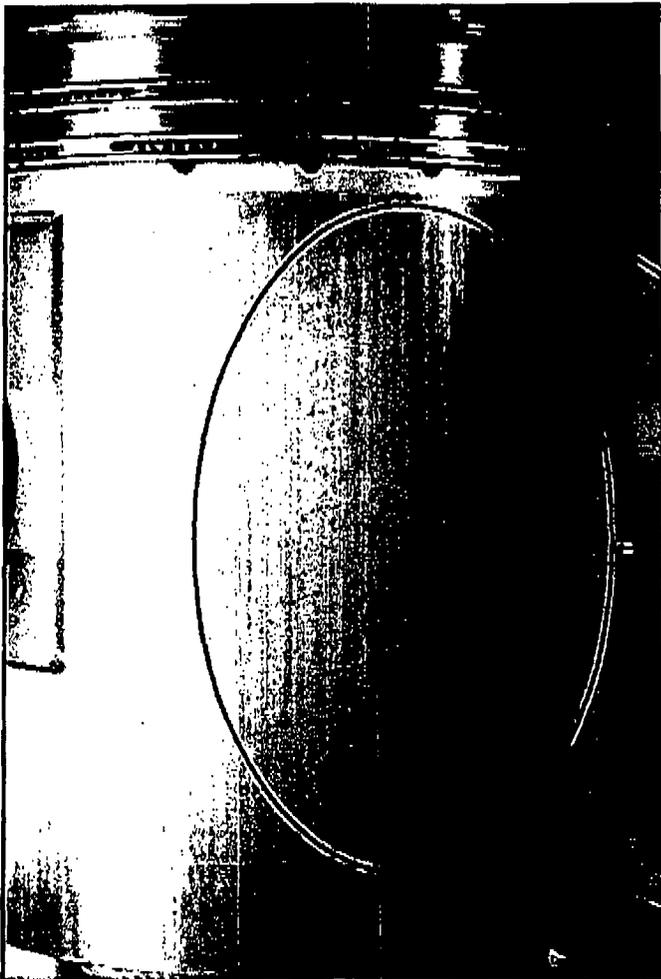
Examples of Acceptable Tin Streaking or Smearing
