MONTICELLO NUCLEAR GENERATING PLANT

Docket No. 50-263 License No. DPR-22
Reporting of Malfunction of Core Spray Injection Valve

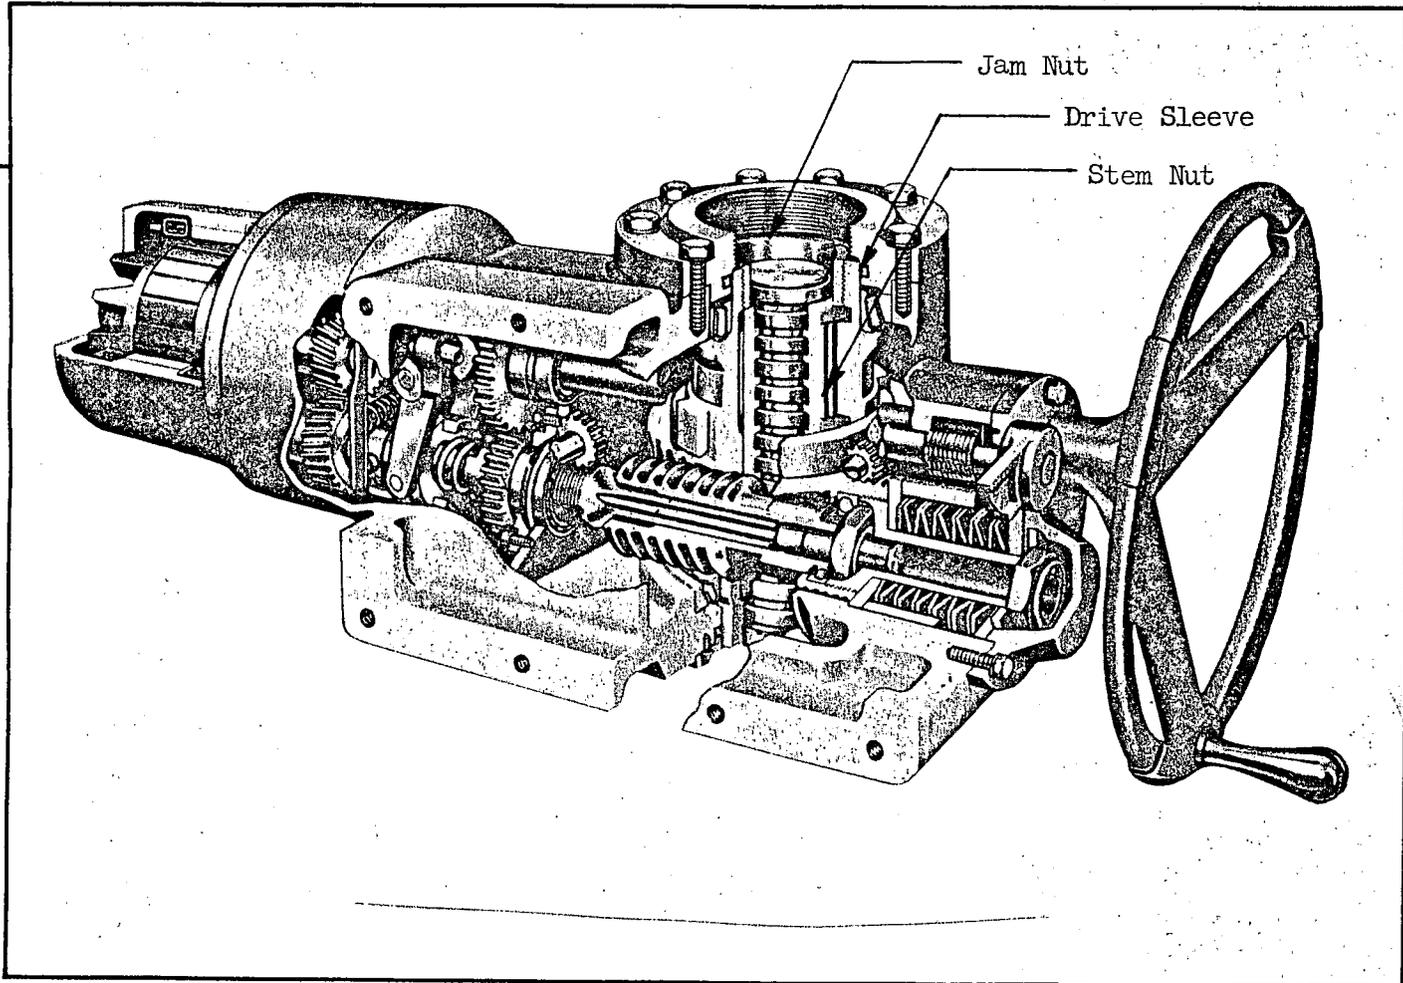
During the procedure for filling and pressurizing the core spray piping in preparation for a reactor startup on January 20, 1972, it was found that the core spray injection valve, MO-1753, did not open. A cutaway view of the operator is attached. The operator motor turns the worm gear drive which in turn rotates the drive sleeve. The stem nut which sits inside the drive sleeve is threaded internally to mesh with the valve stem; the stem nut is splined such that it cannot rotate within the drive sleeve. A jam nut screws into the drive sleeve to hold the stem nut in place as the drive sleeve turns. The threads are staked to keep the jam nut from unscrewing. On investigation of MO-1753, it was found that the jam nut had unscrewed completely, allowing the stem nut to ride up the valve stem as the drive sleeve rotated. Position indication is from switches in the motor operator; "open" and "close" indication was observed without the valve opening.

The immediate solution to correct MO-1753 was to replace the jam nut and drill and tap a vertical hole through the mating drive sleeve and jam nut threads; a set screw was then inserted to keep the jam nut from turning. All other motor operated valves of the same type were inspected. Out of 51 additional valve operators, no other jam nuts were found completely unscrewed from the drive sleeve. Nine jam nuts were found to have turned slightly. Five of these were fixed by inserting a roll pin between the jam nut and the drive sleeve. The other four were smaller valve operators;

they were fixed in place by restaking the threads. Each motor operated valve with this type of operator has been staked. All valves were confirmed to function properly by personnel stationed at the valve.
