MONTICELLO NUCLEAR GENERATING PLANT
Docket No. 50-263 License No. DPR-22

Turbine Lockout Following Generator Trip Test
from 15% Power and Subsequent Events

Subject: Turbine Lockout Following Generator Trip Test from 15% Power and Subsequent Events

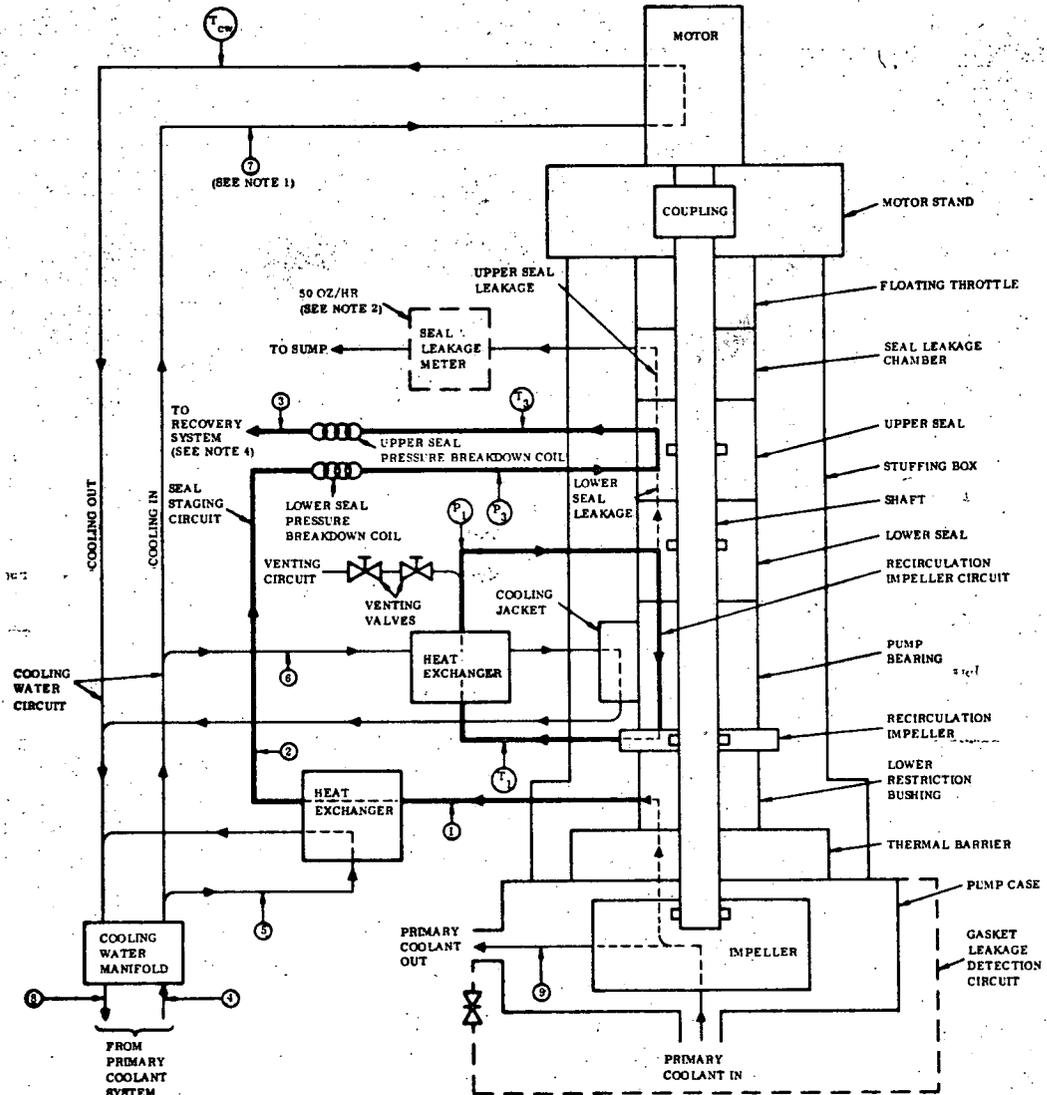
Reactor Recirculating Pump, Functional Diagram

On March 5, 1971, the No. 11 recirculation pump was inadvertently tripped at rated pressure and temperature conditions but was successfully restarted on the second attempt. During this pump trip, the seal temperature had increased to the point of concern. Discussions with Bingham pump personnel on March 8th revealed that seal leakoff isolation valves are required in the seal leakoff lines (following the upper seal pressure breakdown coil - see attached figure) to prevent seal damage following a pump trip unless the pump can be restarted within 10 to 15 minutes. Tripping a recirculation pump without the isolation valves results in primary system water leaking past the pump bearing and lower seal resulting in a failure of the lower and upper tungsten carbide seals due to thermal shock conditions.

On March 10th, after the plant shutdown occurred, unsuccessful attempts were made to isolate the recirculation pumps after the attempts to restart the pumps were unsuccessful. Several minutes after the shutdown, the inner seal temperatures on both pumps were greater than the 300°F range of the indicator. The No. 12 pump inner seal cavity pressure dropped from a normal operating pressure of approximately 500 psi to approximately 300 psi indicating a failure of the inner and outer seals. The No. 11 pump inner seal cavity pressure increased to approximately 750 psi indicating an inner seal failure but no outer seal failure.

- NOTES: 1. FLOW TO MOTOR IS DIVIDED 10 GPM TO UPPER THRUST AND JOURNAL BEARING, 1.5 GPM TO LOWER JOURNAL BEARING.
 2. IF UPPER SEAL FAILS, LEAKAGE INCREASES TO 1.1 GPM. IF BOTH SEALS FAIL, LEAKAGE INCREASES TO 20 GPM.
 3. IF UPPER SEAL FAILS, LEAKAGE INCREASED TO 1.1 GPM.
 4. A SOLENOID-OPERATED BLEED-OFF BLOCK VALVE IS PROVIDED IN THE RECOVERY CIRCUIT.

Following the shutdown on March 10th, the seals for both recirculation pumps were replaced. The lower bearing on the No. 11 pump was damaged and was also replaced. The seal leakoff isolation valves were installed and the controls checked out. These valves are operated from auxiliary contacts on the drive motor breaker. When the drive motor breaker trips, the isolation valves close to prevent seal leakage from the upper seal breakdown coil. By blocking the seal leakoff path, the cooled water is trapped in the seals preventing hot primary system water from entering along the pump shaft through the pump bearing and lower seal.
