## NORTHERN STATES POWER COMPANY

MONTICELLO NUCLEAR GENERATING PLANT  
Docket No. 50-263 License No. DPR-22  
Reporting of Operating Occurrence

## Unusual Occurrence Report No. 5

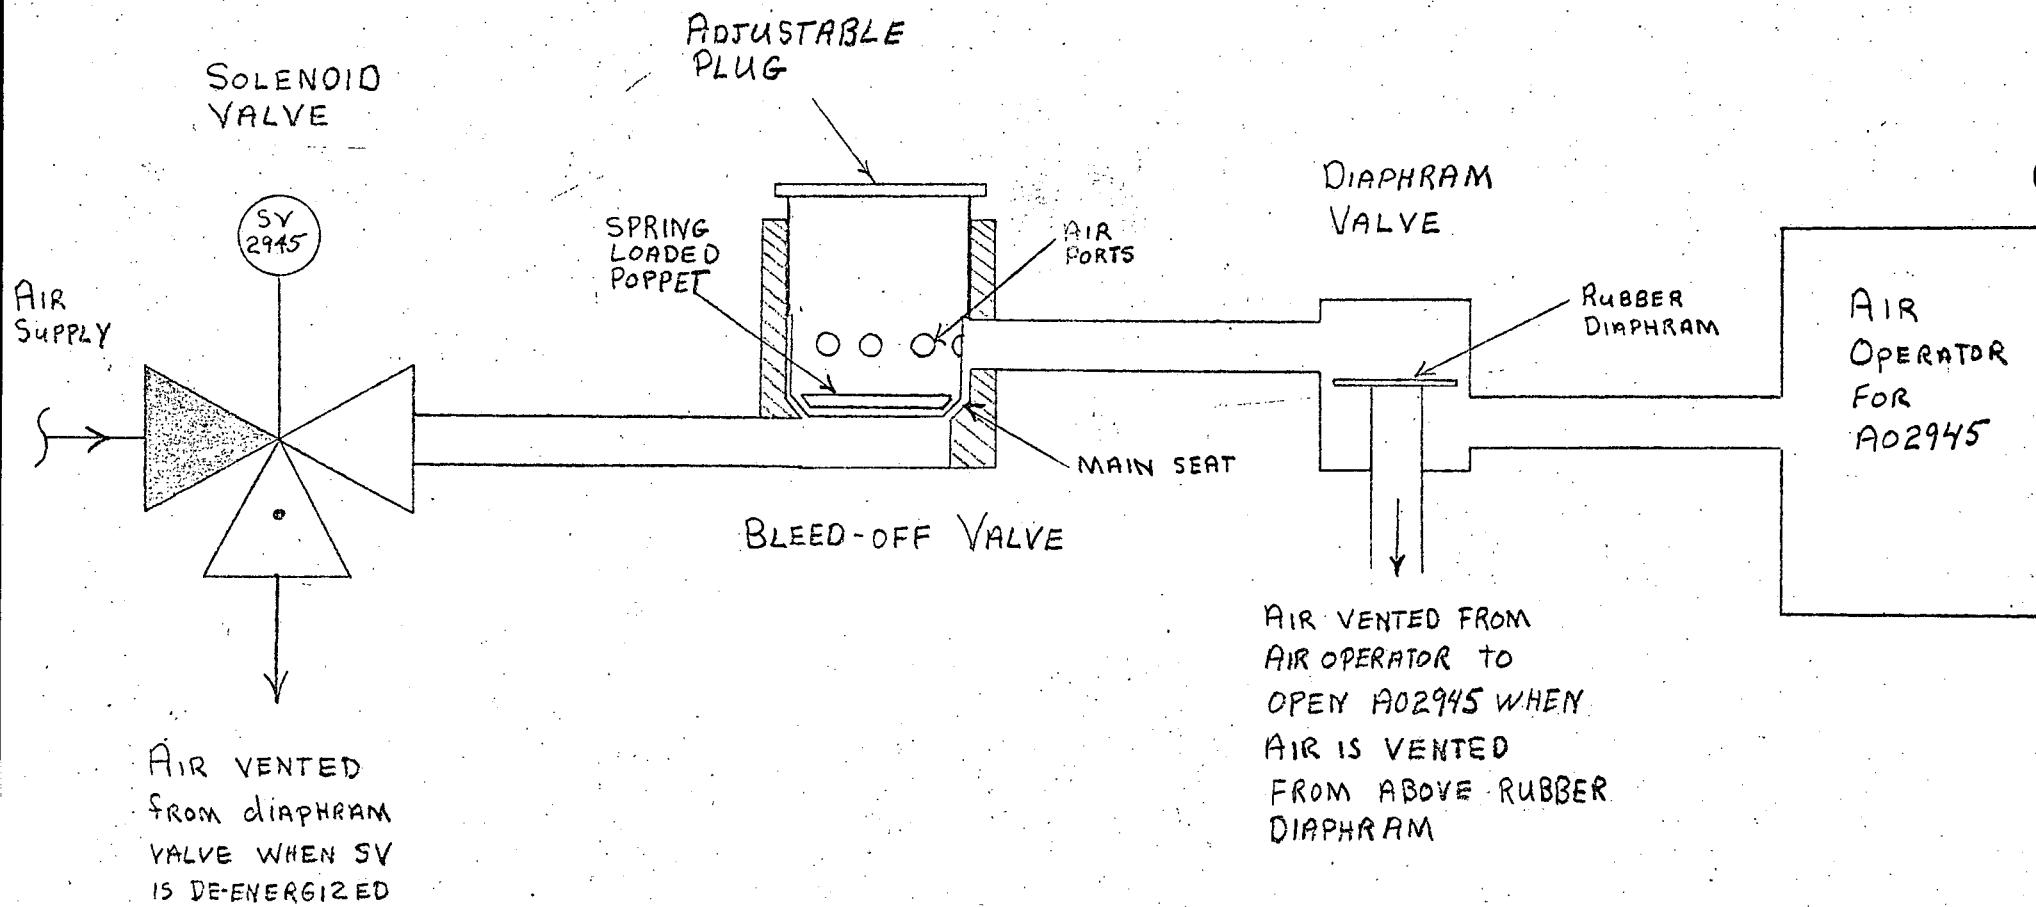
The following brief description of the valve operating mechanisms (refer to attached diagram) will aid in understanding the account and findings of the investigation. When the solenoid valve is energized, air is allowed to pass through the solenoid valve, through the bleed-off valve via the spring loaded poppet and air ports, around the rubber diaphragm of the diaphragm valve and to the air operator, causing the butterfly valve (AO 2945) to close. When the solenoid valve is de-energized, the air supply is interrupted and the air above the rubber diaphragm is vented via the bleed-off valve and the solenoid valve. When air is vented from above the rubber diaphragm, the diaphragm is lifted due to the high pressure below it, allowing the air from the air operator to vent and causing the valve (AO 2945) to open.

It is noted that the air which is vented via the bleed-off valve must do so by passing between the seat of the adjustable plug and the main seat of the valve. The rate of venting is therefore dependent on the setting of the adjustable plug.

opening (15 to 20 seconds) during one of the cycles. The plug was then removed from the bleed-off valve at which time it was discovered that there was a piece of teflon tape approximately  $1\frac{1}{2}$  inches in length located near the main seat. The teflon tape, which was still attached to the copper tubing, was removed and the plug was put back into the bleed-off valve. SGTS train A was then started by Mr. Tighe under the direction of Mr. Antony and was shutdown approximately 10 seconds later because AO 2945 had not opened. Another adjustment of the bleed-off valve was made and AO 2945 was cycled and found to be slow at opening (15 seconds). During the course of this testing it was discovered that the filter train discharge valve AO 2979, was also slow at opening (15 seconds).

Investigation of this occurrence indicated that air operated valve, AO 2945, failed to open due to adjustments made to the bleed-off valve on September 26, 1970. These adjustments were made by Mr. Seedorf under the direction of Mr. Antony in an attempt to quiet AO 2945 which had been excessively noisy when opening. Both SGTS trains were run on September 26th and 27th and they operated properly. It is believed that when the bleed-off valve was adjusted on September 26, the adjustable plug was fully seated. This would normally prevent AO 2945 from opening, however, it is also believed that the teflon tape which was found in the bleed-off valve had prevented the spring loaded poppet from seating, allowing the valve (AO 2945) to open during the operability tests on September 26th and 27th. The teflon tape was apparently blown from the seat of the poppet during operation on September 27th. With the poppet seated and the adjustable plug seated there was no means of venting the air, thus preventing AO 2945 from opening on September 28th. The slowness in opening during subsequent testing is attributed to the valve overtravel condition and the rate of bleed-off.

teflon tape from the bleed-off valve and adjustment of the bleed-off valve to provide for rapid venting. The air operator was also adjusted to prevent overtravel of the butterfly valve. Neolube was applied to the lining of the valve and paint was removed from the valve bushings. The bleed-off valves for AO 2944 (filter train B inlet), AO 2978 (filter train B discharge) and AO 2979 (filter train A discharge) were also disassembled and inspected. A piece of teflon tape was found and removed from the main seat of the bleed-off valve for AO 2978. Neolube was applied to the valve liners and the valves were inspected for overtravel. Overtravel was discovered on AO 2979 and the air operator was adjusted accordingly. The rate of bleed-off for AO 2979 was also increased. All of the valves (AO2944, 2945, 2978 and 2979) were tested and found to operate properly.
