MONTICELLO NUCLEAR GENERATING PLANT
Docket No. 50-263 License No. DPR-22

Submittal of Cycle 2 Startup Report

MONTICELLO NUCLEAR GENERATING PLANT
CYCLE 2 STARTUP REPORT

JULY, 1973

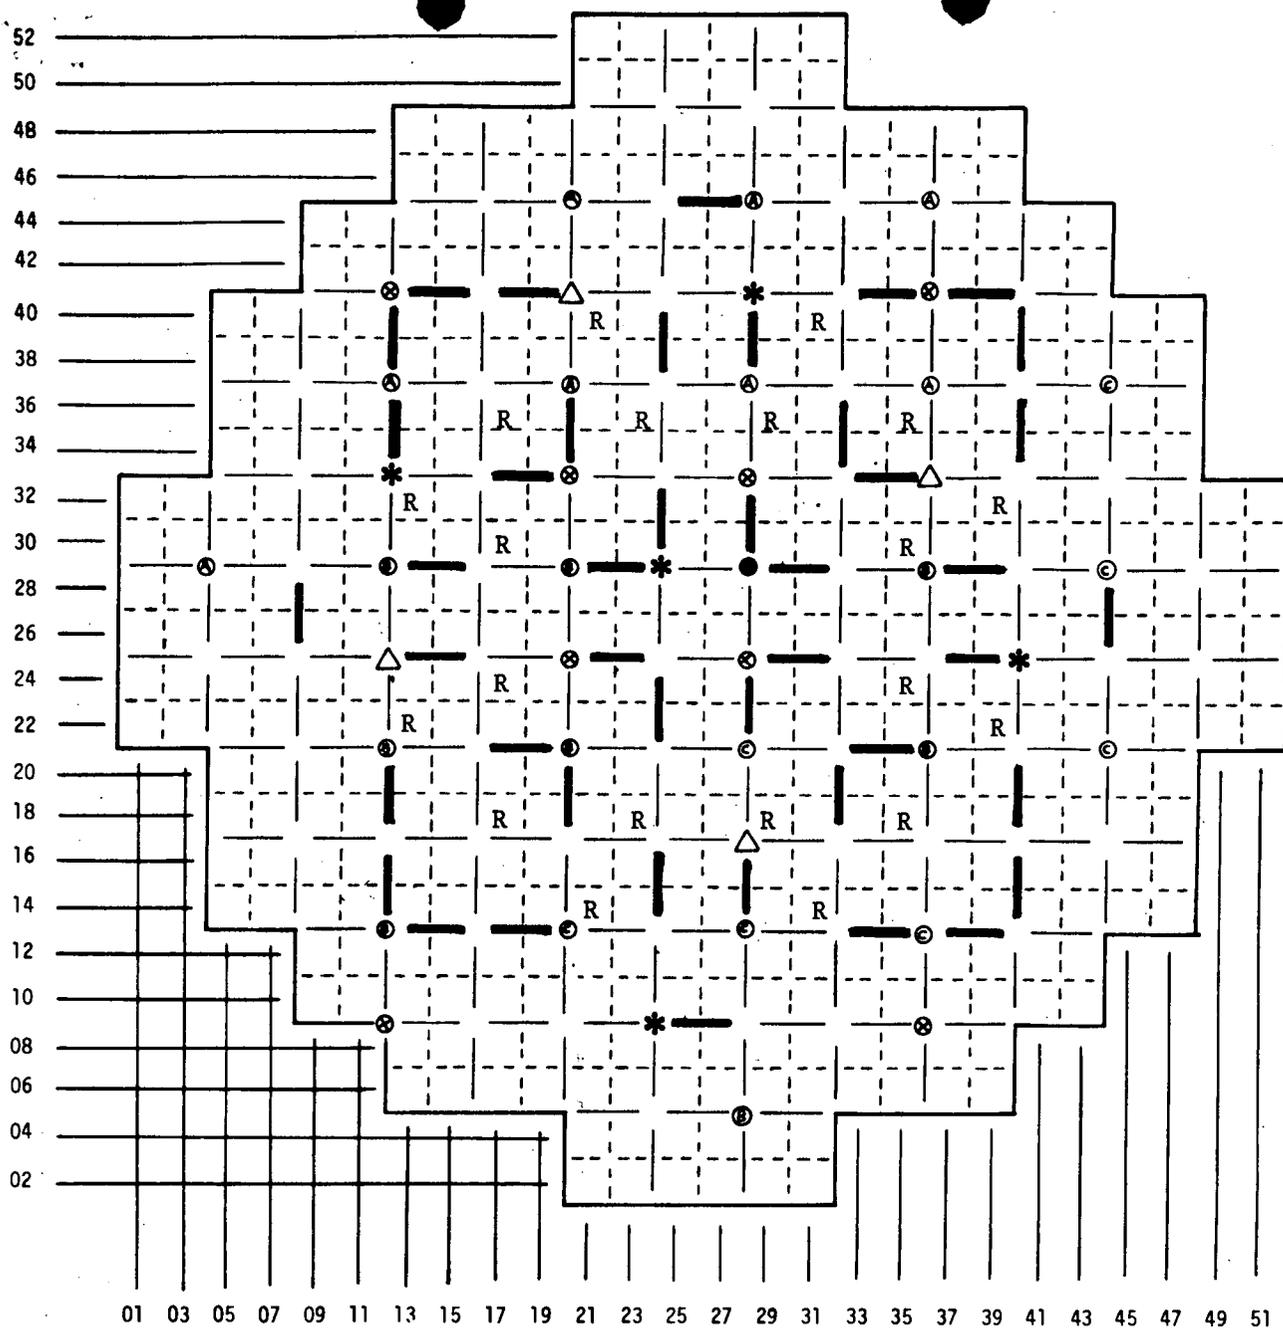
FIGURE 1
MONTICELLO CORE CONFIGURATION AT THE BEGINNING OF CYCLE 2

Core preparations for startup testing included certain calibration and verification steps. Following control rod drive maintenance and fuel movement, all control rods were stroked; scram timing was checked and adjusted as necessary in the cold condition. Six control rods were scrambled in the hot condition to verify the preestablished correlation between hot and cold scram times. After all in-core work was completed, the core was scanned by underwater television for proper fuel assembly orientation, curtain location, fuel assembly seating and general core condition. The individual fuel assembly serial numbers were checked to confirm fuel accountability records. The core was verified to be assembled as shown in Figure 1.
