FAILED HANGERS FOR EMERGENCY CORE COOLING SYSTEM SUCTION HEADER

MONTICELLO NUCLEAR GENERATING PLANT
Docket No. 50-263 License No. DPR-22

Inspection of Support Hangers for Emergency Core
Cooling System Suction Header

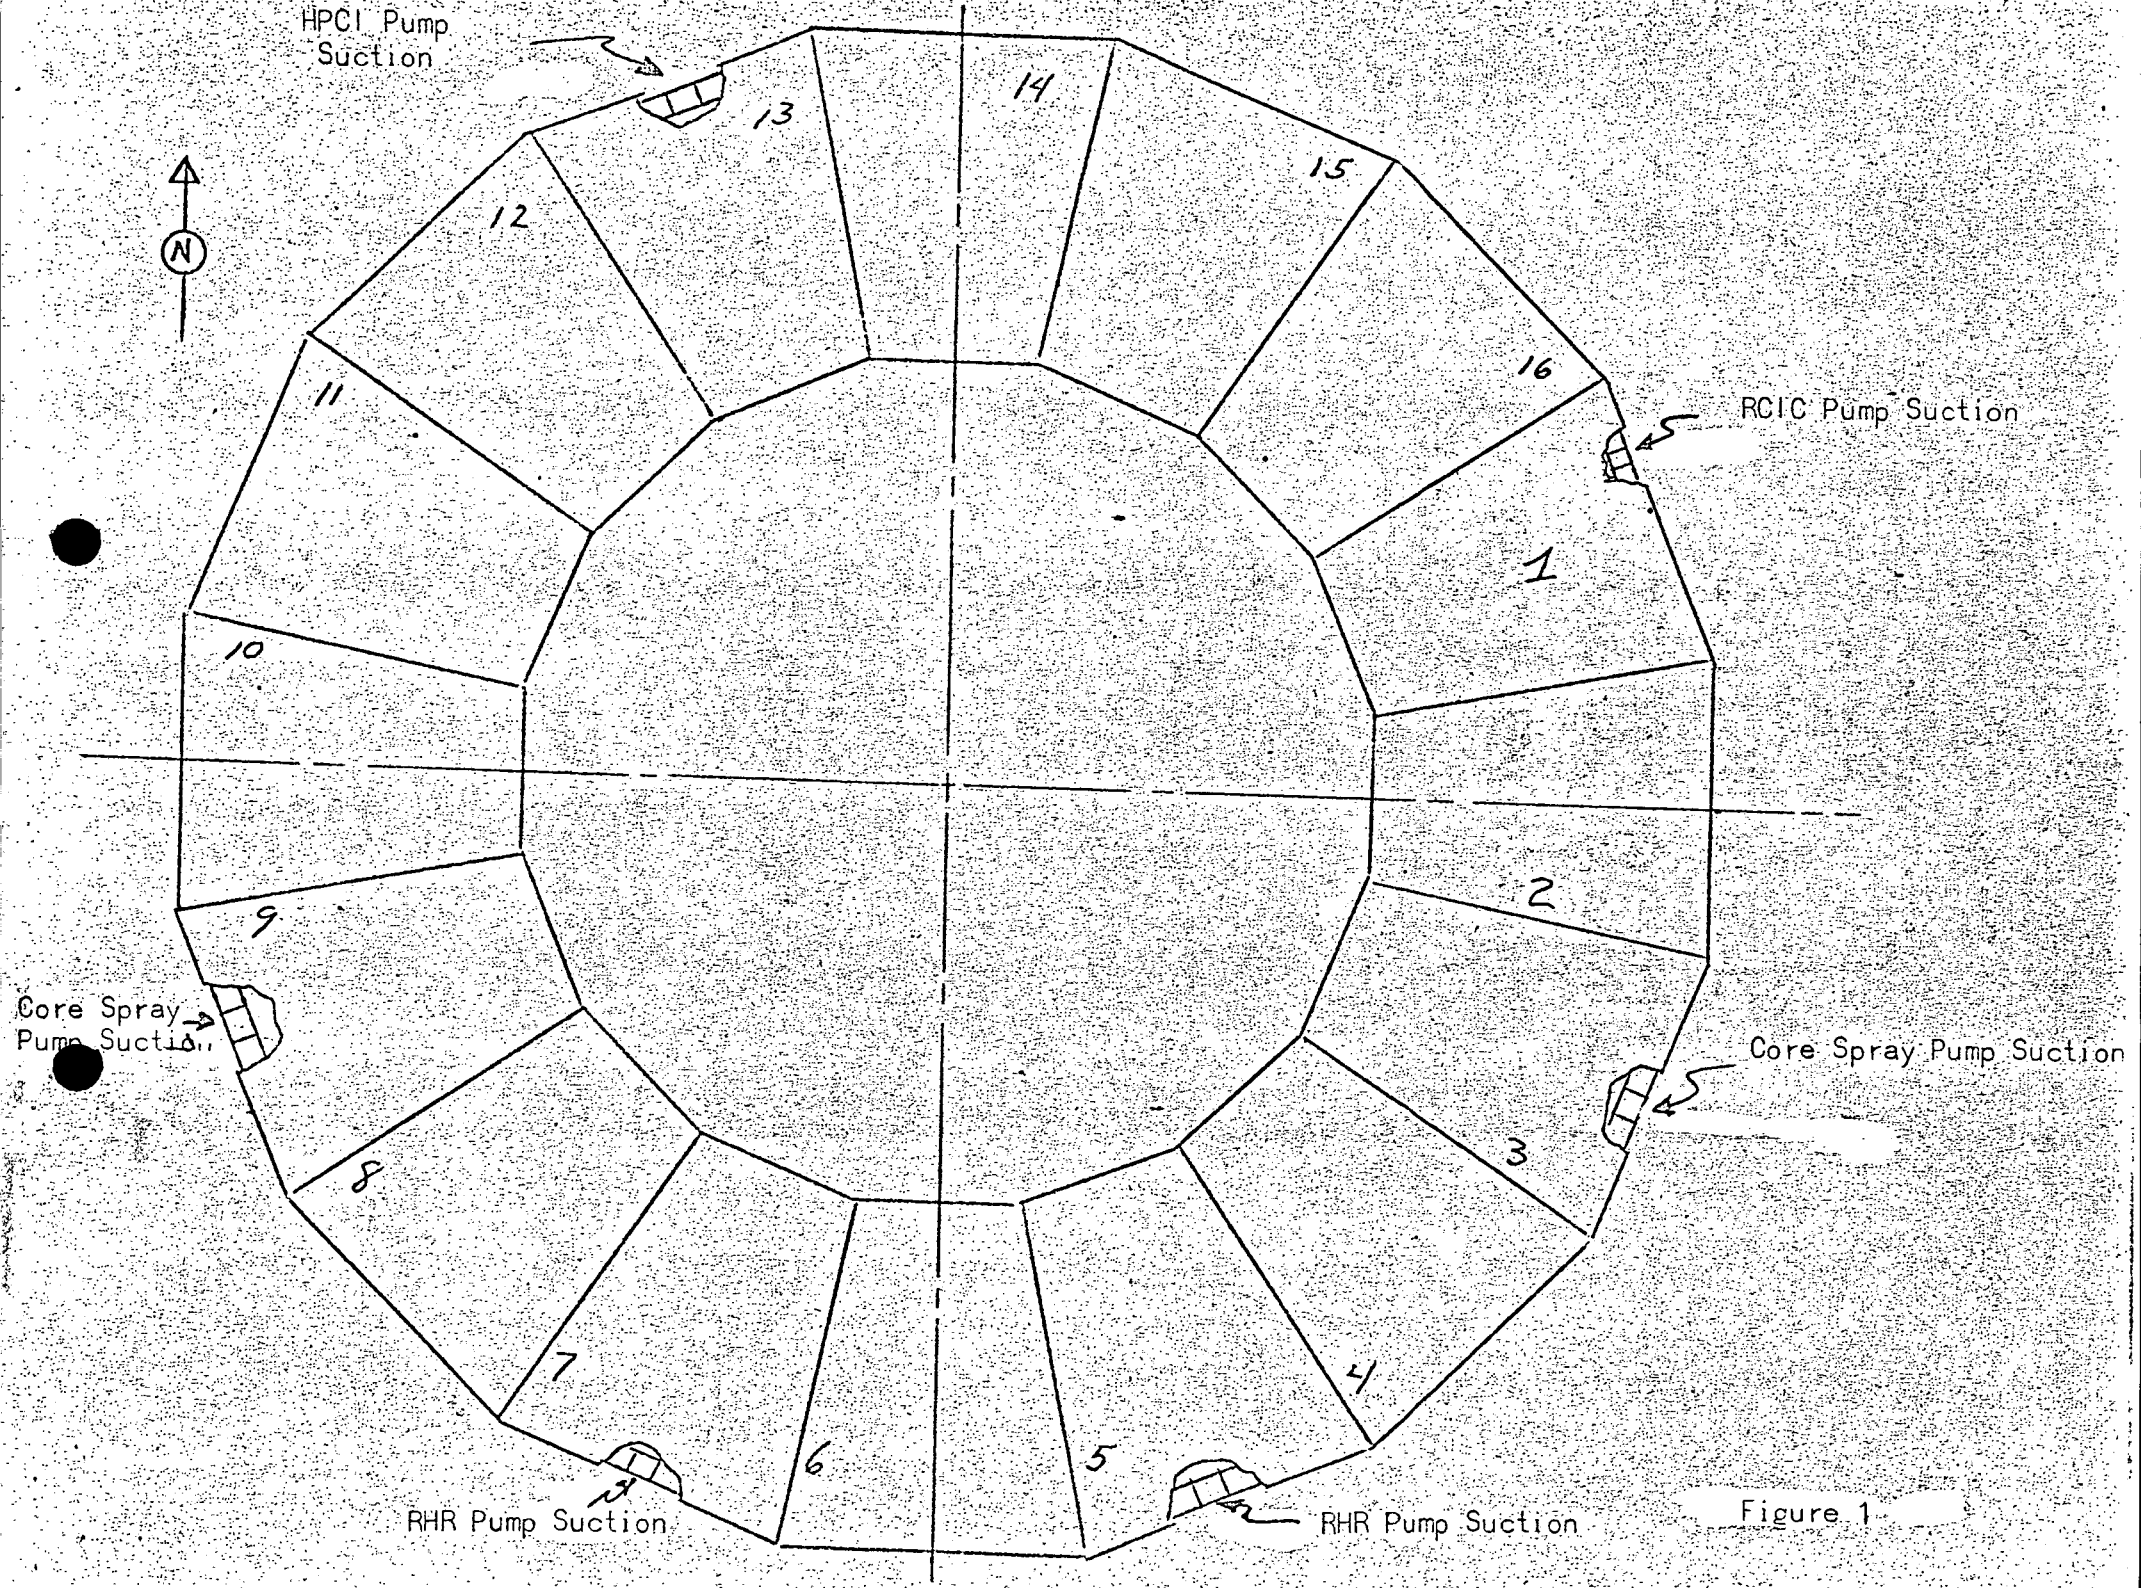
Figure 1

The support structure and bolting arrangement are exhibited in Figures 1 and 2. For clarity, the bolting arrangement has been identified as "upper vertical, lower vertical, outboard horizontal and inboard horizontal". The sixteen mitered sections of the torus have been numbered arbitrarily for ease of inspection location as indicated on Figure 1. Of these sections only twelve are support assembly locations. As specified by the Chicago Bridge and Iron Company the bolting should consist of 3/4" HEX HD BOLTS, 2 3/4" in length and 3/4" REG HEXLOCK NUTS both meeting ASME specification A307.

The "as found" bolting consisted of 3/4" HEX HD BOLTS, 2 3/4" in length, full threaded and without lock nuts. No identification markings were stamped on the bolts to specify grade. The bolts exhibited thread damage on the bearing surface varying from crushed threads to moderate thread damage. In several instances localized thread damage was apparent due to the irregularity of a torch cut hole. Of the 48 bolts, only one other exhibited bowing and that to a slight extent.

As of June 8, 1972, all the support bolts for the 20" torus suction ring header were replaced with SAE grade 8 or 9; 3/4" HEX HD partially threaded bolts having no threads in the shear load area. The bolts were locked with double nuts.

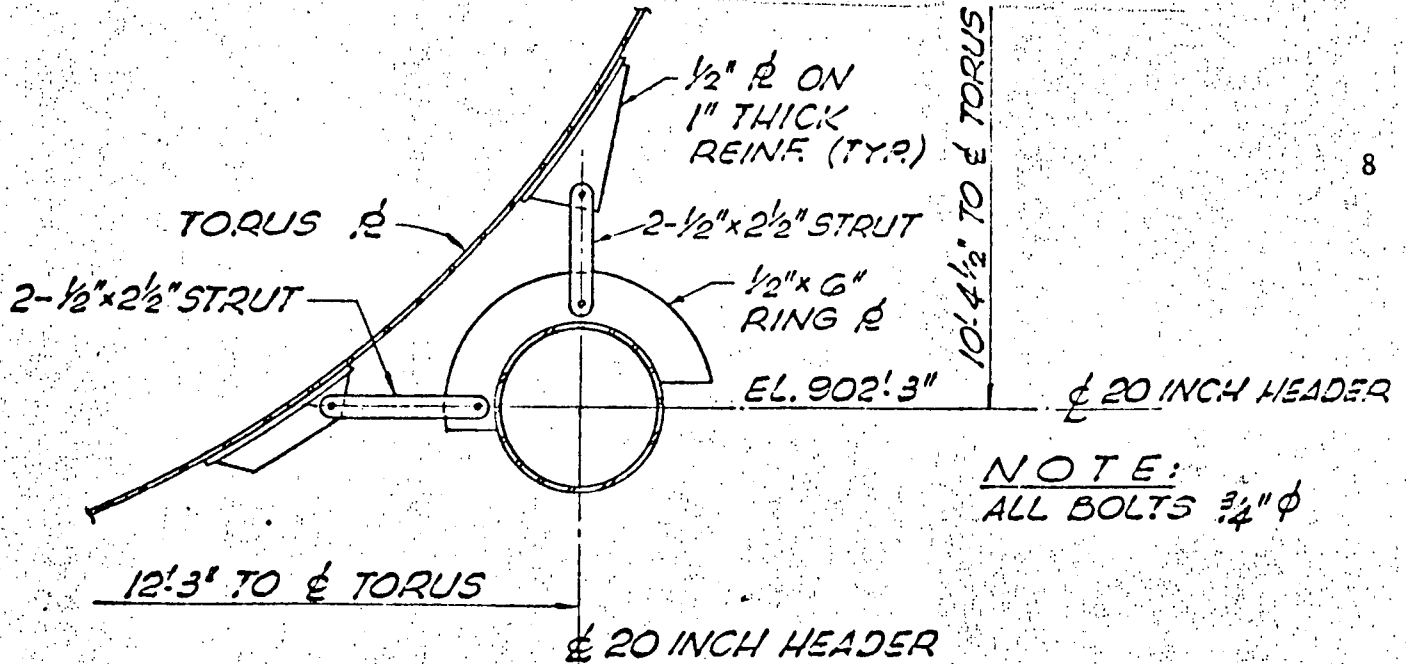
Section - Torus Suction Header Support Structure

As indicated in Table 1, nine sections had torch cut holes in the bracket gusset plate, pipe web or support straps. The torch cut holes were in addition to the drilled hole. A hydraulic jack was required for removal of the outboard horizontal bolts in section nine and section three, indicating horizontal compressive loading on the torus at these points. A qualitative judgment based on the jack size and discussion with the personnel who performed this work indicates the horizontal loading force at these points was in the range of one to two thousand pounds.
