June 2, 1972

MONTICELLO NUCLEAR GENERATING PLANT
 Docket No. 50-263 License No. DPR-22

Momentary Opening of "A" Reactor Safety Valve

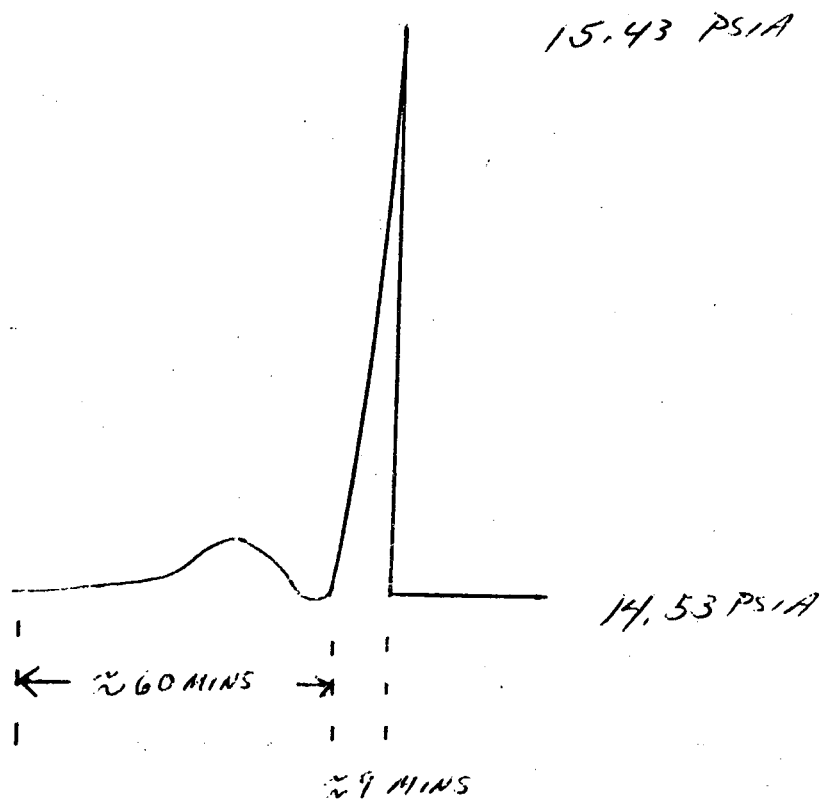
DRYWELL PRESSURE
RECORDER PR 2994
CHART SPEED 1/2" - HOUR
SCALE 13 - 17 PSIA

At 0530 hours on February 26, 1972, while performing the turbine stop valve 10% closure surveillance test, all four stop valves tripped closed simultaneously causing a reactor scram. Actuation of the safety/relief valves limited the maximum transient reactor pressure to a recorded value of 1118 psia. Incident to this event was a 0.9 psia increase in drywell pressure (see attachment) and a 100°F increase in "A" safety valve discharge nozzle temperature. Mid-level drywell temperature was 93°F prior to the scram and an approximate 6°F temperature rise was recorded at mid-level following the scram. Following this indication of a momentary actuation of the "A" safety valve, it reseated with no detectable subsequent leakage. There was no evidence of instrument or equipment malfunction or damage due to the momentary actuation.

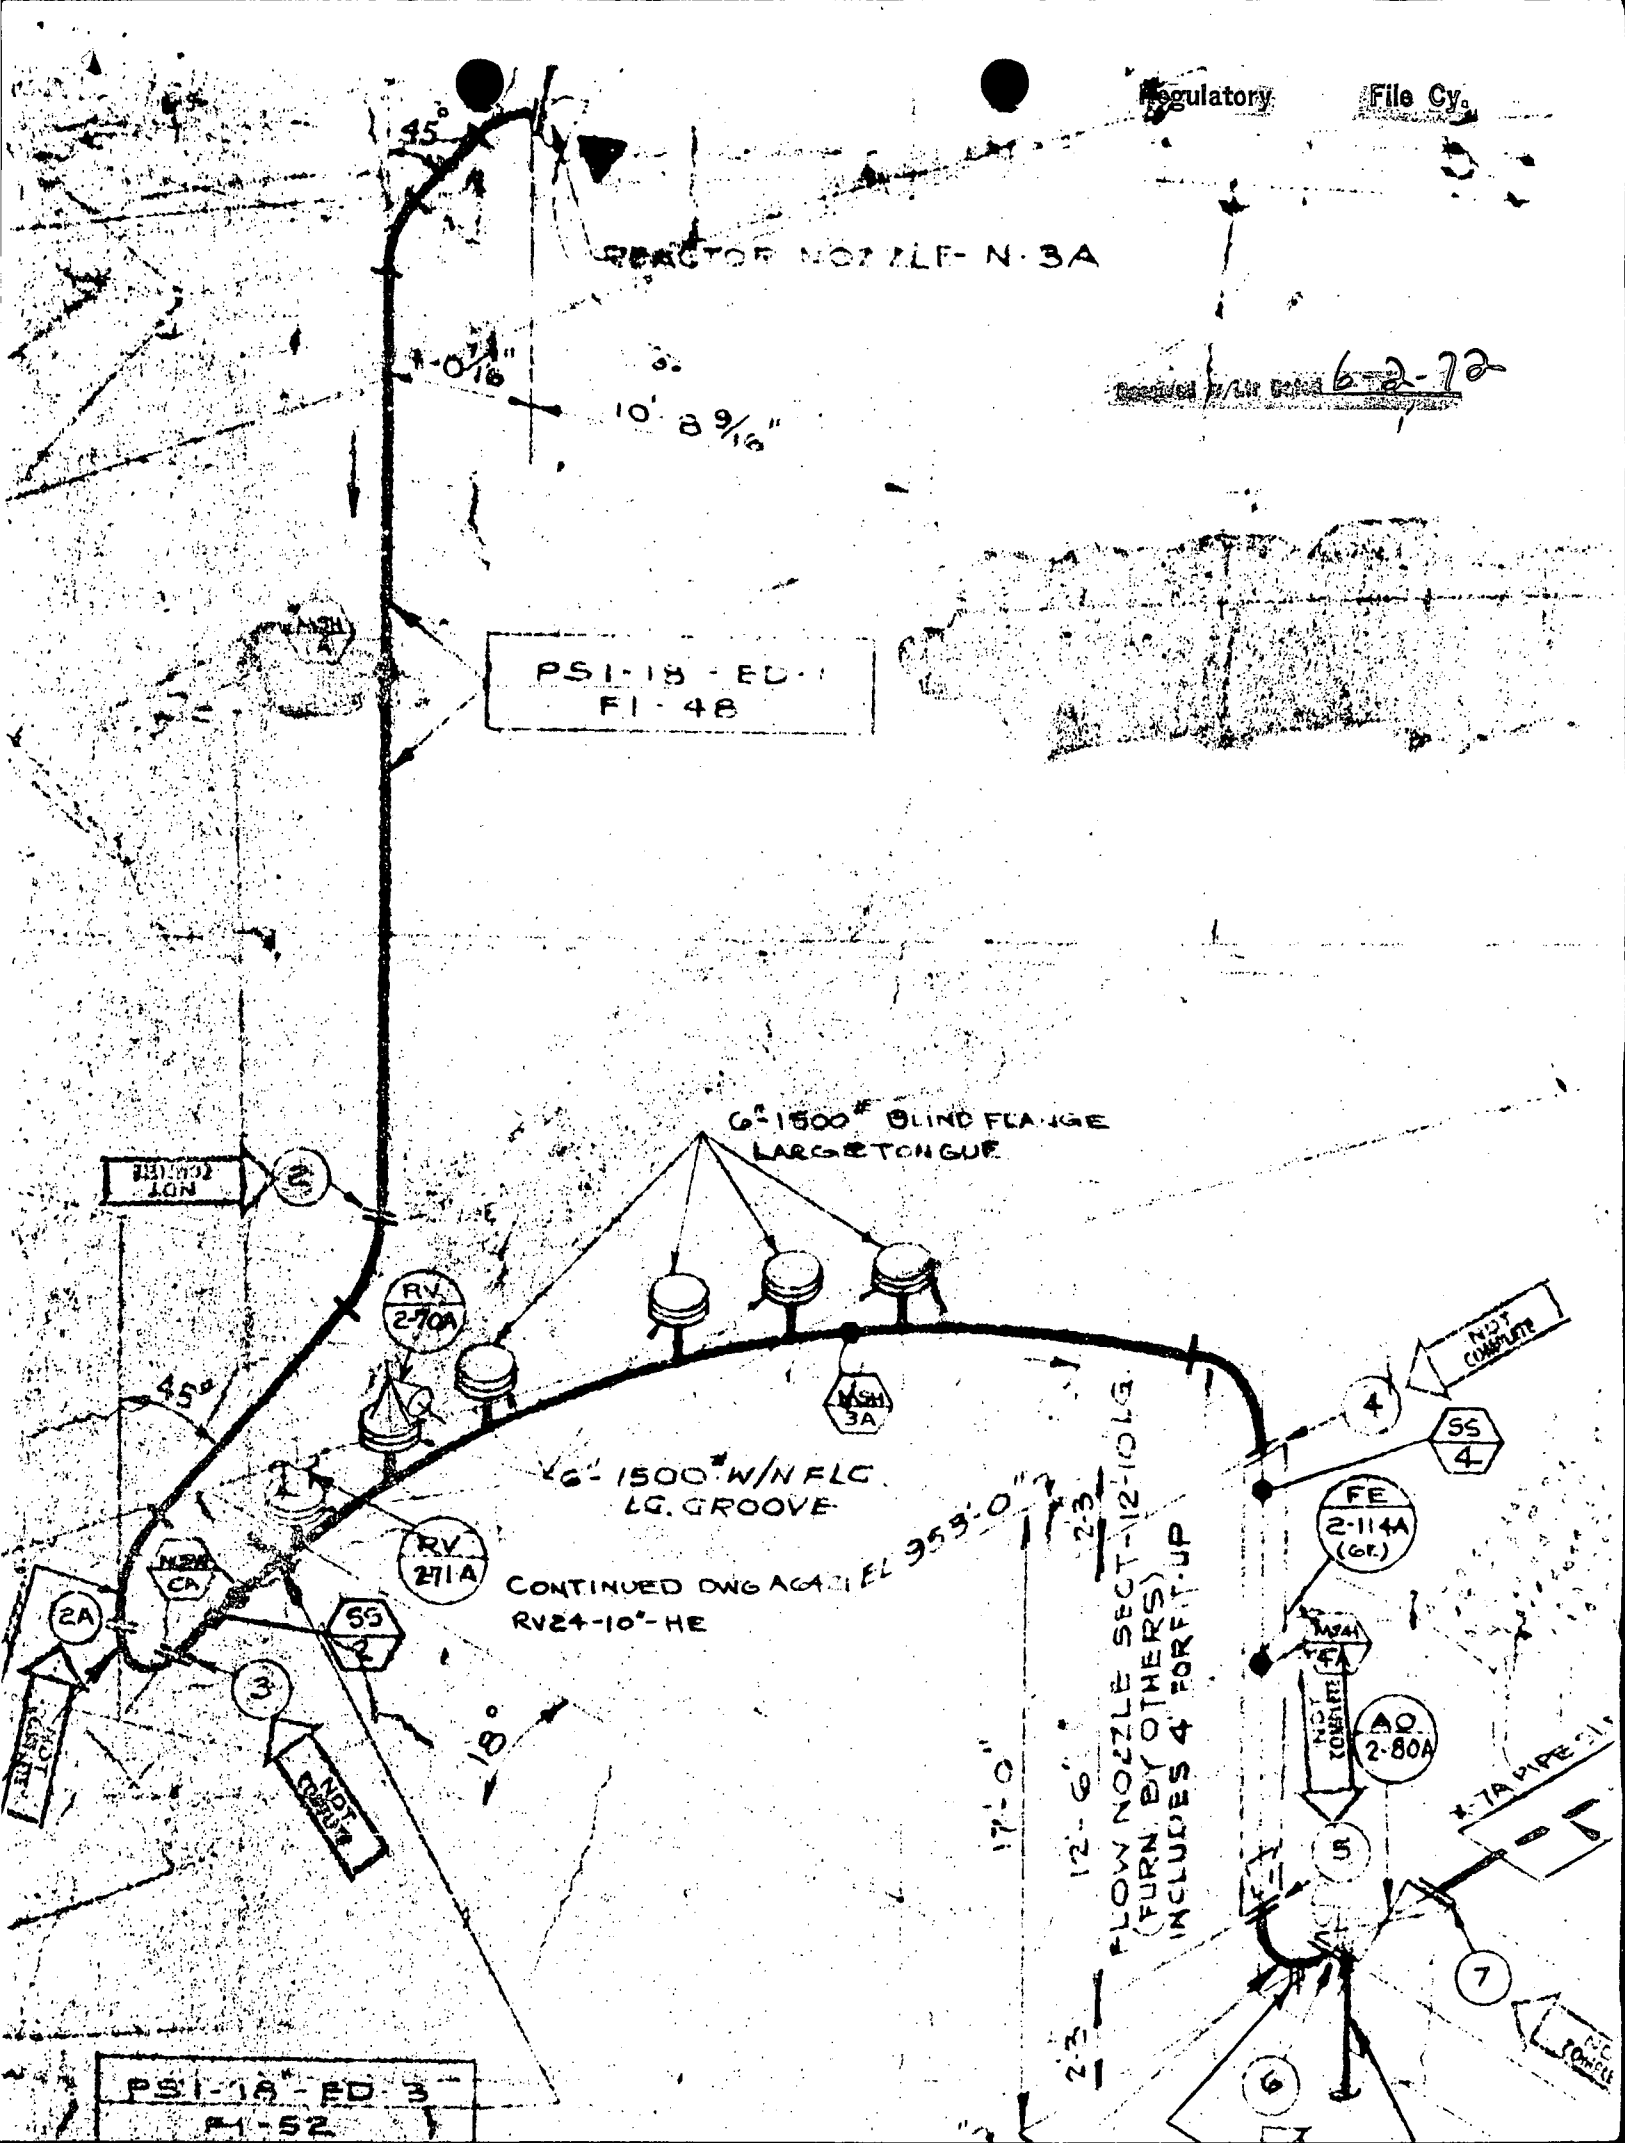
On Saturday, May 13, 1972, during an outage which included scheduled maintenance work in the drywell area, an inspection of the drywell equipment was performed and this inspection confirmed the indicated momentary actuation of the "A" safety valve. The aluminum cover on a blank flange downstream of "A" safety valve had dislocated. The surrounding surfaces had insulation deposits resulting from steam impingement on the flange insulation. An inspection in the reciprocal direction of the tee discharge disclosed the dislocation of a cable tray cover.

The nominal setting of "A" safety valve is 1210 psig. The respective locations of the safety/relief valve (RV2-71A) and the safety valve (RV2-70A) on the "A" main steam line are indicated in the second attachment.
