PLANT NAMES: Monticello Plant

MONTICELLO NUCLEAR GENERATING PLANT
Docket No. 50-263 License No. DPR-22

Malfunction of the "D" Steamline Safety/Relief Valve
and
Inoperability of Bellows Leakage Monitoring Systems

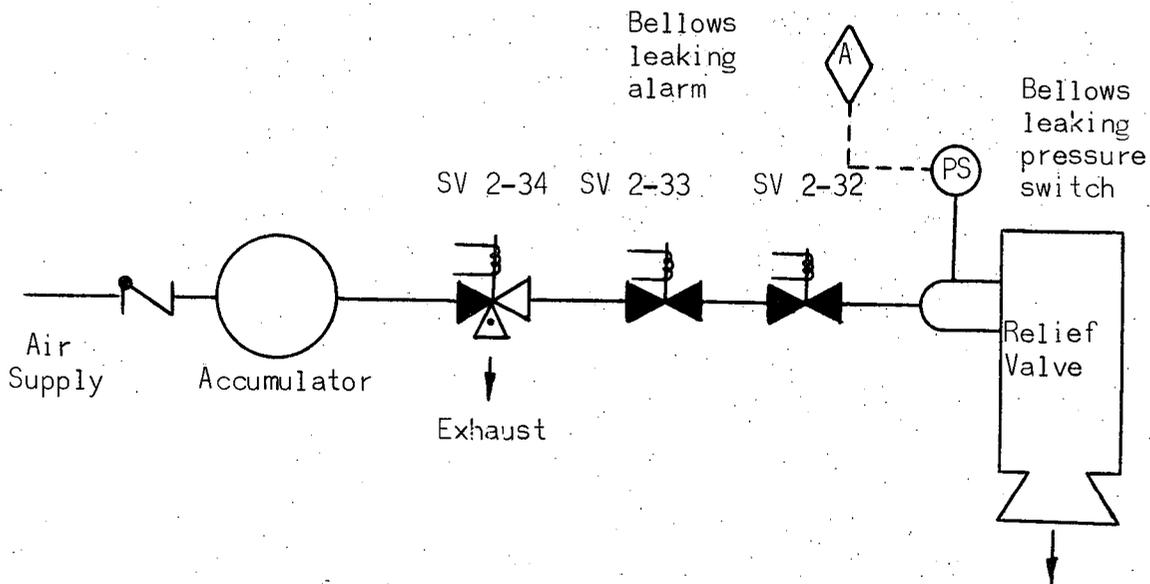
Relief Valve Bellows Leakage Test System

An investigation of the pilot bellows leak detection system was initiated to determine if a back pressure could be created which would affect the valve setpoint. This system consists of a pressure switch which initiates an alarm on high pressure in the chamber outside of the pilot bellows; and air piping, solenoid valves and control switches which permit testing of the pressure switch and alarm from outside the drywell. (Refer to the attached figure for an explanation of the system).

On July 25, 1972, it was found that a small bellows leak could not be detected due to a system design error. It was the original design intent that solenoid valves SV2-32 and SV2-33 should provide redundant isolation to prevent pressurizing of the bellows chamber in the event of a failure of SV2-34 and to assure that pressurization would occur in the event of a bellows leak. It was found that the valves which were used for SV2-32 and SV2-33 are designed for tight shutoff only when pressure is applied to the "inlet" side (side away from the bellows chamber). Tests were conducted to determine the backpressure which could be applied at the bellows chambers before leakage occurs. Tests were also conducted to determine the setpoint of the non-adjustable type bellows alarm pressure switches. The results of these tests are shown below:

These results indicate that the A & D leak detection systems would not have detected a small leak.

1. Test switch in the "TEST" position energizes SV 2-34, SV 2-32, and SV 2-33, which admits air to the bellows assembly and trips the bellows leaking pressure switch alarm circuit.
2. Test Switch in "VENT" position de-energizes SV 2-34, and energizes SV 2-32 and SV 2-33 which vents air from the bellows assembly and resets the pressure switch circuit.
3. Test switch in "NORMAL" position de-energizes all three solenoids.
4. The TEST pushbutton is used to energize SV 2-34 (with the Test switch in NORMAL) to verify positive seating of SV 2-32 and SV 2-33.

The non-adjustable leak detection pressure switches have been replaced with switches set to trip at 5 psig. This setpoint was chosen to be well within the backpressure capability of the solenoid valves and to provide reliable trip and reset action.
