VIRGINIA ELECTRIC AND POWER COMPANY
RICHMOND, VIRGINIA 23261

VIRGINIA ELECTRIC AND POWER COMPANY (DOMINION)
NORTH ANNA POWER STATION UNITS 1 AND 2
RESPONSE TO REQUEST FOR ADDITIONAL INFORMATION (RAI)
STATUS OF NEAR-TERM ACTION ITEMS
RESTART READINESS DETERMINATION PLAN

Status Update of Near-Term Actions to be Completed Prior to Unit Restart

North Anna Power Station Post-Seismic Switchyard Inspection Summary of Identified Conditions Resulting From Seismic Event

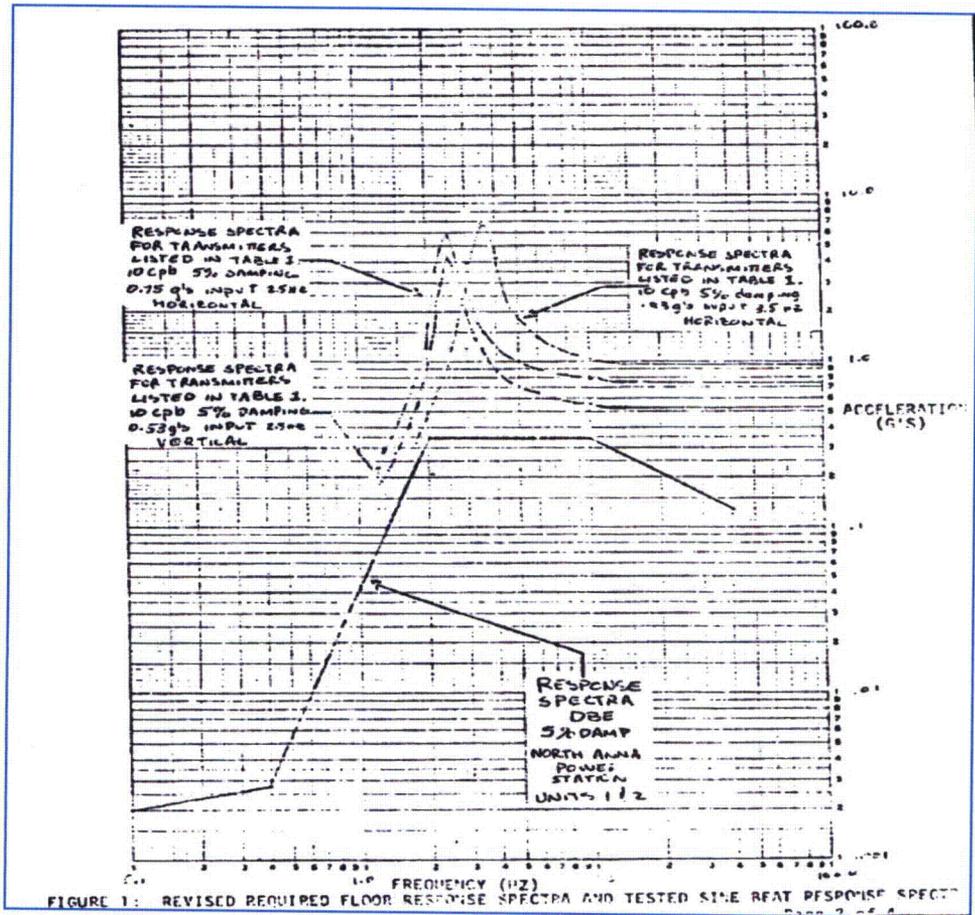
FIGURE 1: REVISED REQUIRED FLOOR RESPONSE SPECTRA AND TESTED SINE BEAT RESPONSE SPECTRA

As mentioned above for the NIS testing, sine-beat testing results in conservative seismic levels applied to the tested equipment, as is demonstrated below.

Seismic Reevaluation for Foxboro Pressure Transmitters

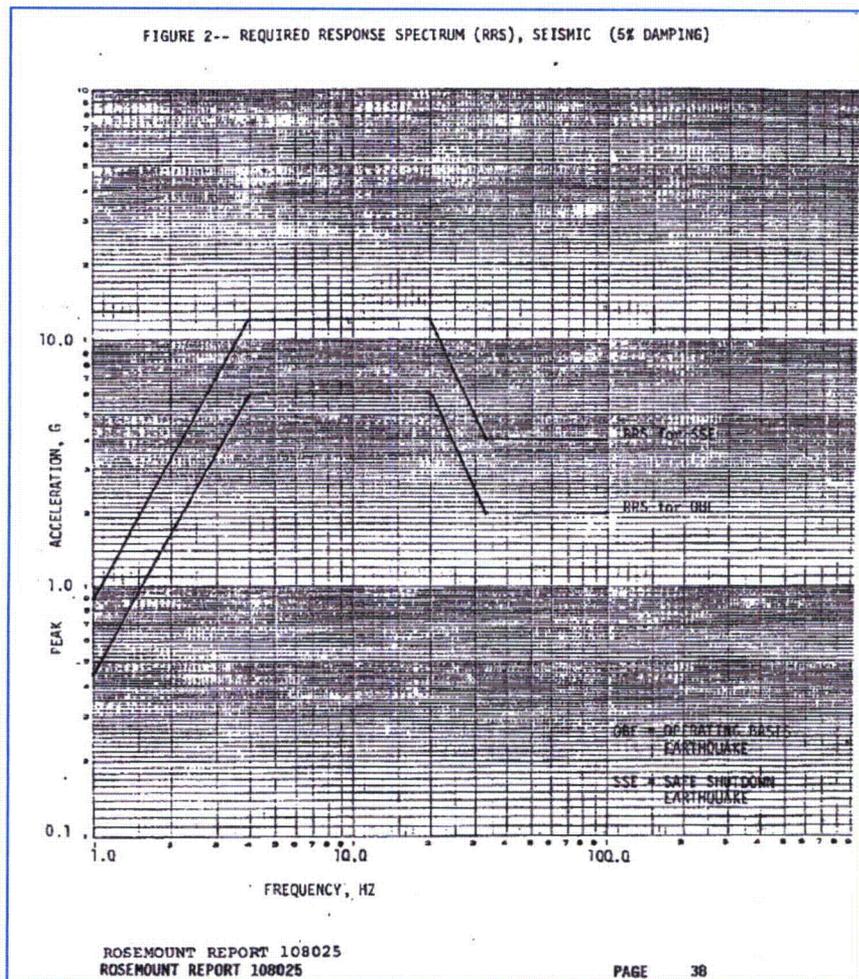
Rosemount transmitter model number 1153 Series B is seismically qualified to an accuracy of $\pm 0.5\%$ of URL during and after a seismic disturbance defined by a required response spectrum with a zero period acceleration (ZPA) of 4g as stated in Rosemount Report 108025. Figure 2 (shown below) from Rosemount Report 108025, shows that the transmitters have significant margin. The qualification levels will envelop any North Anna installation locations with substantial margins..

Model number 1153 Series D and Model 1154 are seismically qualified with an accuracy within $\pm 0.5\%$ of URL ($\pm 0.75\%$ URL for Range Code 0 transmitters) during and after seismic disturbance defined by a required response spectrum with a ZPA of 7g as stated in Rosemount Reports D8300040 and D8400102 and Wyle Test Report 45592-3.

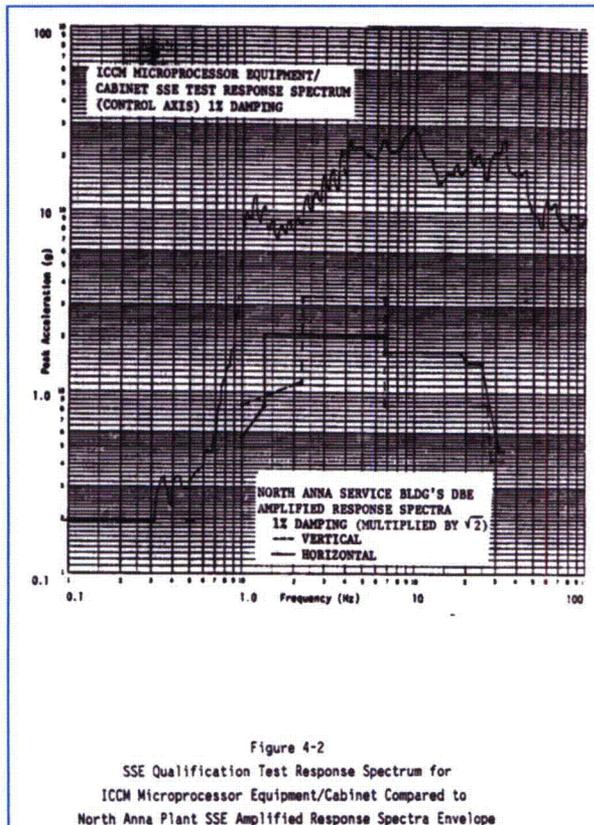
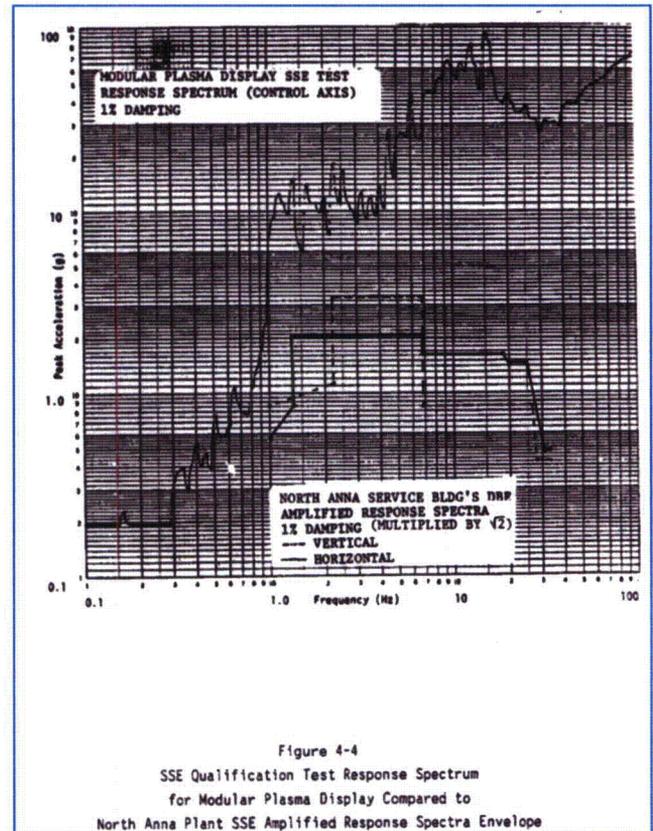
The Qualification SSE Test Response Spectrum (at 1% damping) for the ICCM Microprocessor Equipment and the Modular Plasma Display is shown below. As is demonstrated, the equipment was tested to significantly higher levels than required by Dominion's specification.

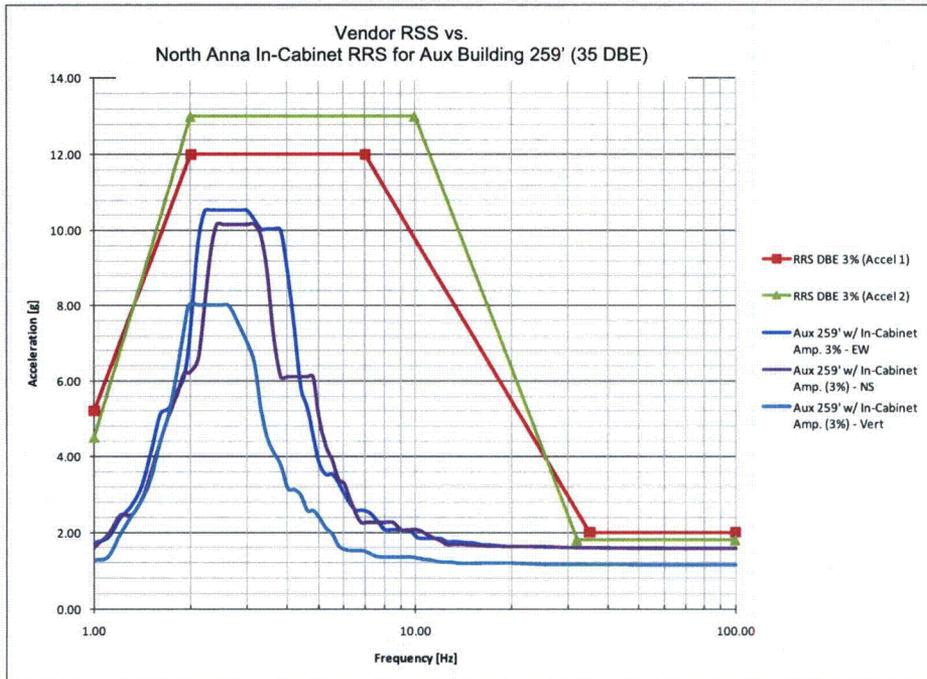
The qualifications of the Validyne Remote Multiplexer Unit Models MC170AD-Q2 and MC370AD-Q2 are discussed in Validyne Test Report Qualification Test Report (QTR) 82-002 dated March 1982. For the Seismic Functional Test, the signal conditioning cards were installed in the module case and tested as a system. The results of the Seismic Functional Test on the system for functionality and failsafe operation were evaluated against the requirements as described in the acceptance test procedure. WYLE Laboratories Report Number 58666 describes the seismic test performed on the multiplexer. The test specimens were subjected to a biaxial multi-frequency random motion which was amplitude-controlled in one-third octave bandwidths from 1.25 to 100 Hz. Two simultaneous, but independent 30-second recordings of the random signal were used as the excitation to produce incoherent horizontal and vertical motions. The test table motions were iteratively calibrated to produce a test response spectra (TRS) which enveloped the RRS shown in the figures attached to WYLE Labs test report 58666. The vendor RRS is compared below to the governing North Anna RRS corresponding to the Auxiliary Building Cable Vault and Tunnel including a conservative in-cabinet amplification factor. The RRS used by the vendor envelops North Anna RRS with margin; the reported TRS envelops the vendor RRS with even more margin (especially at higher frequencies).

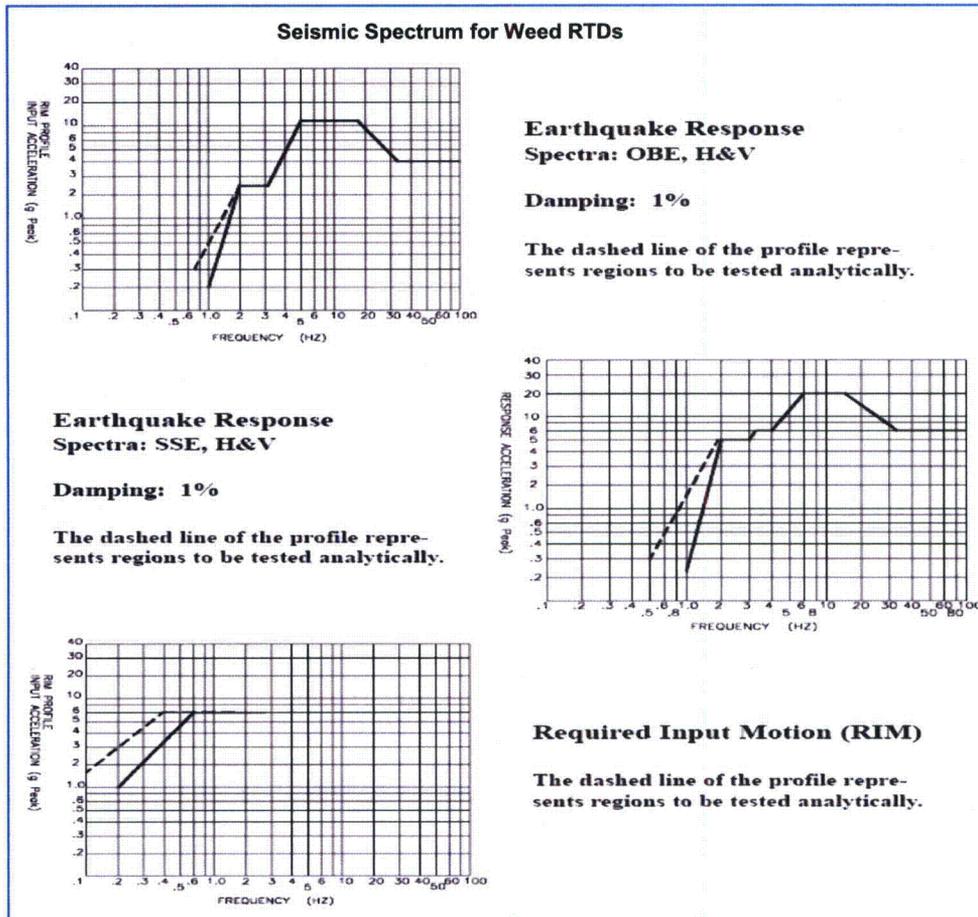
The following Weed RTD Models are qualified for nuclear service to the qualification level shown below:

Therefore, the Weed RTDs are qualified to high seismic levels and have margin to accommodate increased seismic loading.

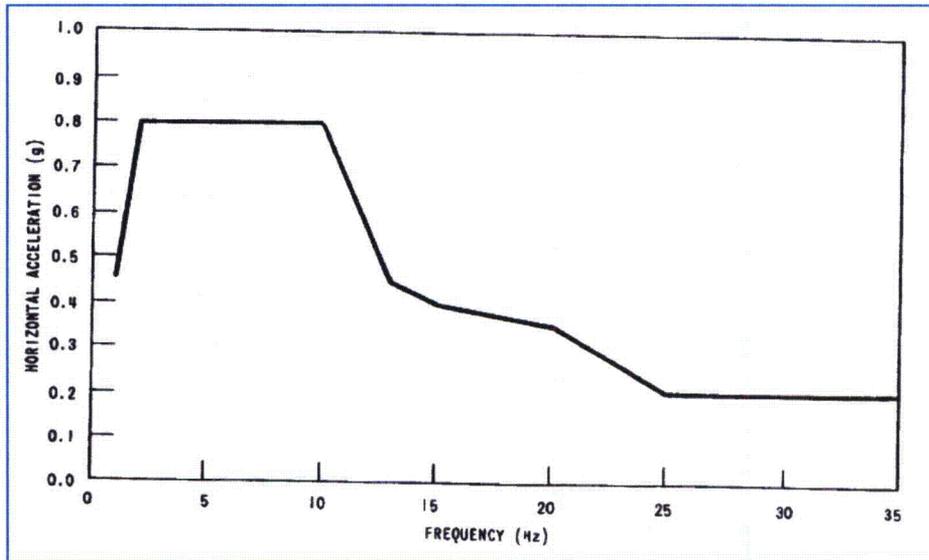
Horizontal Input Acceleration from WCAP-7817

Per Seismic Qualification Test Report WCAP-7817, Supplement 4, dated November 1972, the WCID 7300 Series Process Equipment, which consists of 2-bay or 3-bay cabinet configurations, was qualified to requirements which are consistent with those of IEEE Std. 344-1971. The testing consisted of single frequency, single axis, sine-beat inputs at several discrete frequencies ranging from 1 to 35 Hz. An entire WCID 7300 series prototype cabinet was installed on the table for the test. Applied horizontal input accelerations ranged from 0.8g at low frequencies (up to 10 Hz) down to 0.2g at 35 Hz, as shown in the figure below. Vertical input accelerations were applied at 2/3 of the horizontal level.

For North Anna, the maximum Design Basis Earthquake acceleration (i.e. the ZPA in the DBE Response Spectra Curves) is 0.19g in any of the two horizontal directions, and 0.1g in the vertical direction, at the cabinet mounting location. Therefore, the test levels envelop North Anna's Design Basis levels. Although there is no specific mention of contact monitoring in the mercury-wetted relays or of the NTC, NPC, or NCH Cards in this test report, the test results indicate that no loss of signal, malfunction, or change of contact status occurred during the seismic tests. Therefore, the seismic tests qualify the 7300 Series Process Equipment to the requirements of IEEE Std. 344-1971, and envelop North Anna's seismic levels with margin. As previously mentioned in the review of the Westinghouse Nuclear Instrumentation System testing (Item 1), sine beat testing results in conservative levels applied to tested equipment. For this test, spectral accelerations at 5% damping corresponding to the maximum 0.8g horizontal input are approximately equal to $[1/(2*0.05)](0.8) = 8g$. Similarly, the peak spectral acceleration corresponding to the maximum applied vertical acceleration is approximately 5g. The minimum input acceleration of 0.2g corresponds to approximately 2g at 5% damping. Therefore, there is margin for applied accelerations over the design basis requirements.
