Subject: 10CFR21 Reporting of Defects and Non-Compliance -
Engine Systems, Inc. Report No. 10CFR21-0103, Rev. 0

Piston Assembly – Delamination of Tin Plating on Refurbished Piston Skirts

Report No. 10CFR21-0103

SYSTEM: Emergency Diesel Generator

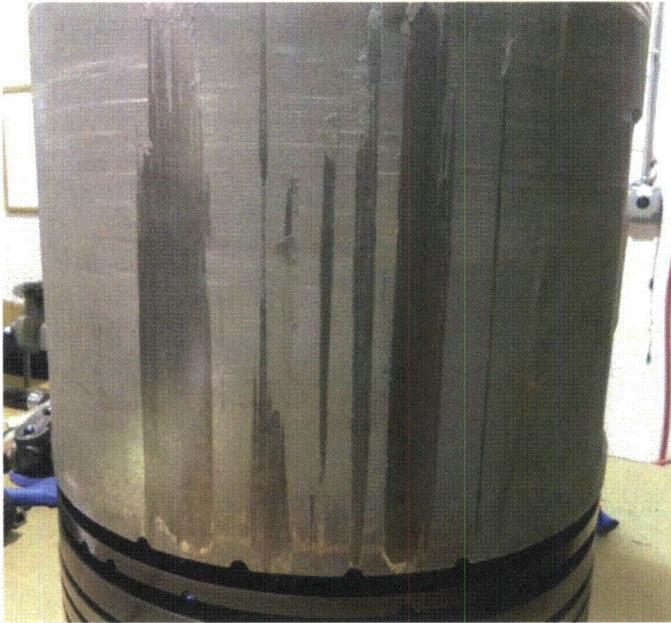
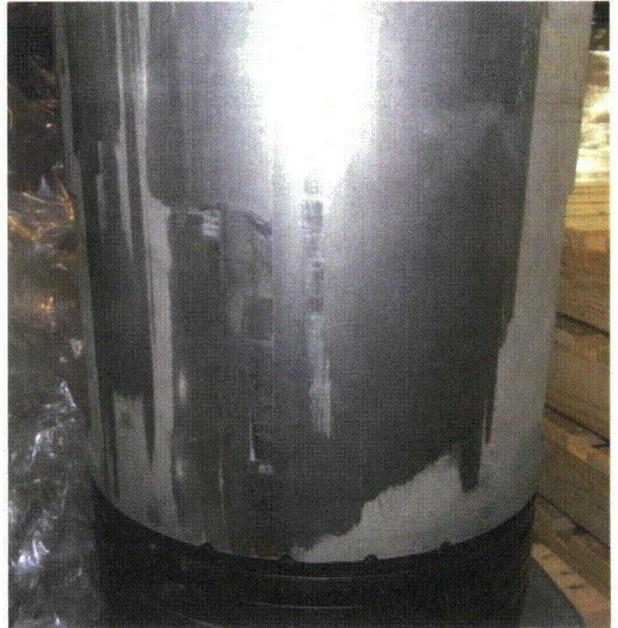
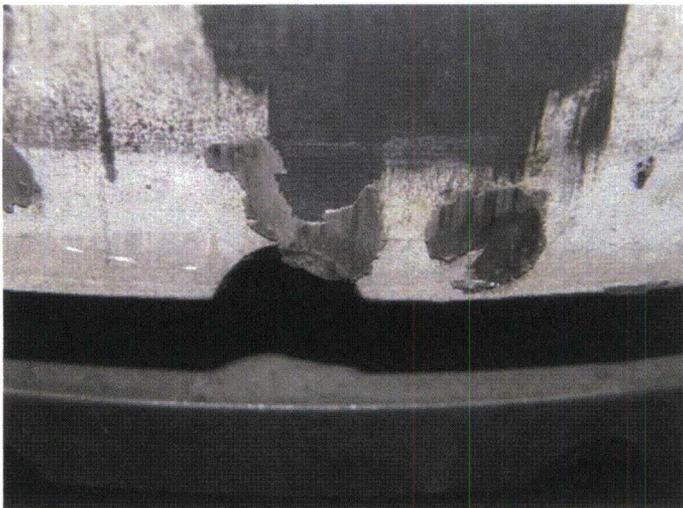
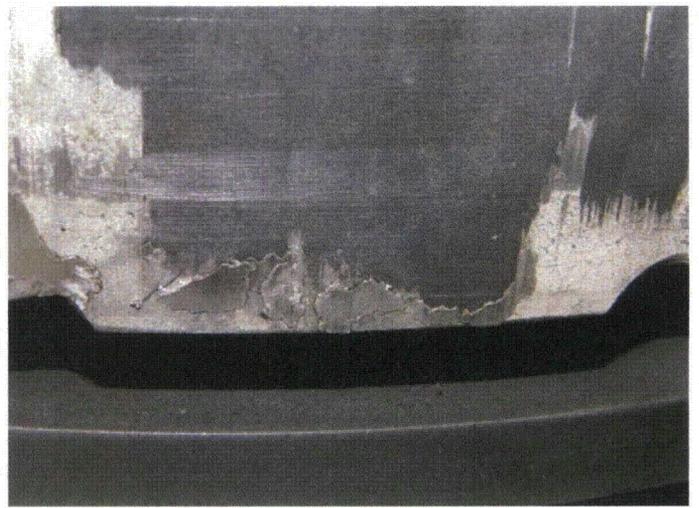
Engine Systems Inc. (ESI) began a 10CFR21 evaluation on 08/12/11 upon receipt of four piston assemblies returned from Perry Nuclear Plant. It was reported that Perry had performed a maintenance activity whereby they replaced four of their piston assemblies with four refurbished pistons provided by ESI. Following installation of the replacement pistons, it was found that large portions of the tin plating were flaking or smearing off.

The evaluation was concluded on 10/11/11 and determined the piston tin plating delamination to be a reportable defect as defined by 10CFR21. The delamination was attributed to residual oil impregnated in the ductile cast iron base material of the skirts. The piston assemblies had previously been in service on the emergency diesel generators and were later refurbished by ESI in 2007. A portion of the refurbishment activity consisted of re-tin plating the piston skirts.

Following consultation with Cameron and discussion with the customer, it was determined that the delamination was most likely the result of oil impregnated in the ductile cast iron base material of the skirt. The pistons had previously been in service where they were exposed to a heated, oil rich environment; meaning the engine's lubricating oil was allowed to penetrate the micropores of the cast iron. Though the piston skirts were subjected to a standard washing and caustic cleaning cycle as part of the re-plating process, further investigation finds this may not be sufficient to remove all residual oils from the base material. This remaining oil prevented the tin from fully adhering and therefore contributed to the tin plating delamination found for these four pistons.

Photos of Pistons Taken at ESI

The root cause analysis determined that the cause of the tin plating delamination was residual oil impregnated in the ductile cast iron material. While there are many different methods for removing imbedded oils from cast iron, ESI is not aware of any absolute methods for ensuring all oils have been removed (or at least to the point that it will not interfere with tin plating adhesion). As a result of this finding, it is ESI's recommendation that piston skirts which have been in service should no longer be re-tin plated.

This is the first incident reported to ESI of tin plating delamination. These four pistons were all processed from the same batch and this batch consisted solely of these four pistons. While this may be an isolated incident, any customers with previously re-tinned pistons must give consideration for what to do with those pistons (see Table on following page for customers affected). ESI recommends that customers with pistons already installed should confirm that a crankcase inspection was performed following installation and that no abnormal deposits or accumulation of tin were noted. For those customers that have not yet installed their refurbished pistons, installation is not recommended unless the customer can adequately verify adhesion of the tin plating.
