SUBJECT: Describes implementation of GE recommendations in Info Ltr 402 re vent header cracking. Nitrogen inerting sys design & operation adequate. Insp of nitrogen injection line revealed no low temp-induced defects.

MONTICELLO NUCLEAR GENERATING PLANT  
Docket No. 50-263 License No. DPR-22

Implementation of Recommendations in General Electric  
Service Information Letter No. 402

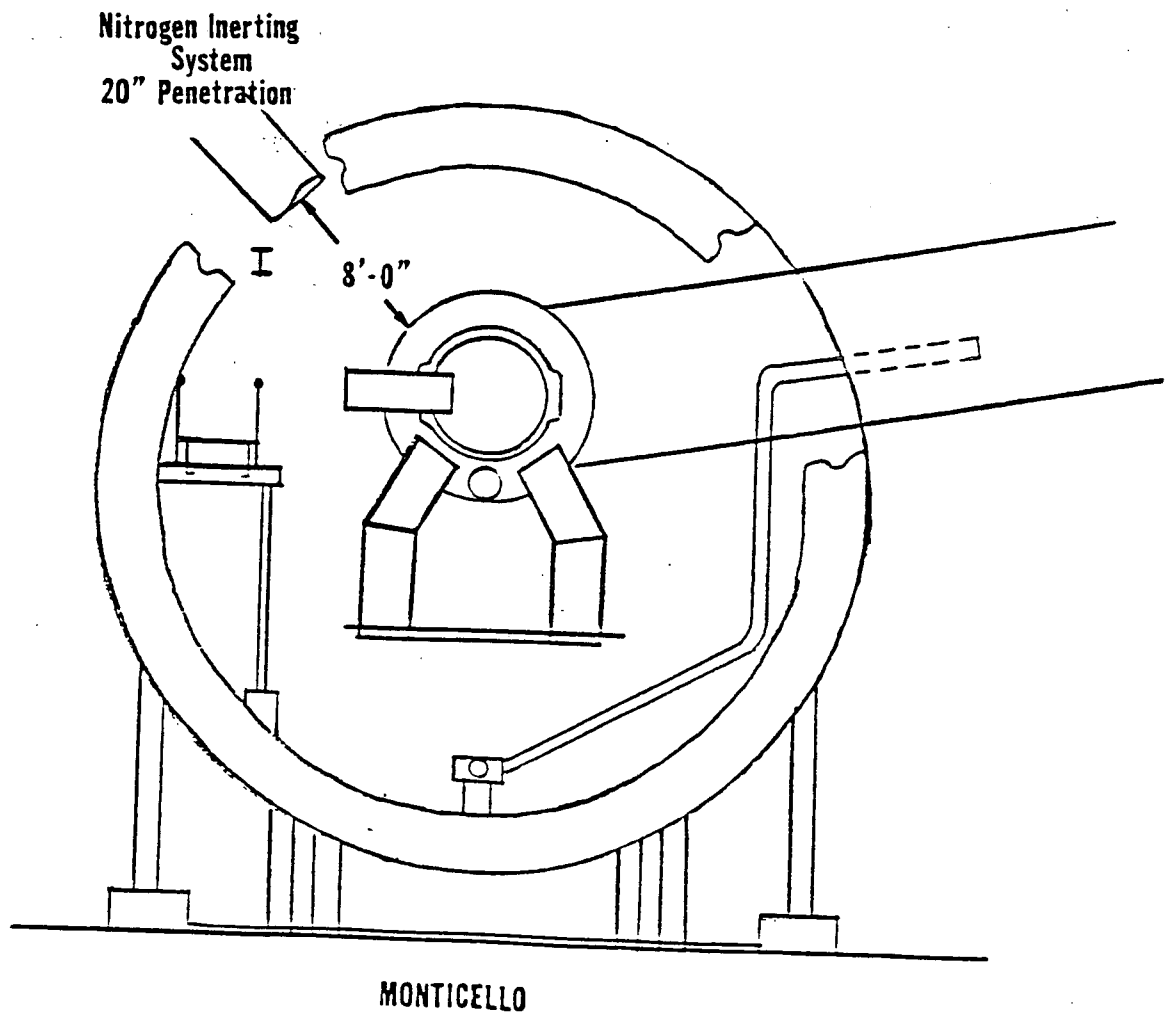
Director of NRR  
September 14, 1984  
Figure 1

The orientation of the nitrogen port relative to the vent header downcomers, and other equipment in the wetwell and drywell has been investigated (Figures 1,2,3). We believe existing plant design is adequate in this area.

The nearest structure to the torus nitrogen injection penetration is the torus monorail at a distance of

sixteen inches below the penetration.

The torus catwalk handrail is the next closet structure at a distance of seven feet-four inches. The vent header is a distance of approximately eight feet.

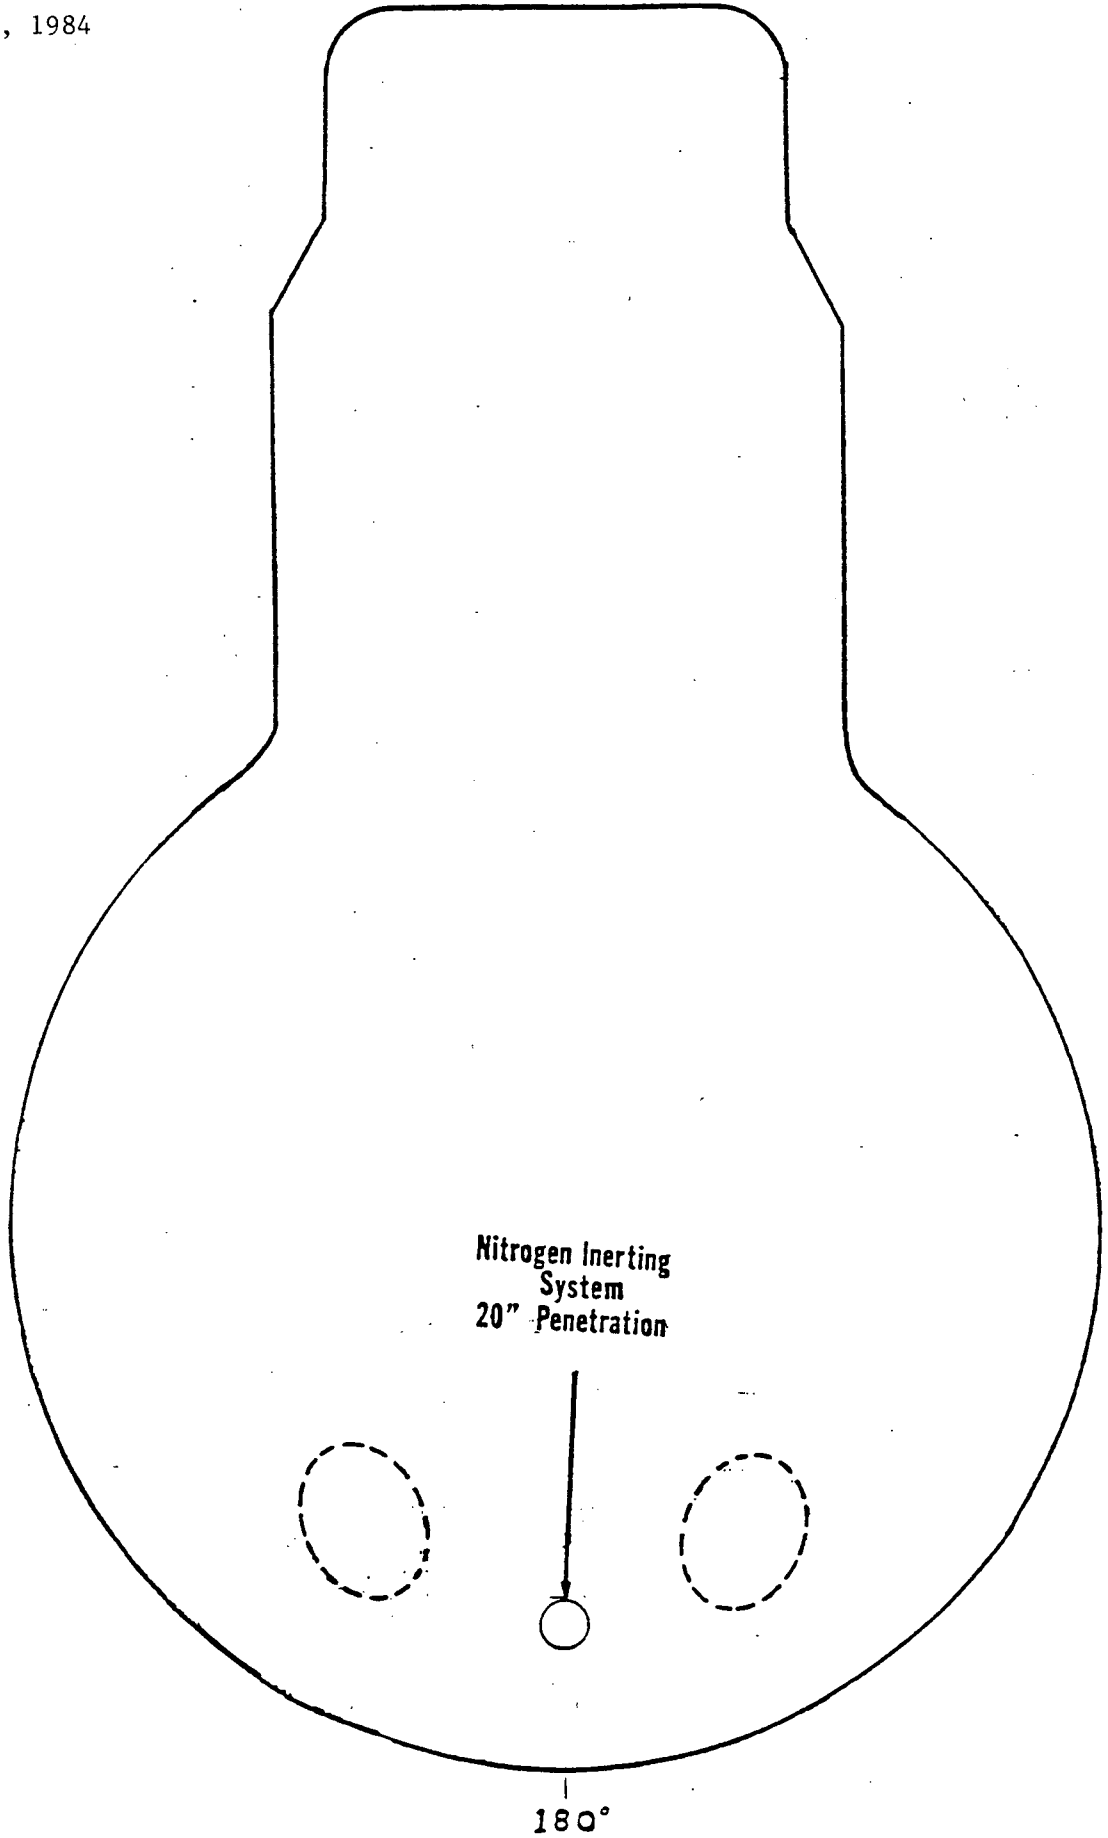
Director of NRR  
September 14, 1984  
Figure 3

Monticello also has nitrogen injection into the drywell. The attached sketch show the drywell injection port location. The nearest structure to the drywell injection penetration is a drywell fan unit housing. The fan unit housing is located five inches to the side of the nitrogen injection penetration and does not obstruct the flow from the penetration. The drywell fan motor support is the next closest structure to the penetration. This vertical I-beam support is at a distance of approximately one foot from the penetration opening.
