SUBJECT: Provides followup notification & addl info re deficiency in high energy line break analysis performed for plant on 730907 by Bechtel. Safety evaluation re impact of postulated feedwater line break in turbine bldg encl.

MONTICELLO NUCLEAR GENERATING PLANT  
DOCKET NO. 50-263 LICENSE NO. DPR-22

Failure to Provide High Energy Line Break  
Protection for the Turbine Building Pipe Chase

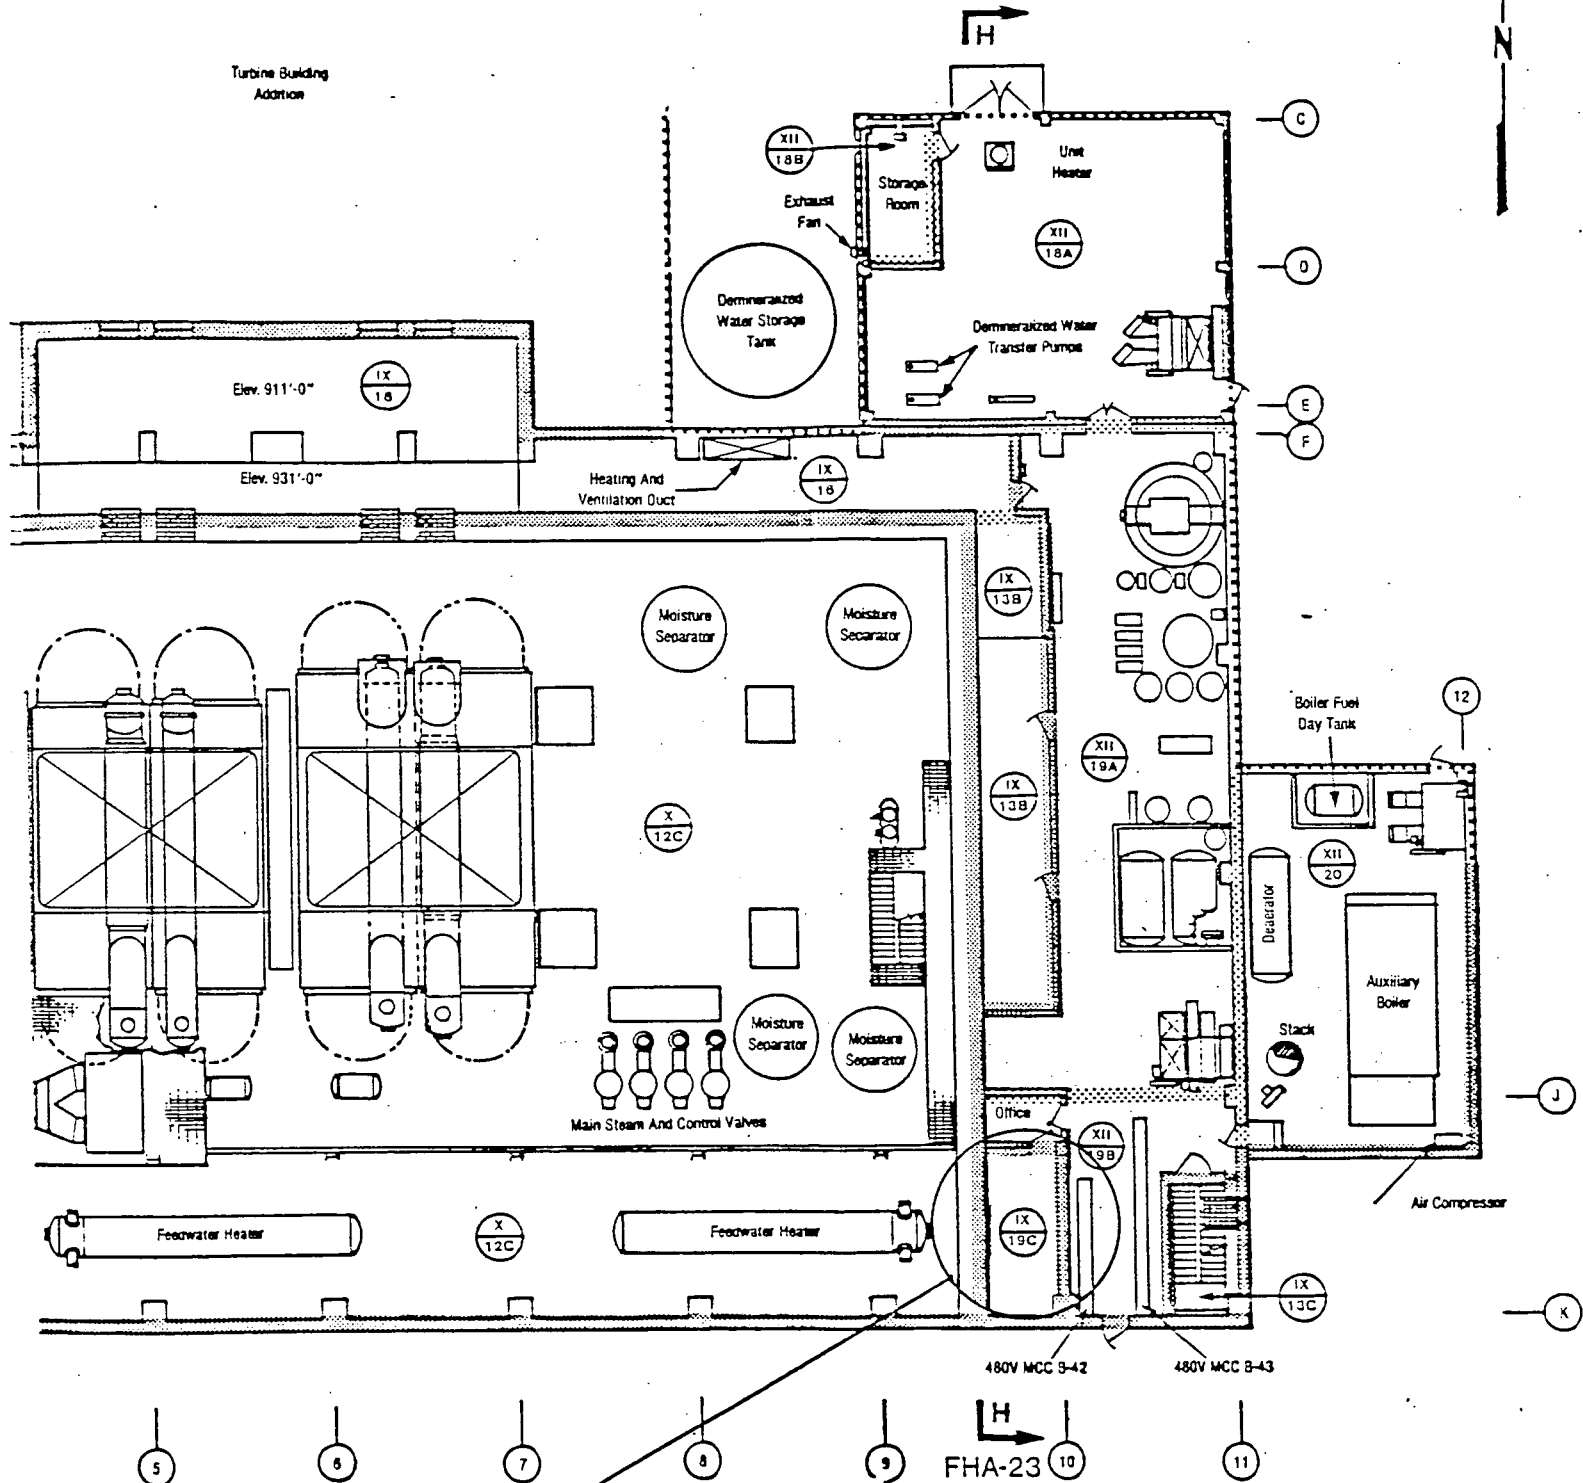
Director of NRR  
 April 9, 1986  
 Figure 1

Following a meeting with Bechtel on March 25, 1986 it was determined that there was a need to quantify the effects of a feedwater line break in the turbine building pipe chase. The primary concern is that a break in this room could damage Division I cables within the room and cause failure of block walls which could damage adjacent Division II motor control centers (Figure 1). Impell Corporation was contacted to perform the HELB analysis for the room.

On April 4, 1986 Impell reported the results of their analysis. A guillotine break of one of the lines in the room would result in failure of the north wall. The NRC Resident Inspector and NRC Region III and NRR management were contacted. Subsequent fracture mechanics analysis by Impell Corporation, with the support of NUTECH, Engineers Incorporated, indicated that such a line failure is extremely unlikely. Fracture mechanics analysis indicated that if a flaw were to exist in this piping, a stable detectable crack would develop under all postulated loading conditions in both suction and discharge lines. This crack would be detected and the plant safely shutdown prior to any equipment damage.

Affected area -  
 Turbine Bldg  
 Pipe Chase  
 SCALE: 0' 2' 4' 8'  
 Also see USAR Figure  
 12.2-8a.

The plant is scheduled to shutdown for a planned refueling outage beginning on April 30, 1986. Prior to restart from this outage, modifications will be made to the turbine building pipe chase to mitigate the effects of a HELB in that room.
