**Homestake Mining Company  
Grants Project  
Collection Ponds and Evaporation Pond No. 1  
Liner Repair Project**

**Cibola County, New Mexico**

**COMPLETION REPORT**

September 2011

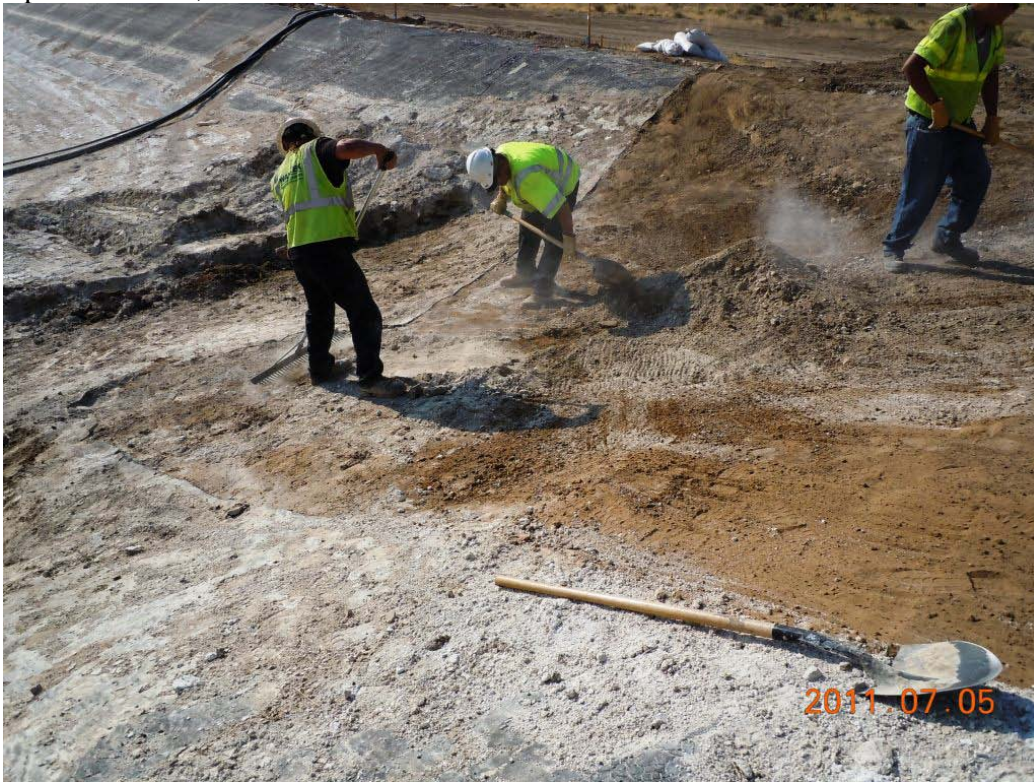
Repair Site No. 1, SW Corner of West Collection Pond

- 1) Repair Area No. 1 was located in the SW Corner of the West Collection Pond (WC Pond). The existing liner had been damaged above the water line by equipment and natural degradation, and the embankment under the liner in that corner was somewhat depressed due to equipment travel and compaction. The WC Pond was drained of fluid and allowed to dry. The liner was then removed from the embankment and additional fill material imported, placed in 12 inch lifts after the addition of water to bring the material up to optimum moisture, and compacted by excavator bucket and wheel rolling with a front-end loader with the loader bucket full of dirt. After the embankment was brought back up to the desired elevation, the liner was replaced and fused to the existing liner left in place by the process described above for fusing the Deery Oil liner with fabric, Deery Oil and mesh. An additional 3 feet of liner was constructed and fused to the

Liner Removed and sub-base prepared for liner replacement / repair

existing liner at the top to recreate enough liner to go into the anchor trench. The material was laid into the 12 inch deep anchor trench and soil was compacted over the liner to re-anchor it.

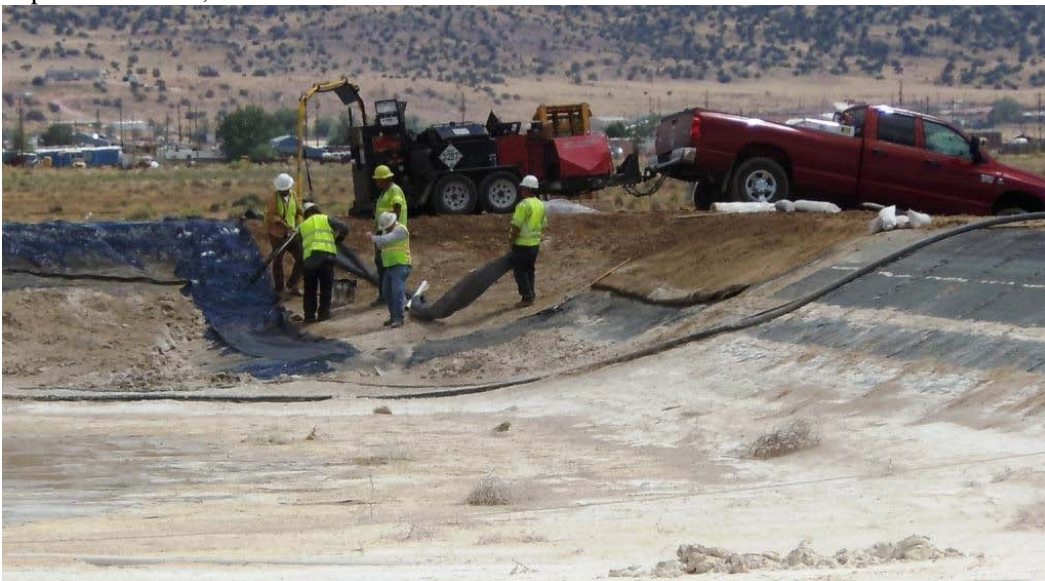
Repair Site No. 1, SW Corner of West Collection Pond

Reconstruction of Deery Oil Liner System in W Collection Pond SW Corner

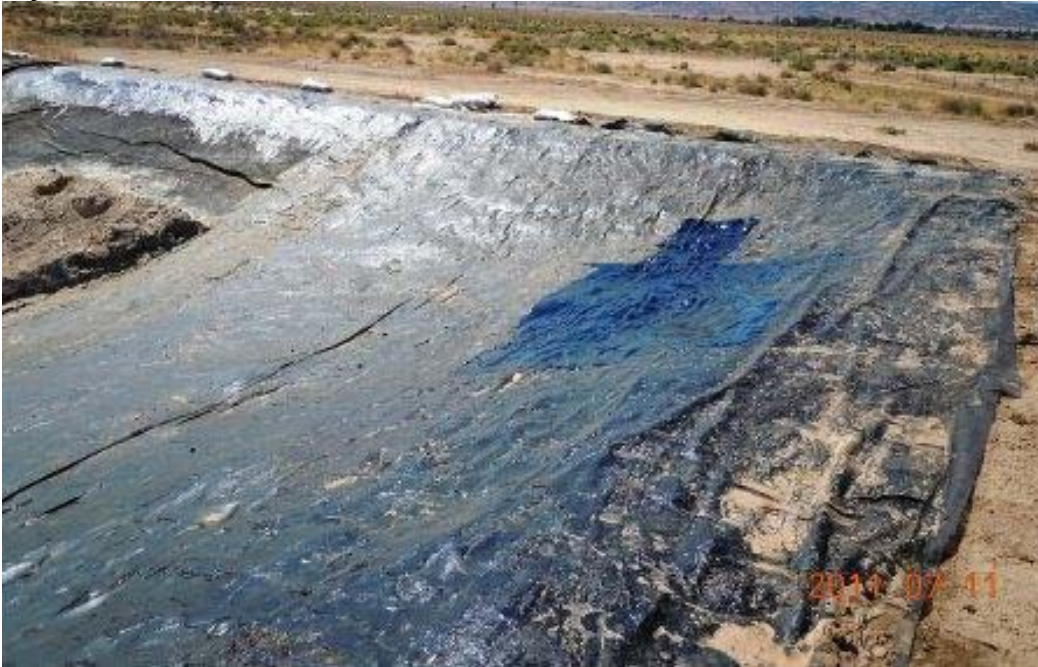
Repair Site No. 1, SW Corner of West Collection Pond

Reconstructed Deery Oil Liner System in W Collection Pond SW Corner

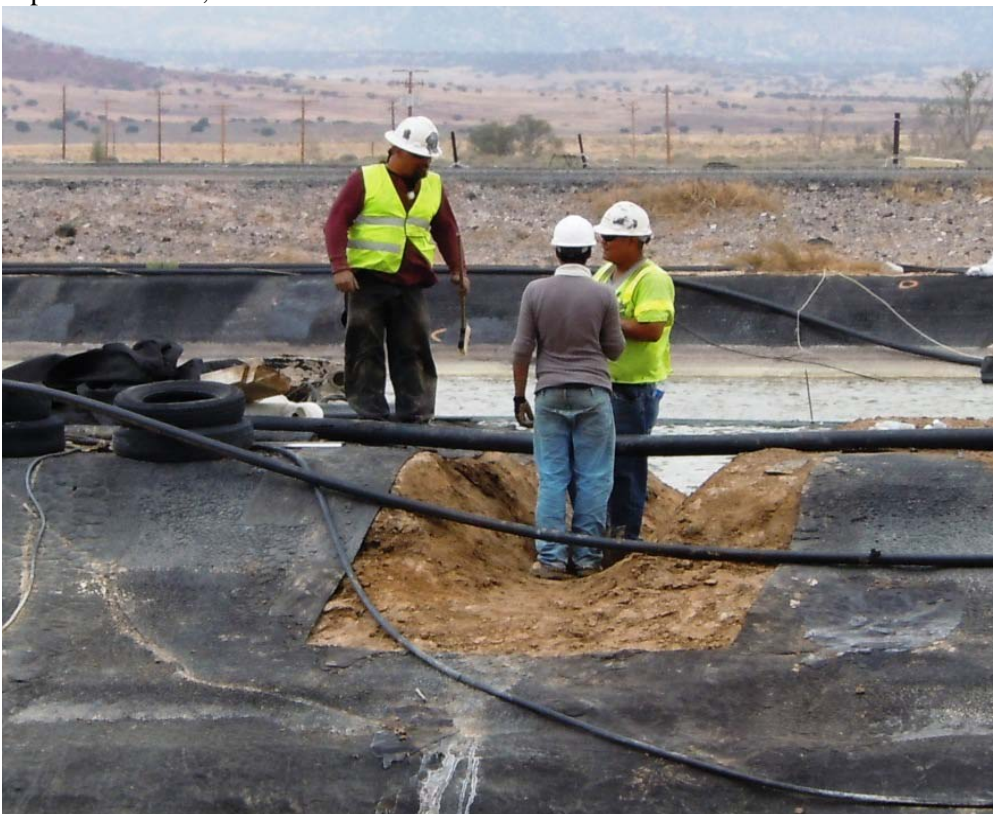
Repair Site No. 2, Cross-Ditch between East and West Collection Ponds

- 2) Repair Area No. 2 was the cross-ditch between the West and East Collection Ponds. This ditch allows management of water levels in the two Collection Ponds. The liner system in the cross-ditch was then reconstructed following the above referenced liner repair method.

West – East Collection Ponds Cross-Ditch excavated for Liner Reconstruction

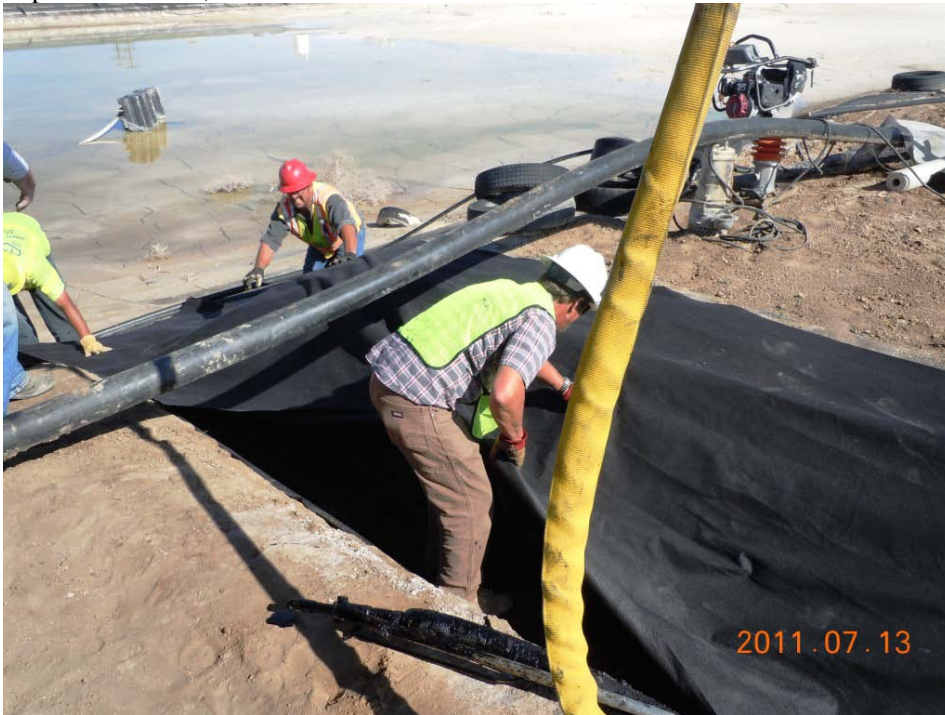
Repair Site No. 2, Cross-Ditch between East and West Collection Ponds

Installation of felt fabric material in Cross-Ditch

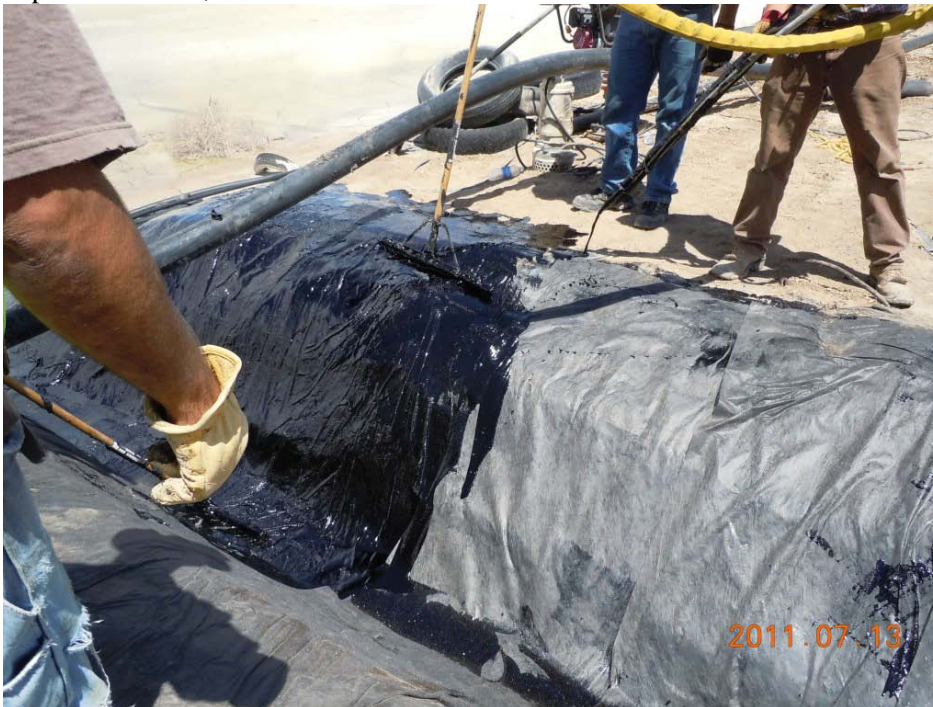
Repair Site No. 2, Cross-Ditch between East and West Collection Ponds

Application of Deery Oil over fabric

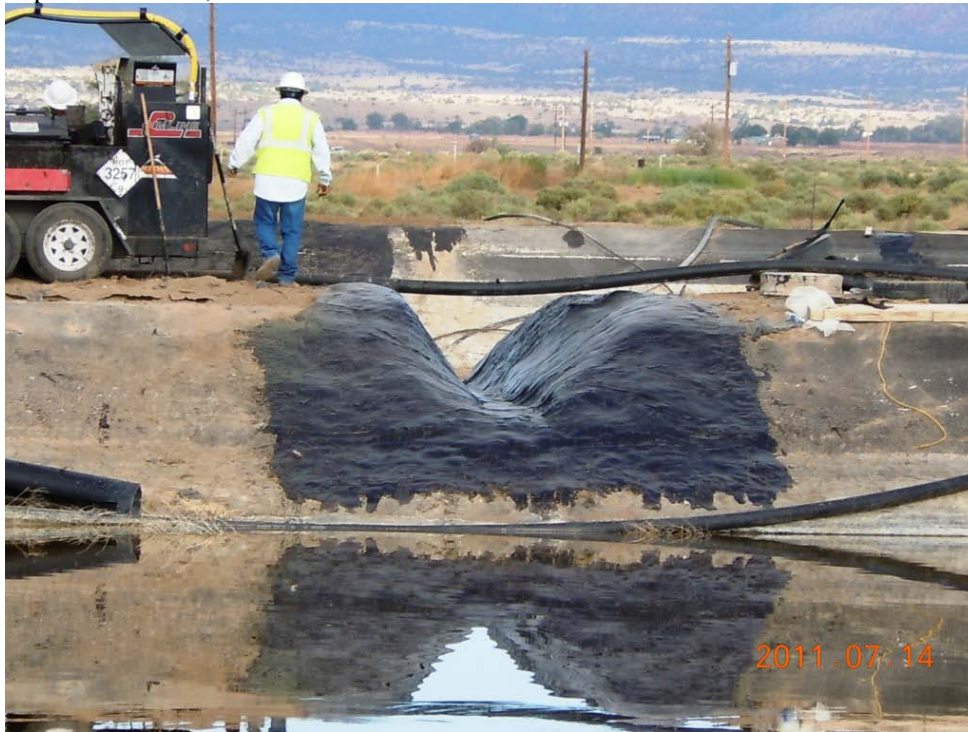
Repair Site No. 2, Cross-Ditch between East and West Collection Ponds

Completed Cross-Ditch between West and East Collection Ponds

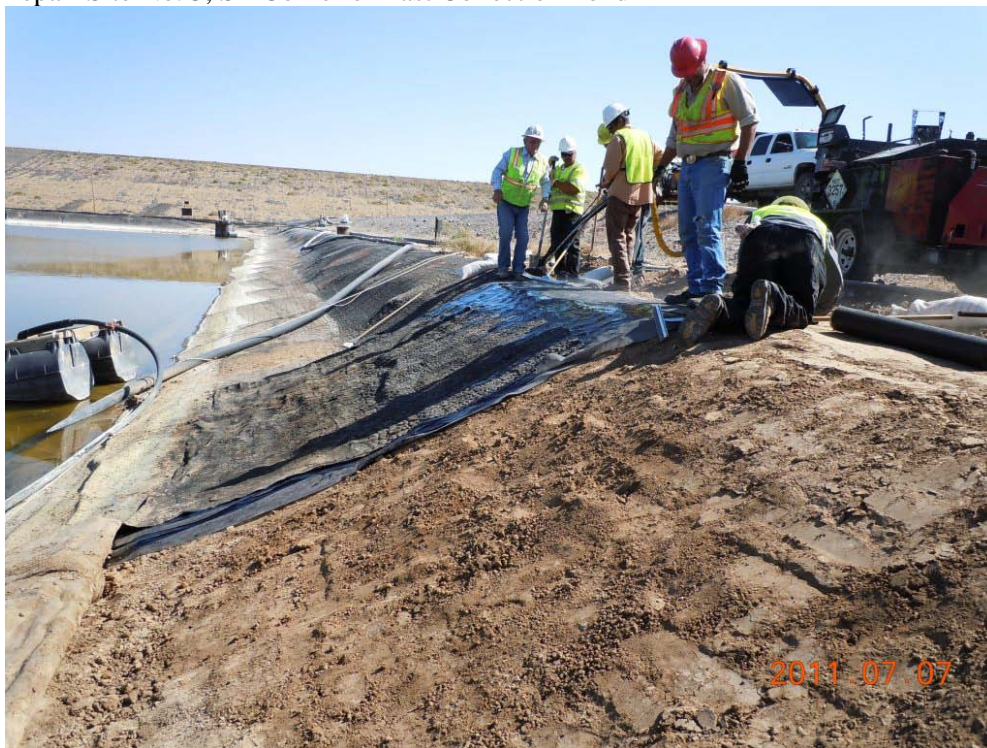
Repair Site No. 3, SE Corner of East Collection Pond

- 3) Repair Area No. 3 was in the SE Corner of the East Collection Pond (EC Pond). A length of about 130 feet of the existing liner had separated from the liner buried in the anchor trench at the top of the embankment and stormwater had created some erosion below the liner system. The existing liner system had vertical cuts incised from the top of the liner to above the water level (approximately 12 feet), and the liner rolled downhill to expose the embankment. Moisture conditioned fill was then imported and the embankment reconstructed in 12 inch lift and compacted with the excavator bucket and a portable "jumping jack" compactor. When the embankment was reconstructed to grade, the liner system was rolled back into place and the vertical incisions repaired as described above. An additional 3 feet of liner was constructed and fused to the existing liner at the top to recreate enough liner to go into the anchor trench. The material was laid into the 12 inch deep anchor trench and soil was compacted over the liner to re-anchor it.

Reconstructed sub-base embankment, spreading of fabric and Deery Oil application

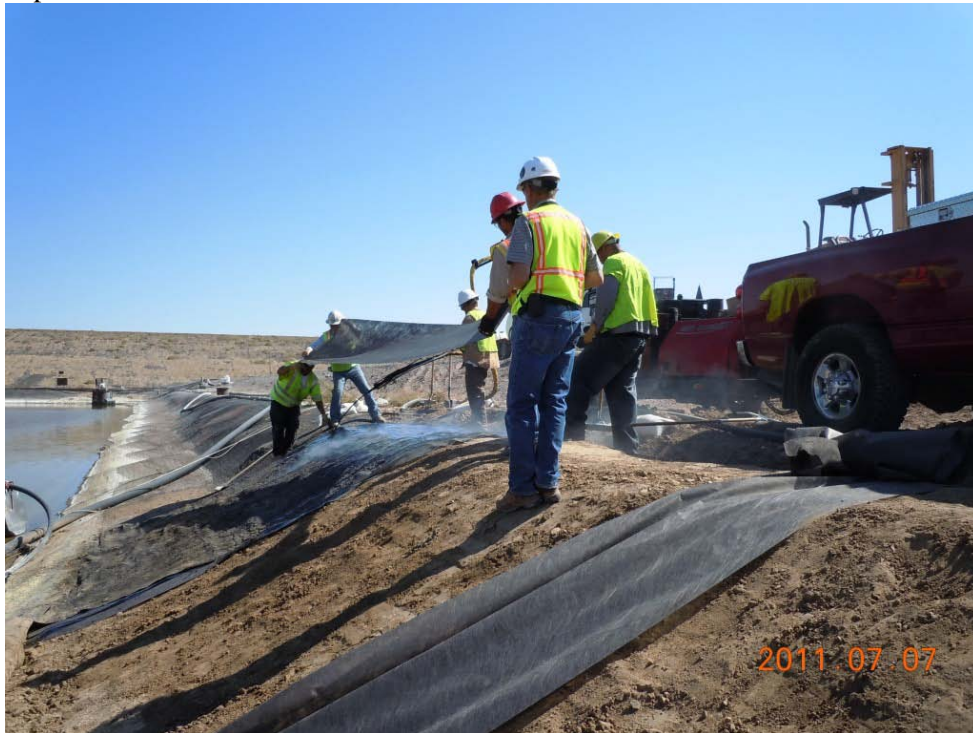
Repair Site No. 3, SE Corner of East Collection Pond

Adding fabric and Deery Oil to extend liner system at top

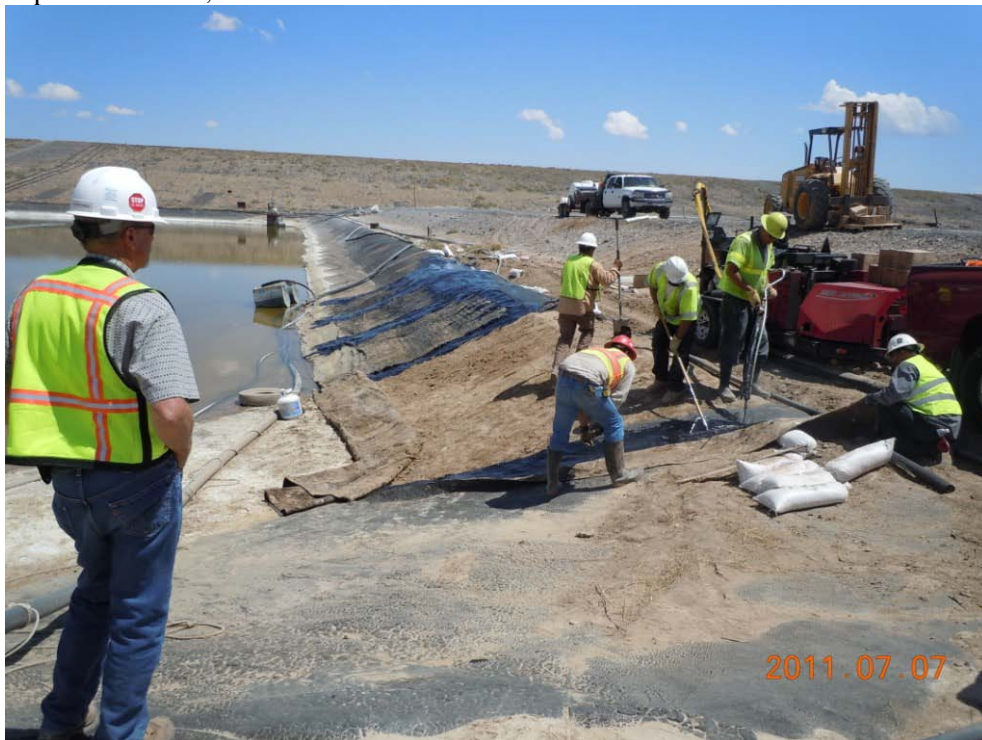
Repair Site No. 3, SE Corner of East Collection Pond

Fusion of section of existing liner system with fabric and Deery Oil & completed sections

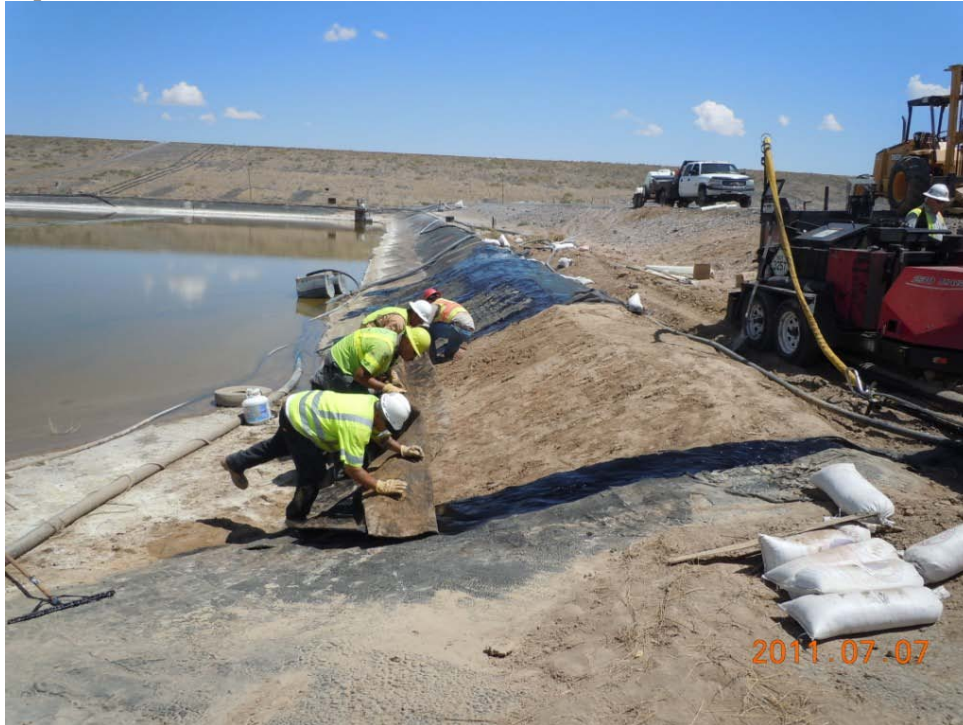
Repair Site No. 3, SE Corner of East Collection Pond

Rolling existing liner back into place for fusion with sides and top

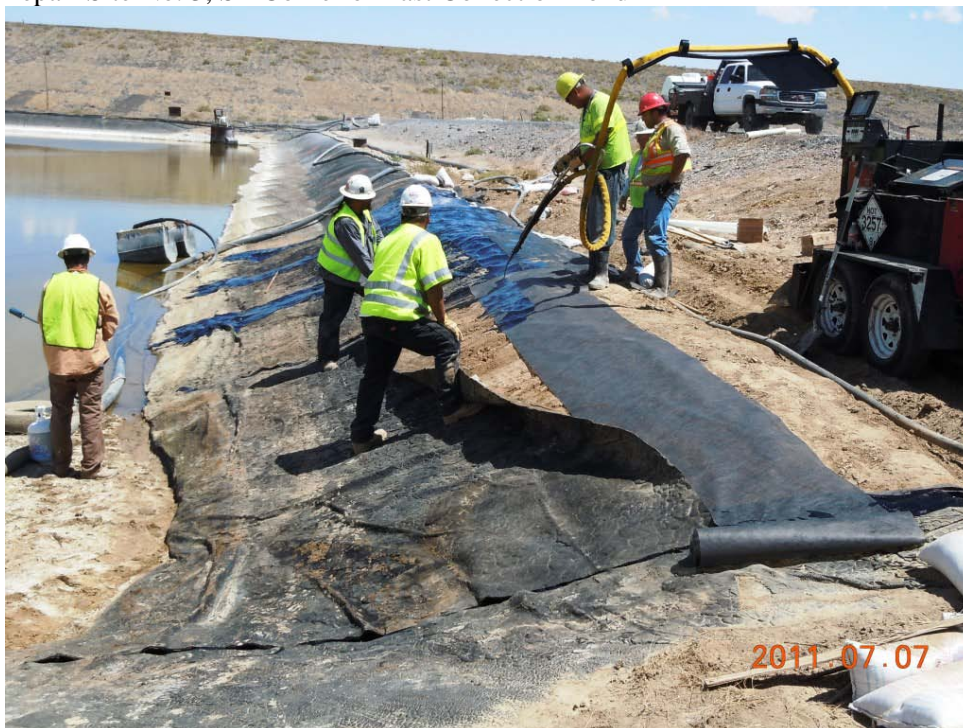
Repair Site No. 3, SE Corner of East Collection Pond

Adding additional liner to top of existing liner where top had been damaged

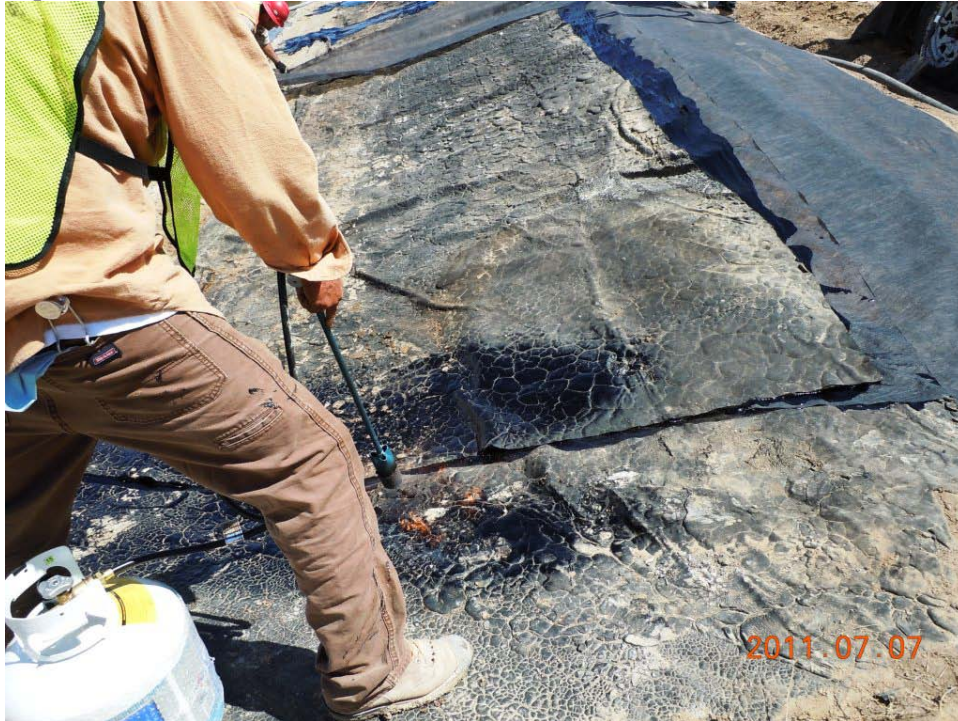
Repair Site No. 3, SE Corner of East Collection Pond

“Conditioning” of existing liner prior to fusion by Deery Oil liner system

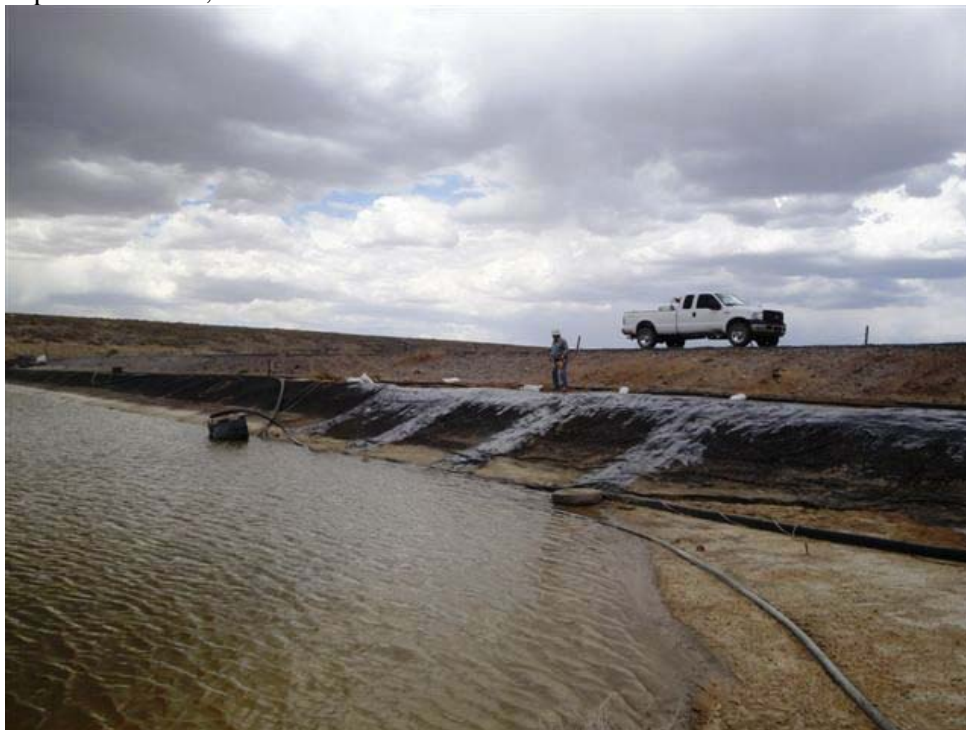
Repair Site No. 3, SE Corner of East Collection Pond

Deery Oil liner system repaired

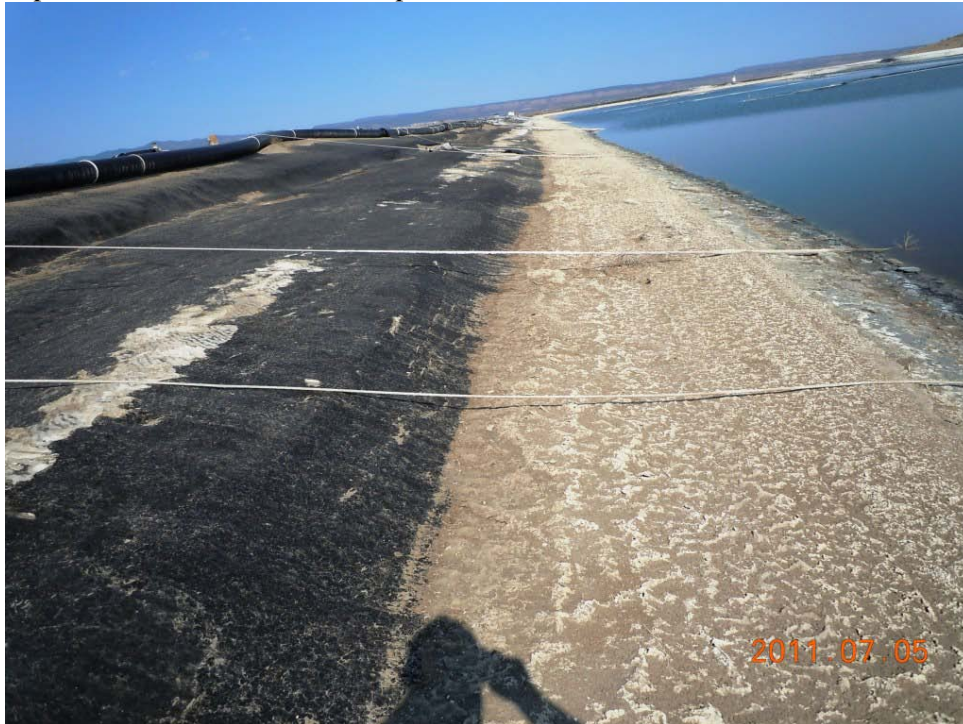
Repair Site No. 4, SE Corner Evaporation Pond No. 1

- 4) Repair Area No. 4, the SE Corner of Evaporation Pond No. 1 (Evap Pond No. 1). The SE Corner of Evap Pond No. 1 was an area where wave action from water in the pond had caused the soil material underlying the Deery Oil liner system to disfigure and slump in some places. Left unaddressed, this could have lead to liner stretch. The area in the SE Corner of Evap Pond No. 1 that was affected and required repair was approximately 700 feet from the SE Corner to the west, along the south embankment. In addition, about 140 feet north from the SE Corner along the East embankment was also affected. The slope is approximately 3H:1V.

Evaporation Pond No. 1, SE Corner looking W. Pre-Existing Condition – wave benches

The water elevation in Evap Pond No. 1 was drawn down by approximately 12 feet to expose all of the area where repairs were required. The liner was then cleaned using high pressure water spray from a water truck and portable trailer mounted high pressure system, as needed. The existing liner was then cut as in the repairs to the East Collection Pond, where vertical incisions were made in the liner and it was rolled down and the embankment under the liner reconstructed and compacted.

The Deery Oil liner system was then rolled back into place and the sections fused with the Deery Oil patch systems as described earlier.

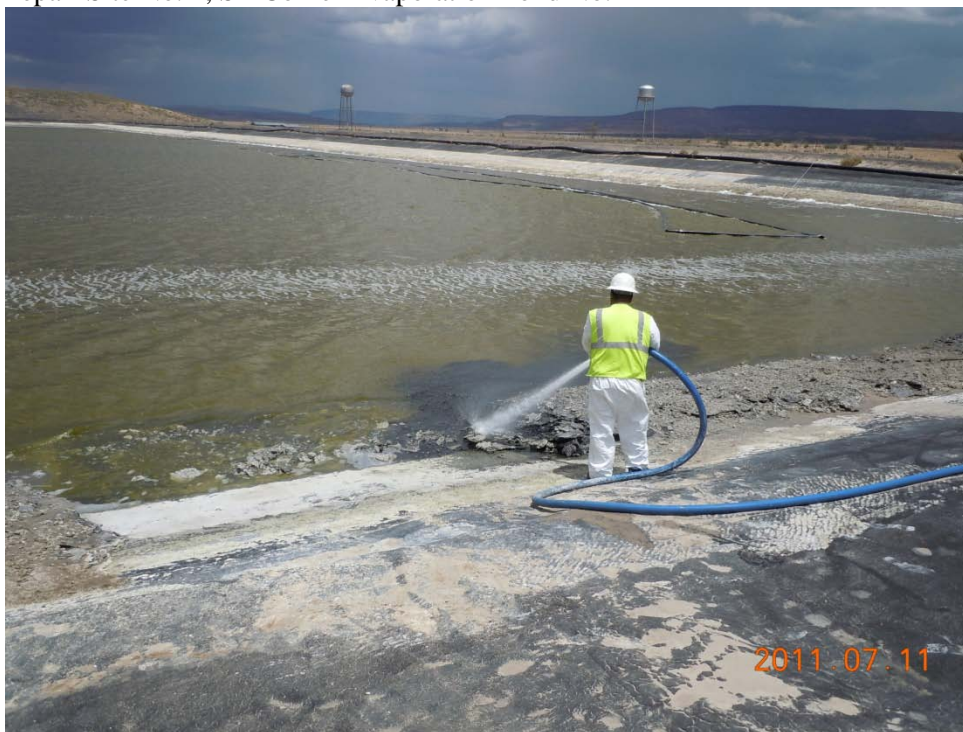
Repair Site No. 4, SE Corner Evaporation Pond No. 1

Evaporation Pond No. 1 SE Corner, washing sediment from liner with water truck

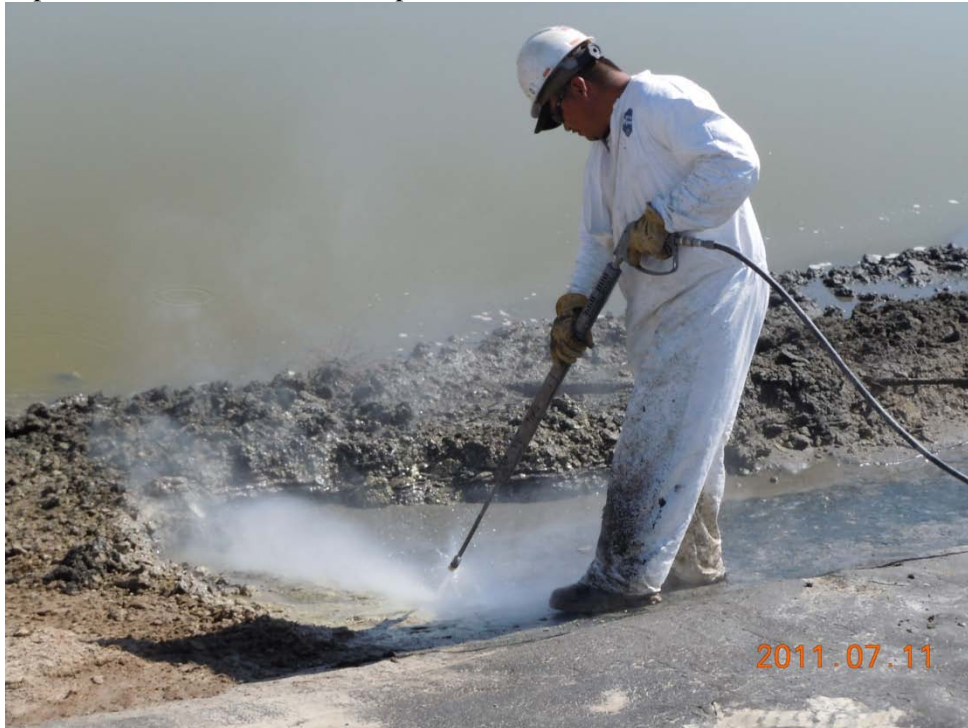
Repair Site No. 4, SE Corner Evaporation Pond No. 1

Evaporation Pond No. 1 SE Corner, washing sediment from liner with high pressure washer

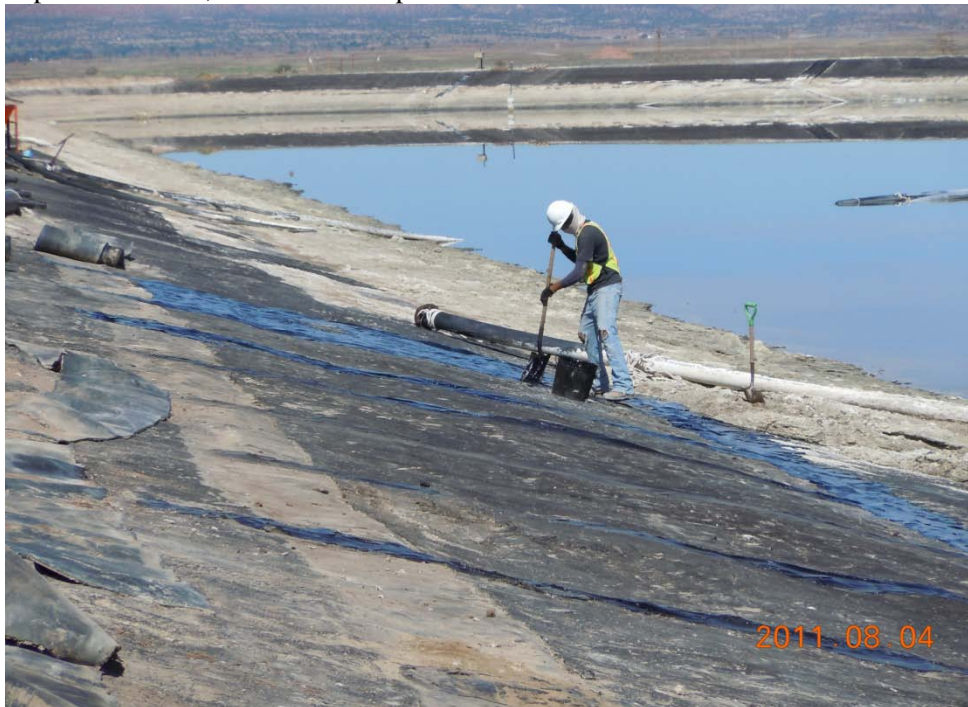
Repair Site No. 4, SE Corner Evaporation Pond No. 1

Applying Deery Oil to seams in liner after recompaction of subbase.

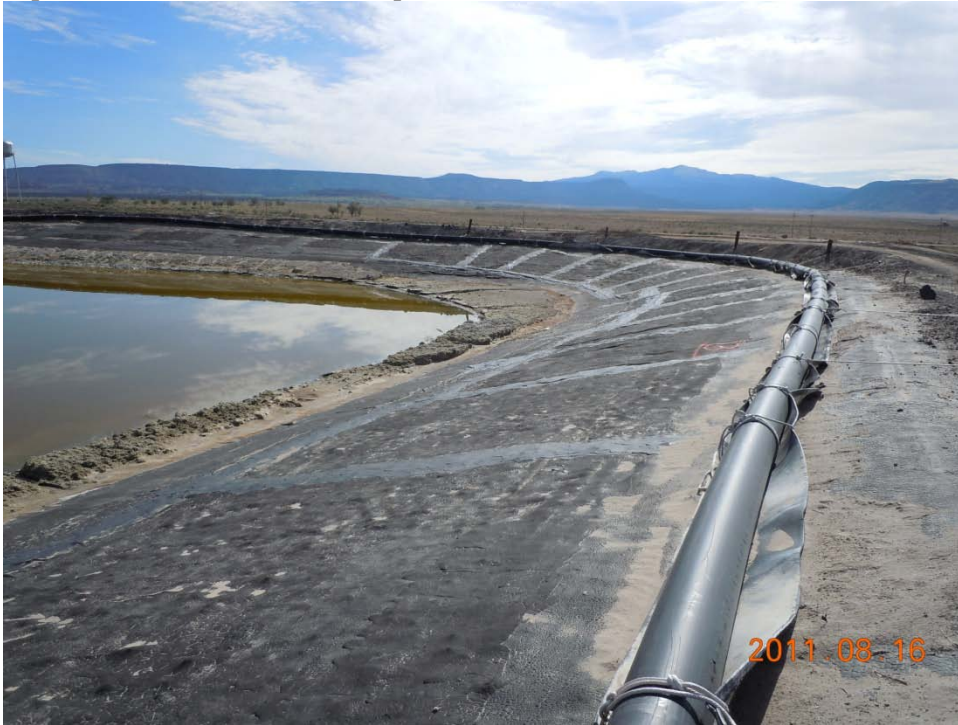
Repair Site No. 4, SE Corner Evaporation Pond No. 1

Deery Oil Liner System after repair. Note subbase recompact and seams sealed.

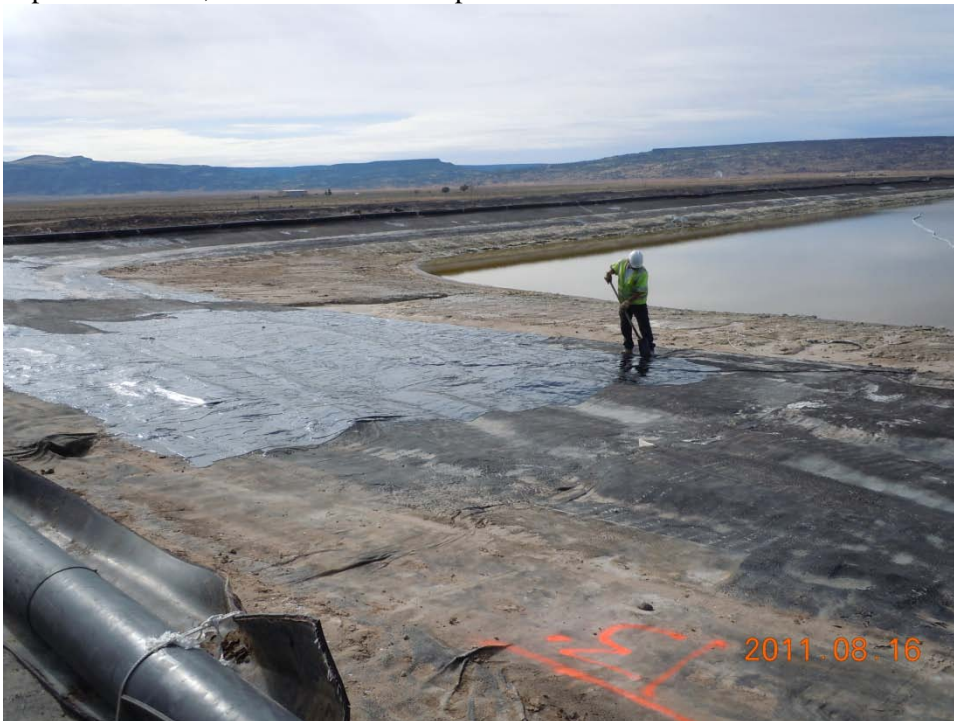
Repair Site No. 5, N Embankment Evaporation Pond No. 1

- 5) Repair Area No. 5, N Embankment of Evaporation Pond No. 1 (Evap Pond No. 1). The N embankment of Evaporation Pond is at a slope of approximately 5H:1V. The Deery Oil liner over the fabric of the liner system has degraded due to apparent under application of Deery Oil over the fabric liner at the original installation, and likely effects from sunlight on this south facing slope.

NE corner Evap Pond No. 1, reapplication of Deery Oil top layer over weathered areas.

The liner was then cleaned using high pressure water spray from a water truck and portable trailer mounted high pressure system, as needed. The areas with a thinning Deery Oil layer were then recovered with a 1/8 to 1/4 inch layer of new Deery Oil.

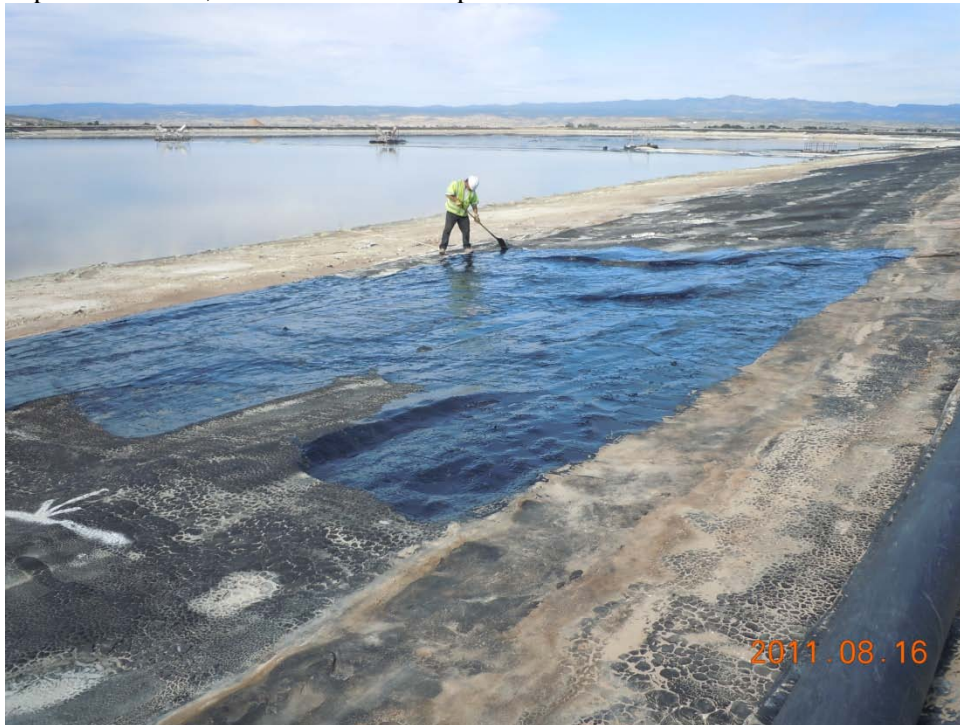
Repair Site No. 5, N Embankment Evaporation Pond No. 1

North embankment reapplication of Deery Oil top layer over weathered areas.

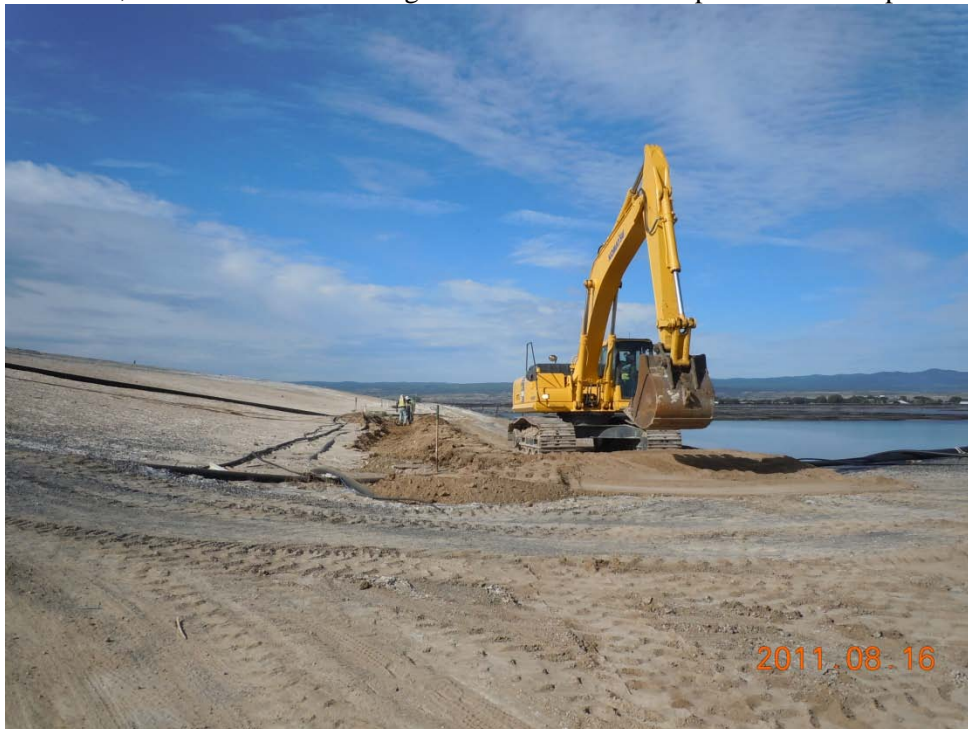
Site No. 6, Construction of Drainage Channel between Evap No. 1 and Evap No. 2

- 6) Construct drainage ditch between Evaporation Pond No. 1 and Evaporation Pond No. 2. A ditch between the two evaporation ponds was constructed at the base of the west embankment of Evap Pond No. 1 to catch precipitation and runoff from the embankment and direct it by the constructed ditch into an armored entry into Evap Pond No. 2.

Initial construction of drainage ditch, looking South.

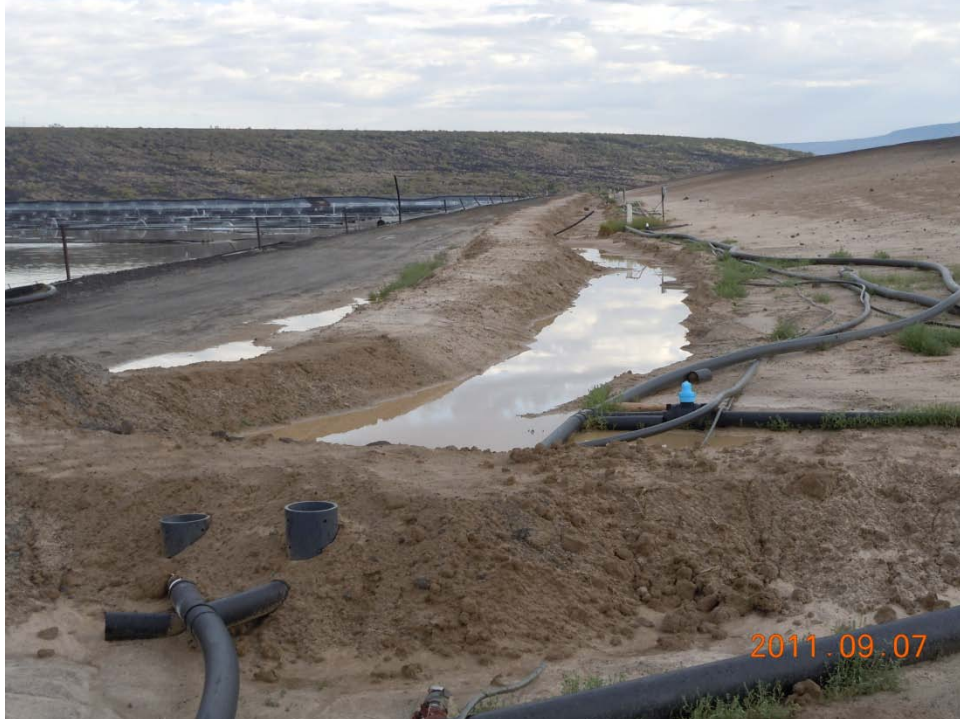
Site No. 6, Construction of Drainage Channel between Evap No. 1 and Evap No. 2

Completed drainage channel between Evap No. 1 and Evap No. 2, looking North.

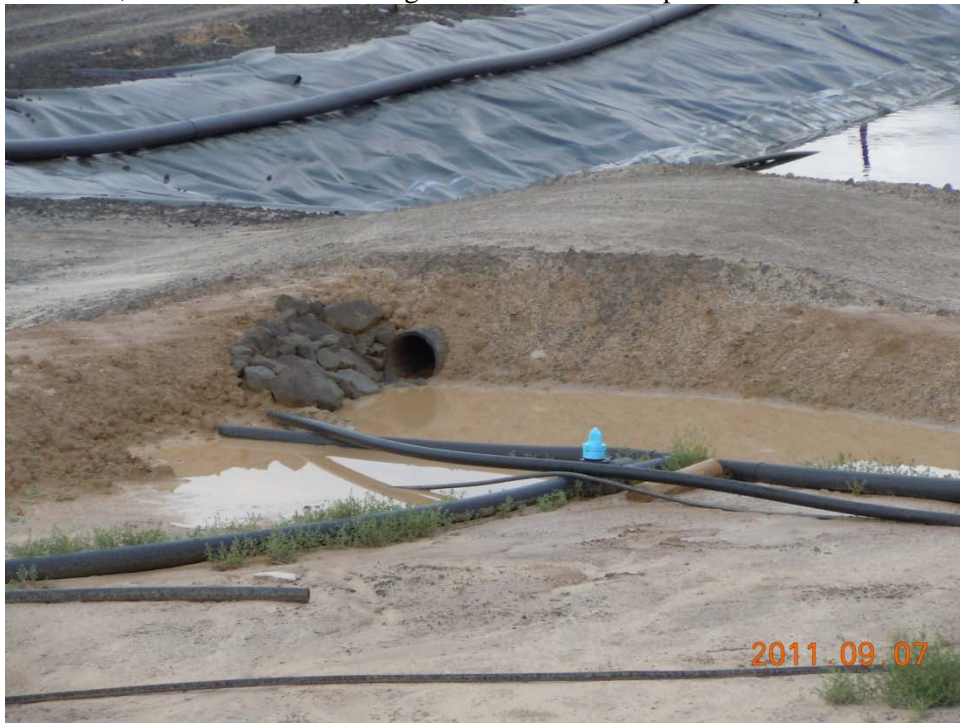
Site No. 6, Construction of Drainage Ditch between Evap No. 1 and Evap No. 2

Completed drain pipe at South end of drainage channel, directing water into Evap No. 2
