RE: Excursion at Monitor Well DM-010, Plan and Compliance Schedule, 90-day Notification,
Cameco Resources, Permit 603

Excursion at Well DM-010, Plan and Compliance Schedule, 90-day Submittal

Cameco Resources, Permit 603

Re: Mine Unit D Excursion Recovery and Prevention Plan

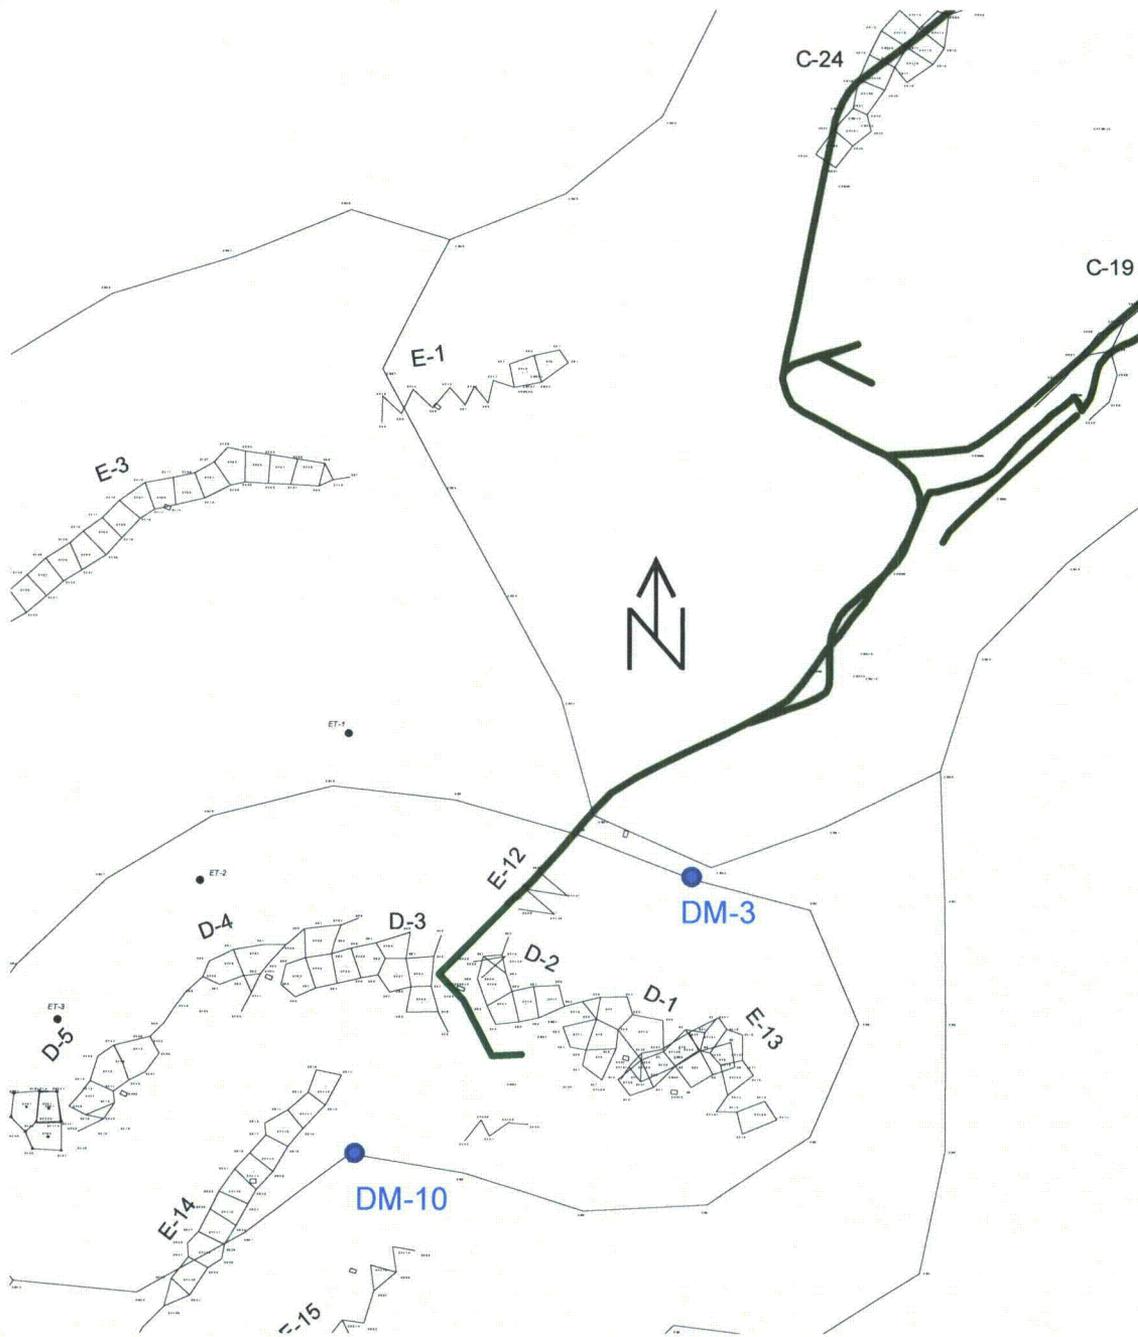
Former underground mine workings (drifts) are present in the 40-Sand production interval in Mine Unit D (**Figure 1**). The 40-Sand aquifer is hydraulically connected to the overlying 50-Sand aquifer (production interval for MU-C and MU-E) by virtue of a series of raises and drifts connecting MU-C and MU-D, by collapsed mine workings within the MU-D footprint, and by exploration “fan” drilling during underground mine operations.

Figure 1. Location of mine workings in MU-D and MU-C. Excursion wells D-3 and D-10 also shown.

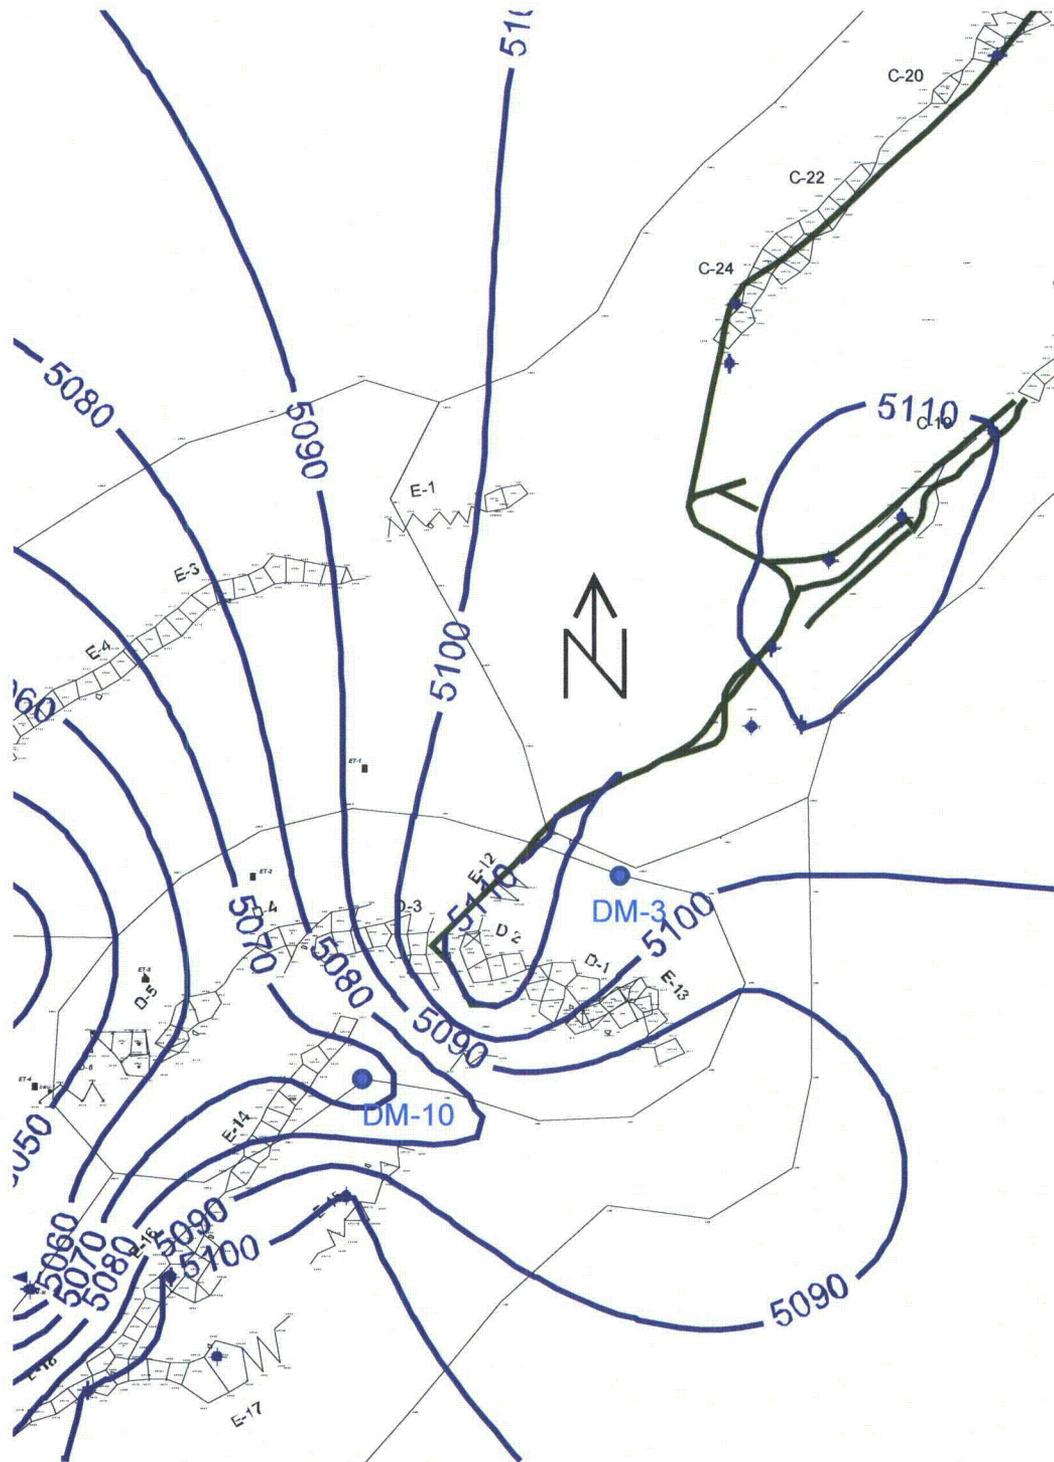
Groundwater elevation data for the 40- and 50-Sand aquifers was contoured for select wells monitored over the period May 15 to May 26, 2011, as shown in **Figure 2** and **Figure 3**. Examination of these maps illustrates groundwater flow into the workings in the 50-Sand, and discharge from the workings in the 40-Sand in the MU-D area. In addition, water level elevations are shown to decrease significantly in the 40-Sand east of the mine workings due to significant withdrawal (bleed) of approximately 60-85 gpm in MU-D and D-Ext. These data support the conceptual model of groundwater flowing downward through the workings from the 50-Sand and discharging into the underlying 40-Sand in the MU-D area.

Figure 2. Water Level Elevation in the 40-Sand Aquifer, May 15-26, 2011.

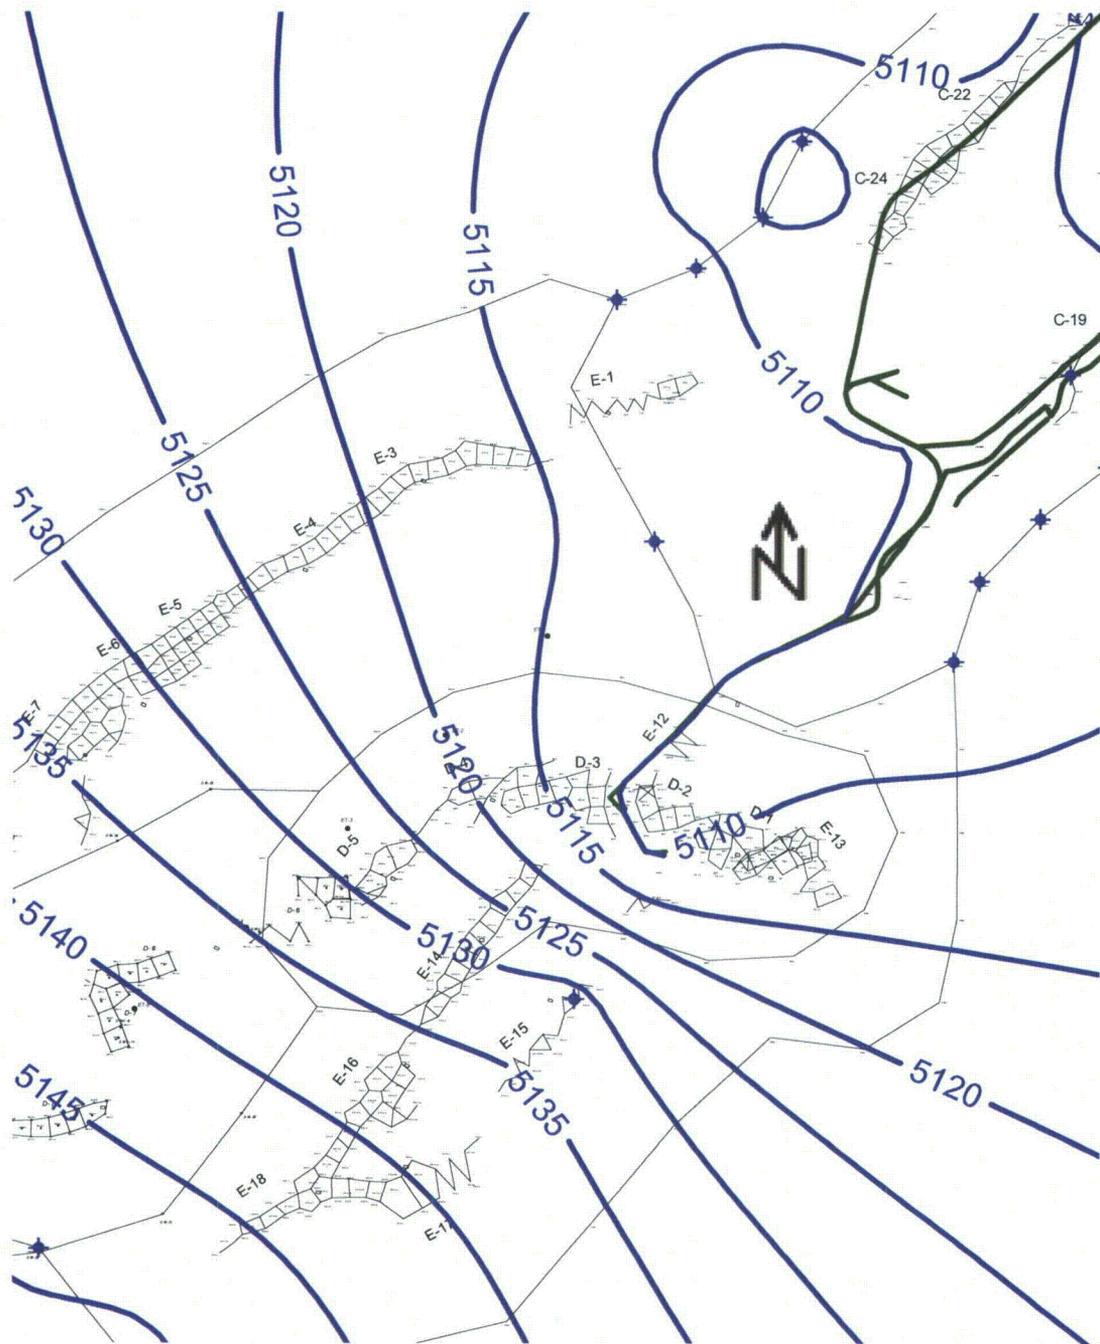
Figure 3. Water Level Elevation in the 50-Sand Aquifer, May 15-26, 2011.

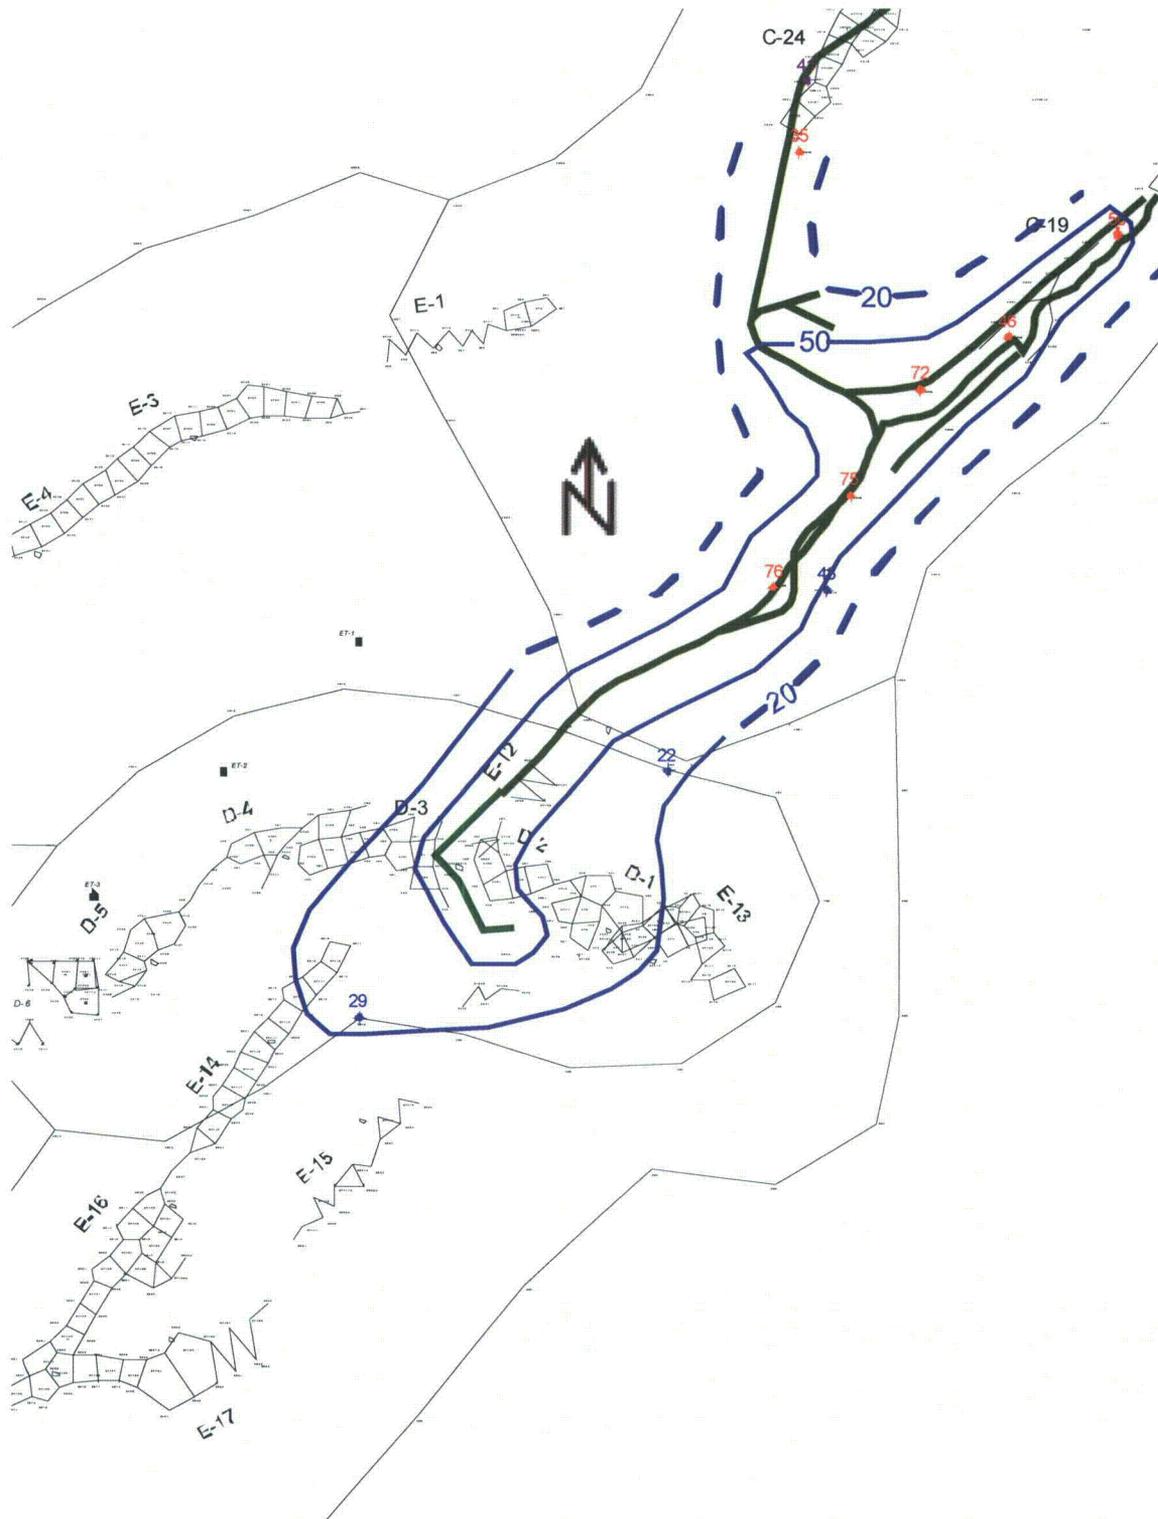
Groundwater chloride concentration data for the 40- and 50-Sand aquifers was contoured for select wells monitored over the period May 15 to May 26, 2011, as shown in **Figure 4**. Chloride concentrations were contoured for wells installed within underground mine workings (drifts and raises), as well as the surrounding aquifer. The chloride concentration within underground mine workings connecting the MU-C and MU-D areas was observed to be in excess of 70 mg/L. The distribution of chloride shown in **Figure 4** is consistent with the conceptual model of discharge of high TDS groundwater from mine workings in the MU-D area.

Figure 4. Chloride concentration (mg/L) in underground mine workings (red) and 40-Sand monitoring wells (blue), May 15-26, 2011.

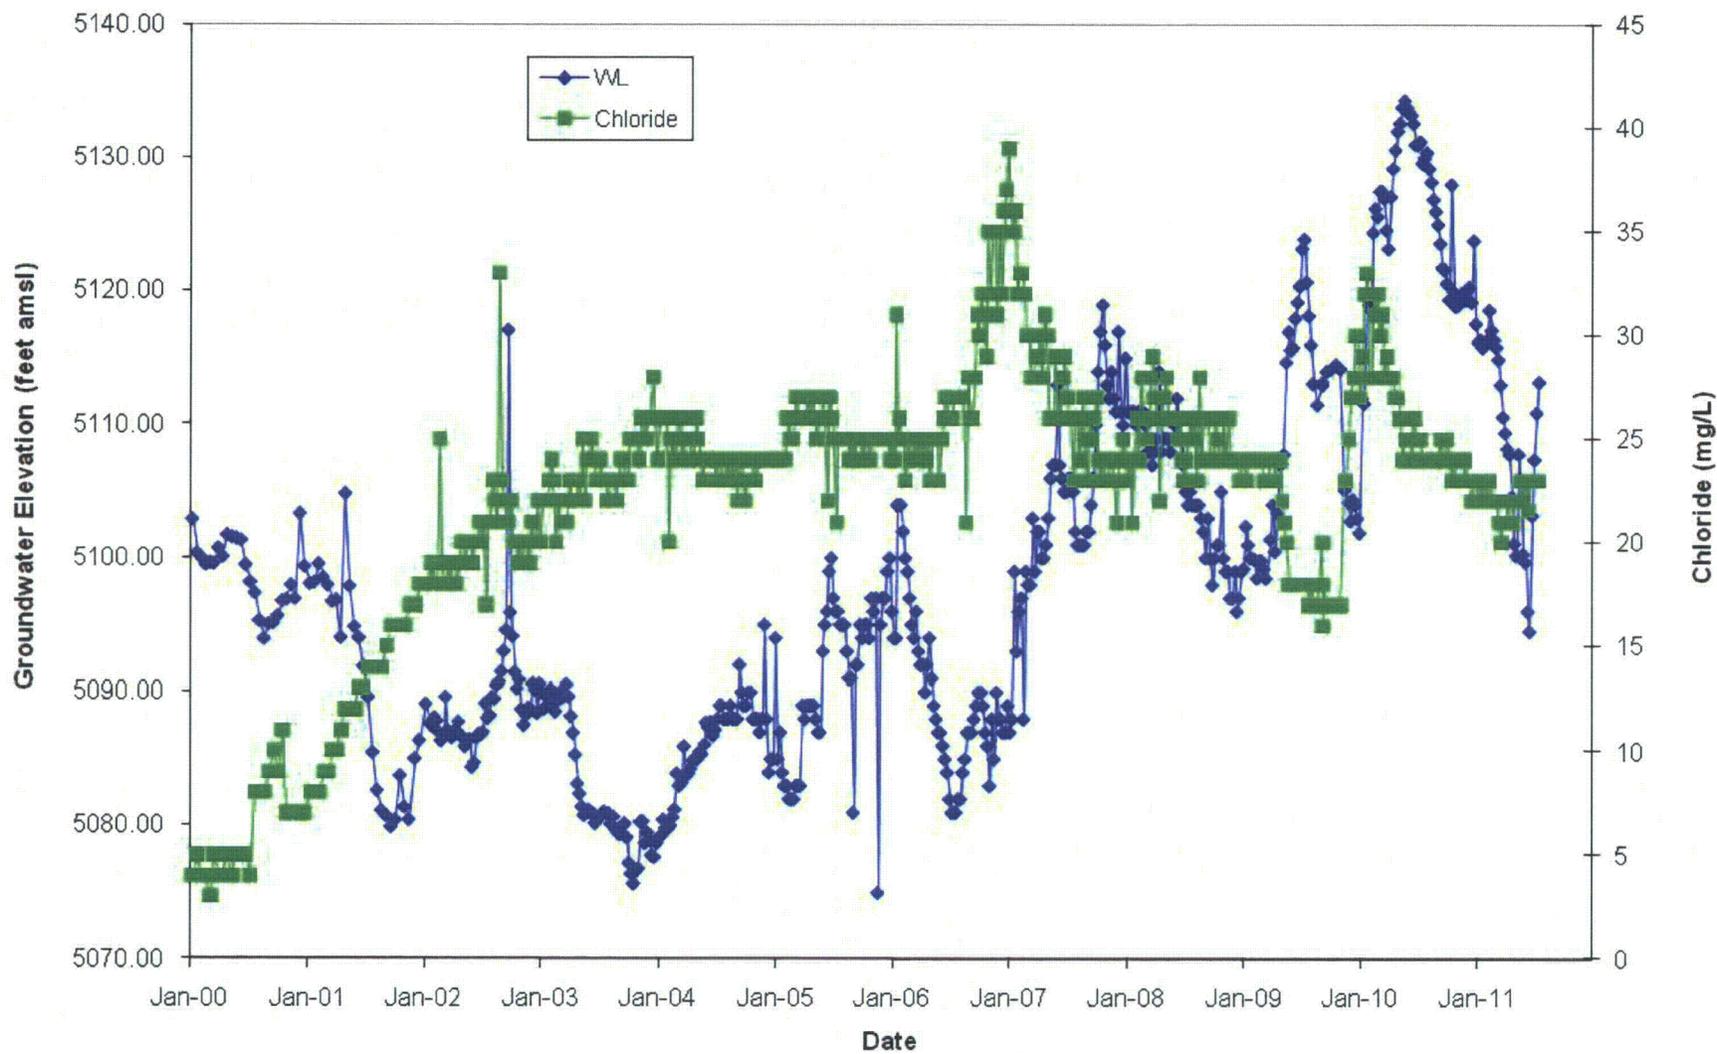
DM-3 (40 Sand Well)

Water quality data for excursion wells DM-3 and DM-10 were examined for the period of record to identify any correlations between parameters and water level elevation. As expected, there is a strong correlation between water level elevation and water quality observed in both excursion wells, as shown in **Figure 5** and **Figure 6**. This correlation is most obvious over the 6-year period from approximately January of 2005 to January of 2011 observed in excursion well DM-10 (**Figure 6**). In general, increasing groundwater elevation is correlated to decreasing chloride concentrations in both excursion wells. In general, groundwater elevation greater than

5085 ft-MSL promote acceptable water quality in excursion well DM-10. Although the trends in excursion well DM-3 are not quite as clear, better water quality is generally observed in when water level elevation is greater than 5110 ft-MSL. These data are also consistent with the conceptual model of decreasing downward flow through the mine workings into MU-D as 40-Sand water levels increase (decrease in downward hydraulic gradient), which results in a decrease in chloride concentration in adjacent monitoring wells.

Figure 5. Chloride concentration (mg/L) in excursion well DM-3 over time.

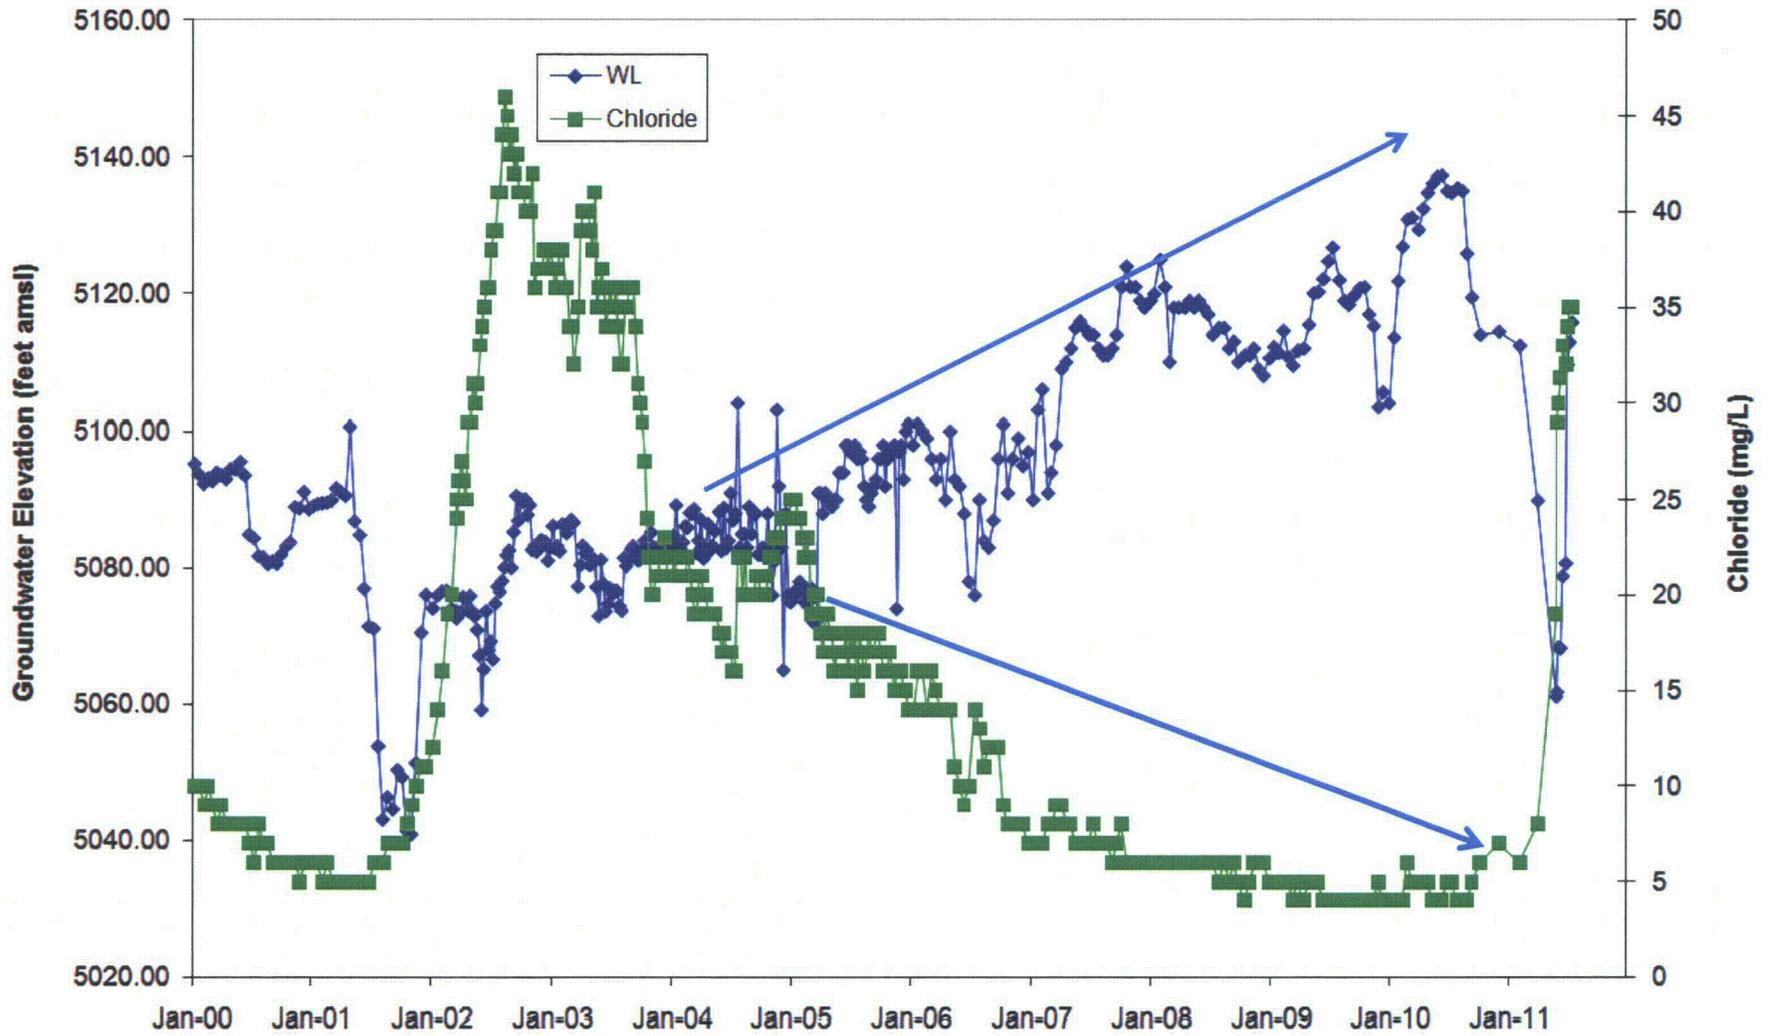
DM-10 (40 Sand Well)

Figure 6. Chloride concentration (mg/L) in excursion well DM-10 over time. Note trend over six-year period from 2005 to 2011 indicated by arrows.

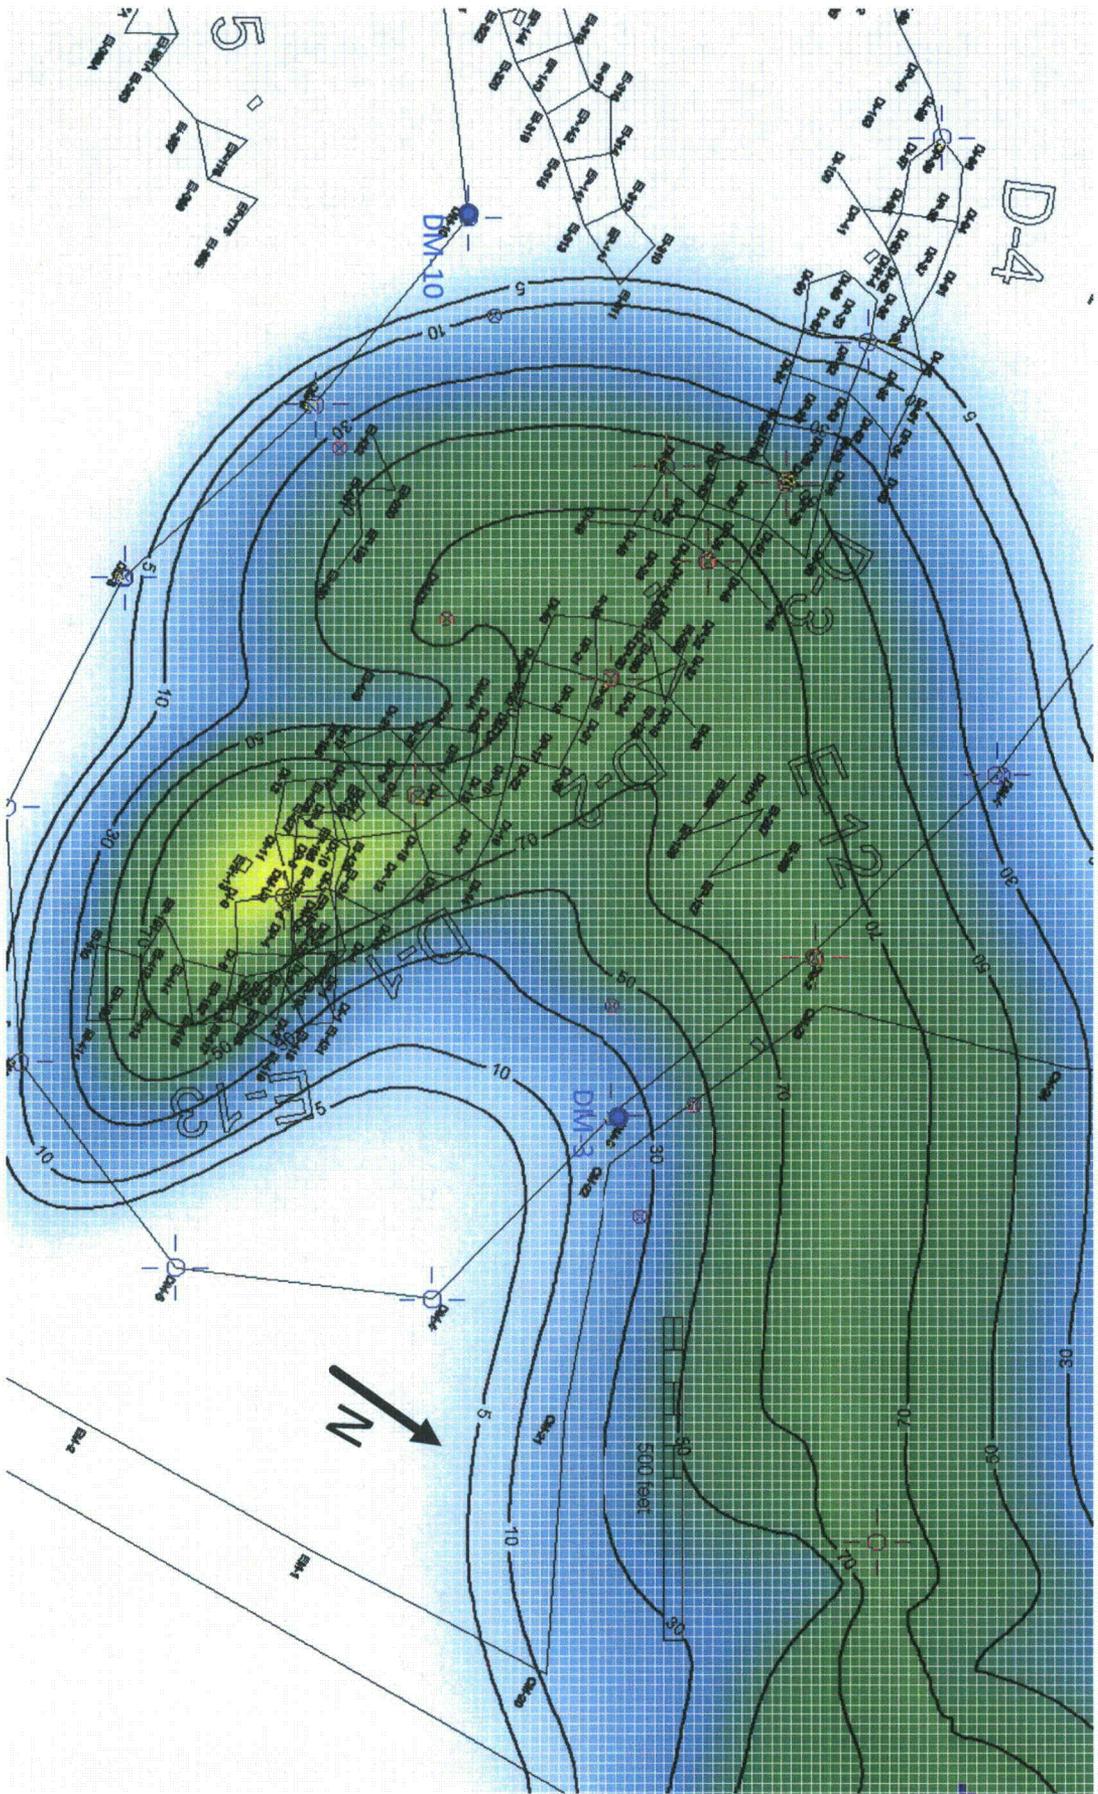
Prior to using the groundwater flow model for excursion control and prevention, the chemical transport model (MT3D) was calibrated by reproducing the excursion currently observed in DM-3 and DM-10 in MU-D. **Figure 7** illustrates the calibrated chloride concentration in MU-D in May of 2011. The resulting chloride plume is generally consistent with observed chloride concentrations in site monitoring wells, including concentrations observed in excursion well DM-3 (approximately 25 mg/L). An exception exists in the vicinity of DM-10, where the model predicts lower chloride concentrations than observed, and instead predicts adjacent monitoring well DM-9 should be nearing excursion status. This observation is not surprising, however, since well DM-9 has been placed on excursion status in the past. Despite the small differences observed in modeled and observed chloride concentrations, the model is considered a reasonable representation of existing conditions and is further validation of the conceptual model of historical and recent excursions in MU-D.

Figure 7. Model calibrated chloride concentration (mg/L) in MU-D as of May 2011.

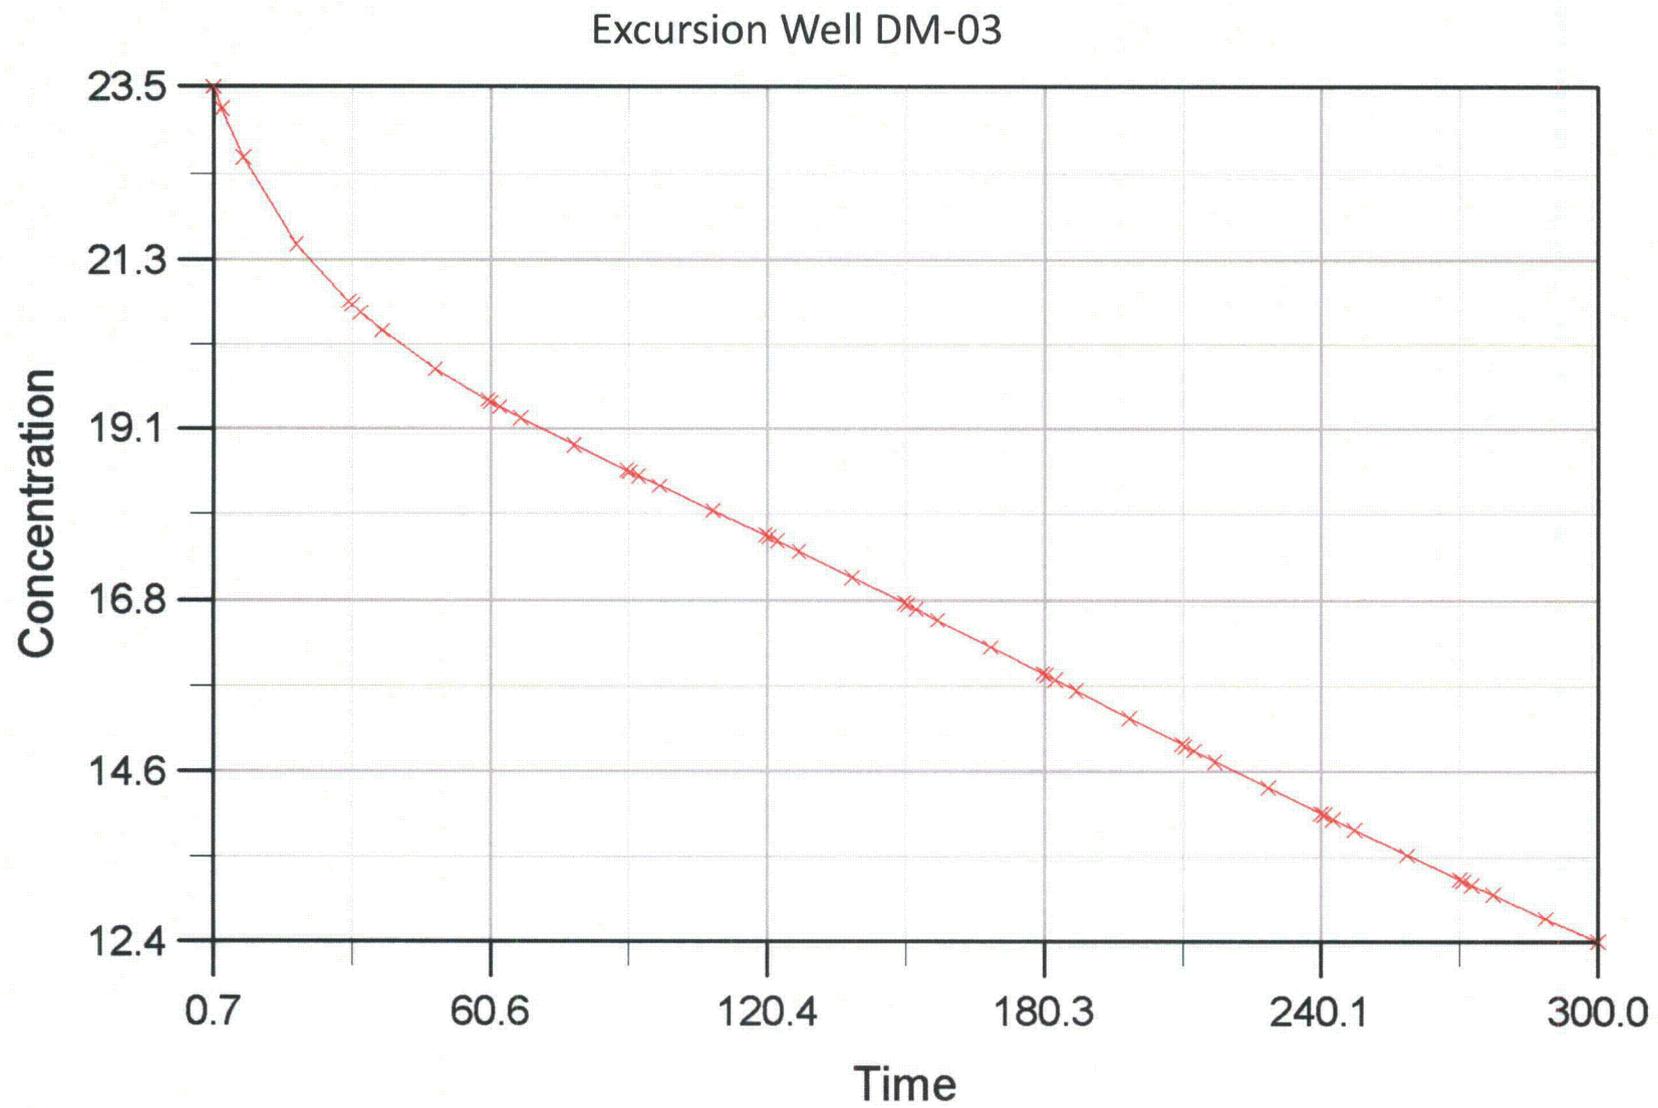
The effectiveness of the proposed excursion recovery and prevention plan described below was tested using the calibrated groundwater flow and transport model. Results of the modeling indicate chloride concentrations in excursion wells DM-10 and DM-3 should decline to below UCL's (and removed from excursion status) within approximately 90 days of implementation of the plan, as illustrated in **Figure 8**.

Figure 8. Model projected chloride concentration (mg/L) curve based on proposed excursion control and prevention plan.

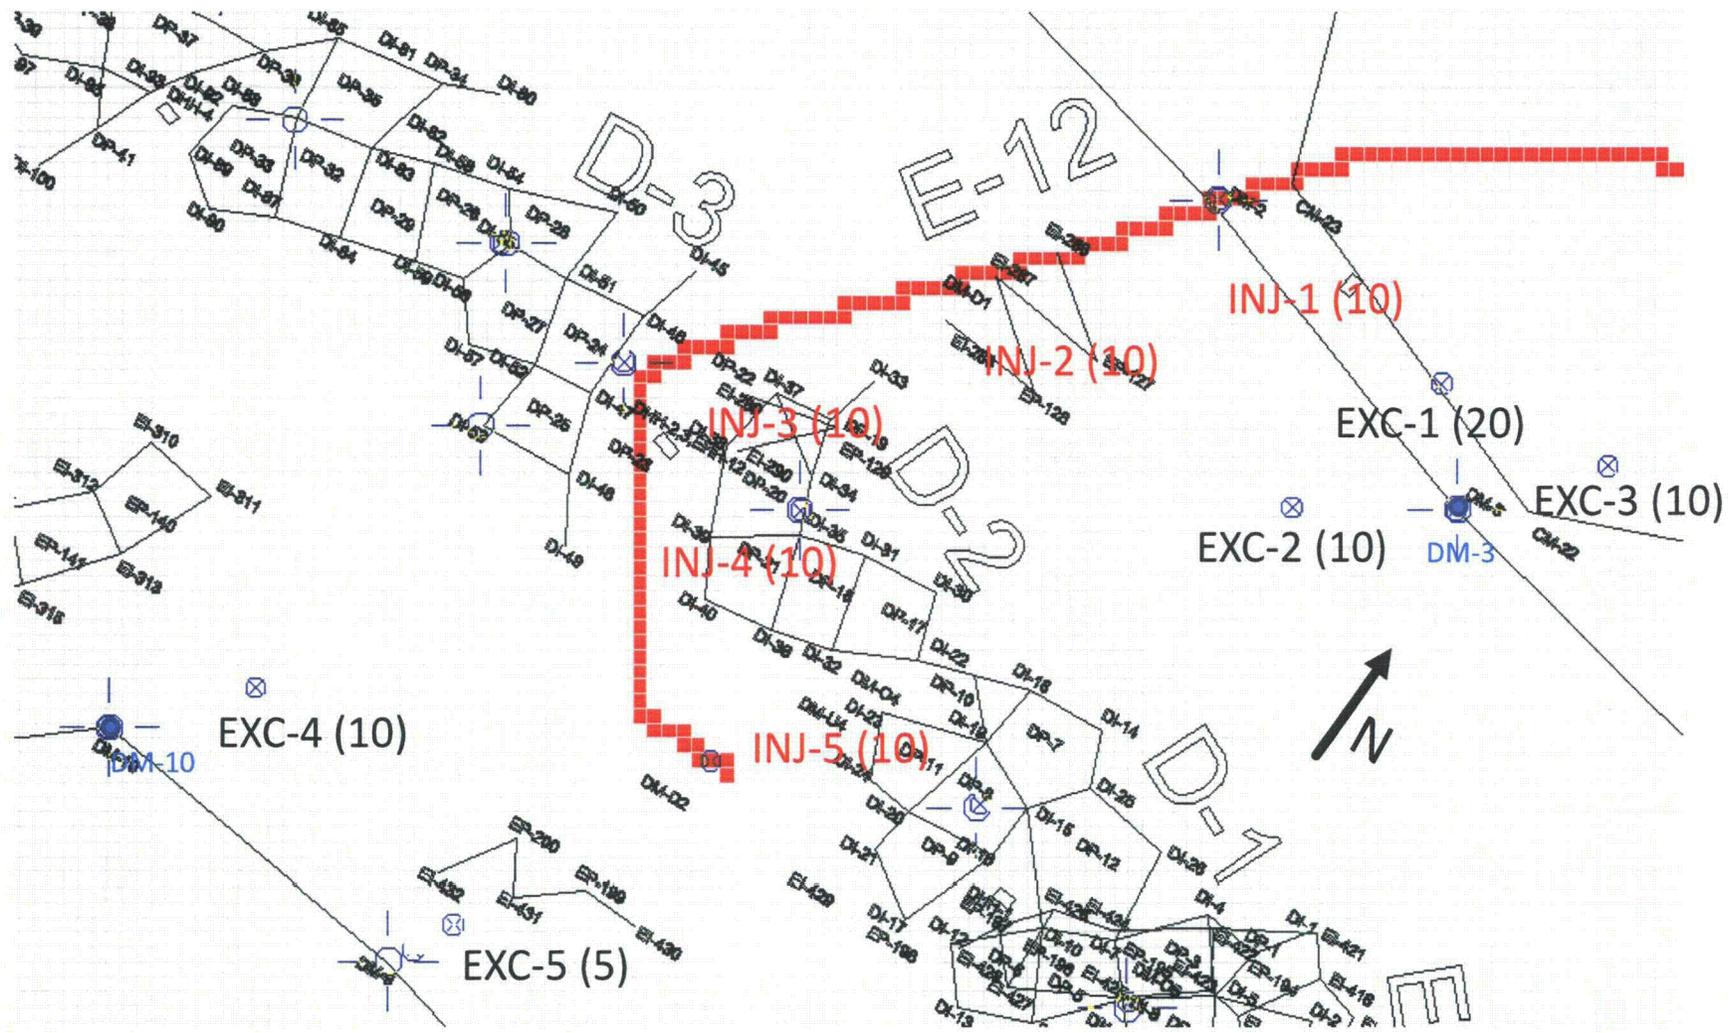
Figure 9. Excursion control and prevention plan well configuration. “EXC” wells are excursion control (and restoration) wells (to be installed). “INJ” wells are injection wells to be used for RO permeate injection (existing wells). Numbers in parentheses are approximate pumping or injection rates.

- Inject RO permeate into underground workings using existing drift wells (up to five existing wells available), and using the workings as an injection source for the overall MU-D wellfield restoration plan (**Figure 9**). An injection rate of approximately 25 to 50 gpm from two or more MU-D drift wells is recommended. The restoration bleed in MU-D wellhouses D-2 and D-3 should be increased to approximately 50 gpm (slightly greater than the injection rate) to contain injected fluids, moderate water levels in the workings, and provide sweep of production areas adjacent to the workings.
- Improve water quality in the MU-C portion of the underground workings to assist in the long-term stability of water quality in MU-D and MU-C, as previously described. This could include pumping from existing drift wells in MU-C in Wellhouse 19 as previously described, in conjunction with MU-C restoration.
