Department of Environmental Quality

RE: North Butte ISL Operation, Permit No. 632

BOND RELEASE INSPECTION REPORT

SUBJECT: Cameco Resources' North Butte Project

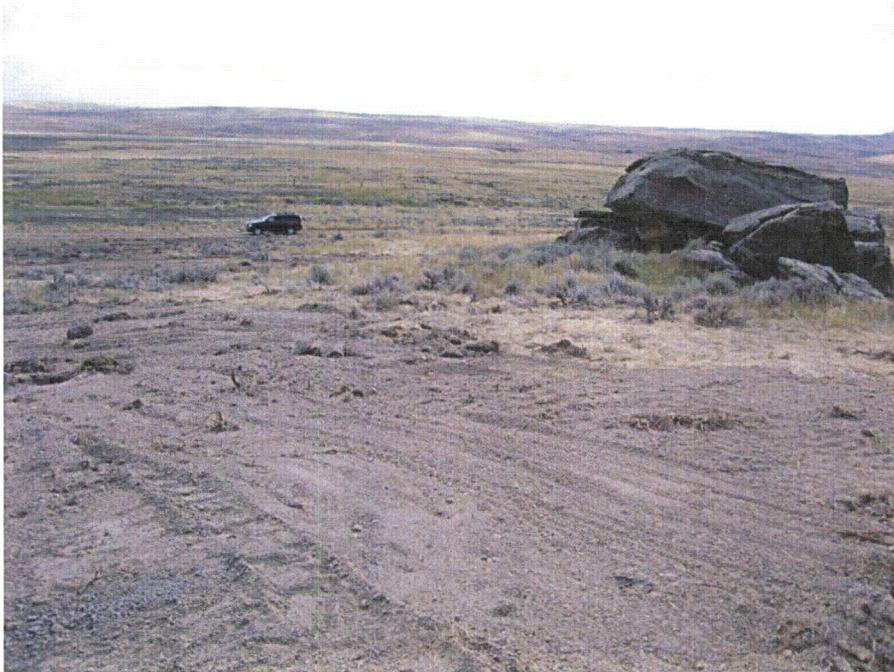
Photo No. 1

Some problems were noted on this inspection, most relating to uneven spreading of topsoil. On numerous hole locations, grading and smoothing of the replaced topsoil had resulted in exposure of the subsoil used to backfill the mudpits (Photos Nos. 1, 2, and 6). It appears one reason for this may have been the backfilling of the mudpits with subsoil causing the subsoil to be heaped over the mudpits. Then, before the subsoil had settled into the mudpits completely, topsoil was spread over the subsoil and then graded, sometimes exposing the underlying subsoil.

Looking southeast at Drill Hole No. 13-733 showing area of abandoned drill hole where mudpit has been backfilled and the topsoil replaced and spread over the mudpit area. Process has left some subsoil exposed at the surface.

What effect this will have on future revegetation remains to be seen as revegetation will depend in large part on the ability of the subsoil to support vegetation which is unknown at present. It is important that this situation does not occur again in the future during reclamation of the mudpits used for drilling of the projection and monitor wells during well field installation. The topsoil resource is limited on this permit area, particularly toward the higher portions of the well field area.

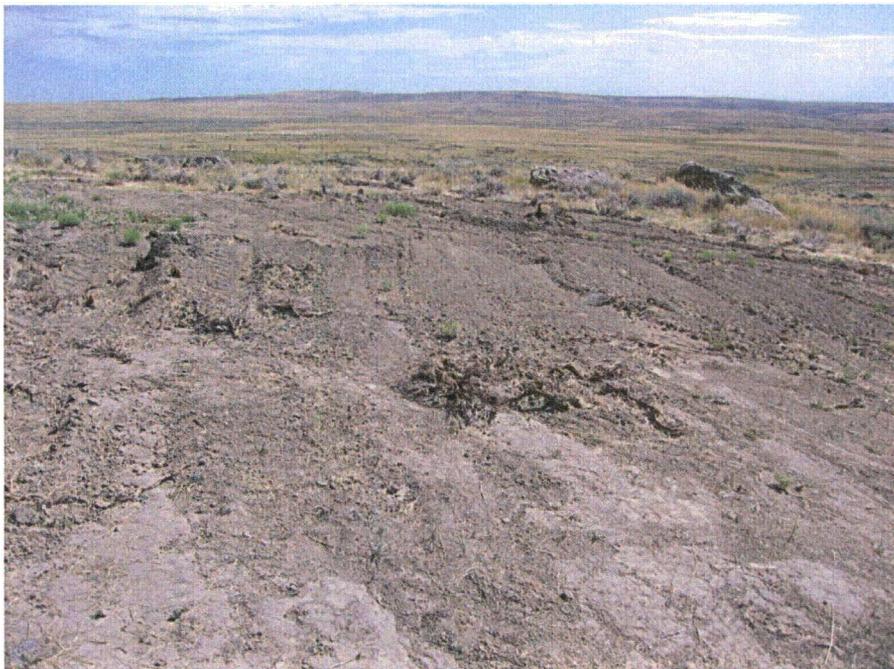
Photo No. 2

Looking southeast of location of Drill Hole 13-725 which has been abandoned and the mudpit backfilled and the topsoil respread over the mudpit. Grading of the topsoil has exposed some subsoil.

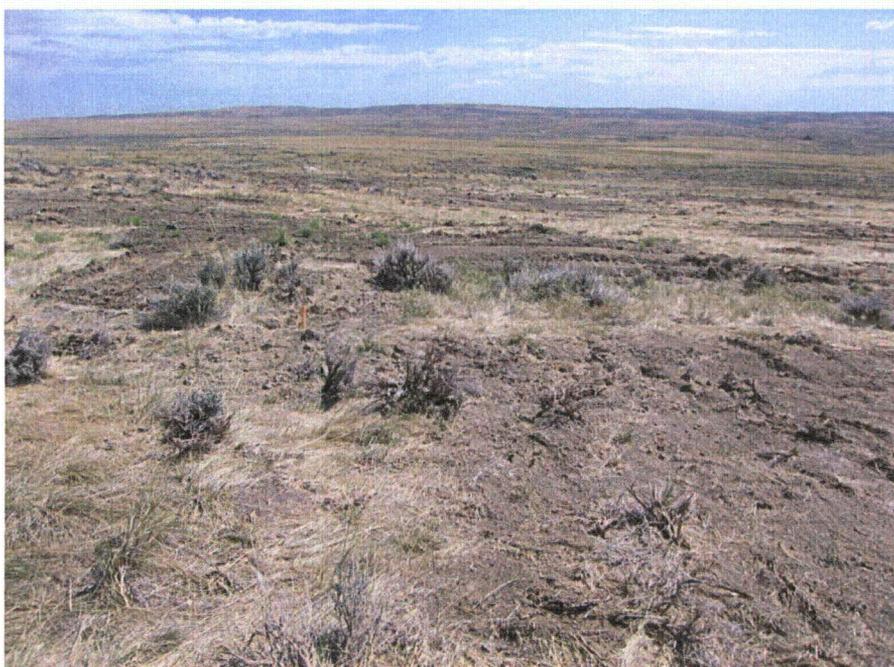
Photo No. 3

Looking east at location of Drill Hole No. 13-721 in foreground and 13-722 in background. As in holes above, drill holes have been abandoned and mudpits backfilled and topsoiled. Topsoiling of these and nearby hole locations was good.

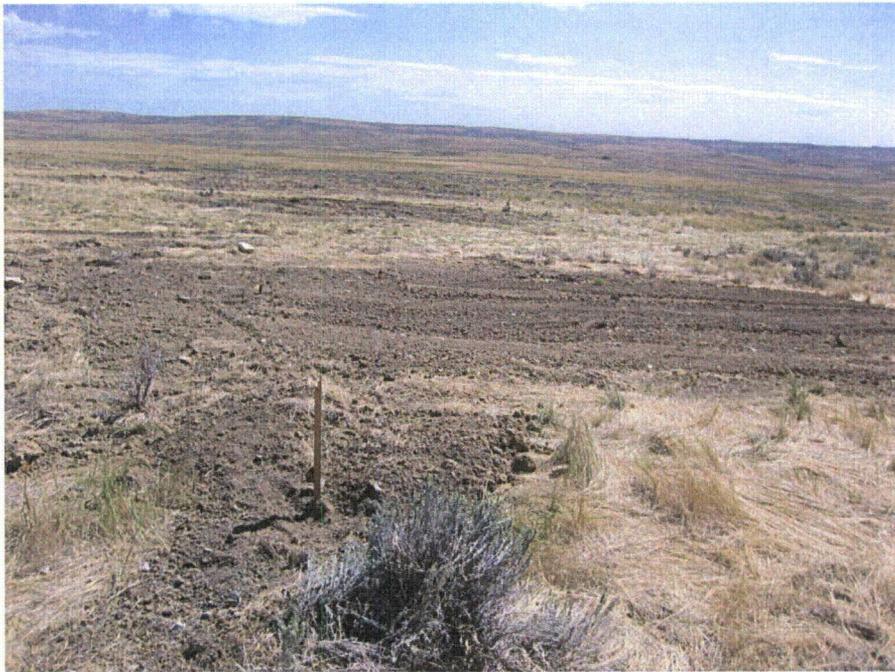
Photo No. 4
Looking east at location of Drill Hole No. 13-753 where hole has been abandoned and mudpit backfilled and topsoiled. Good topsoil replacement has been achieved here.

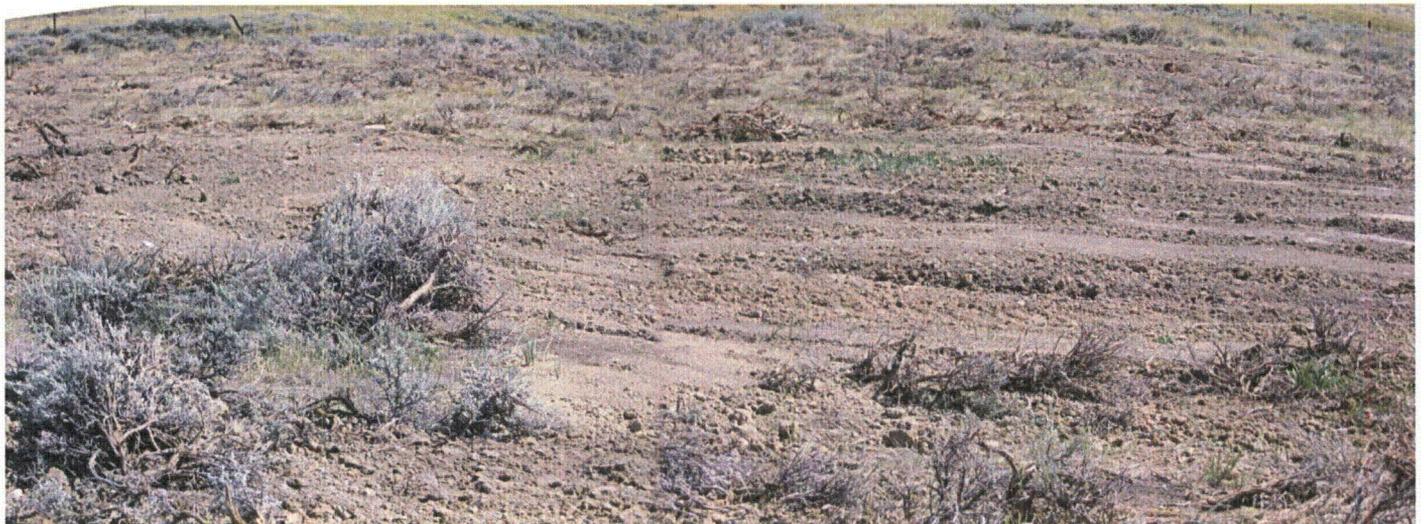
Photo No. 5
Looking south at Drill Hole No. 13-681 where topsoil replacement has been good.

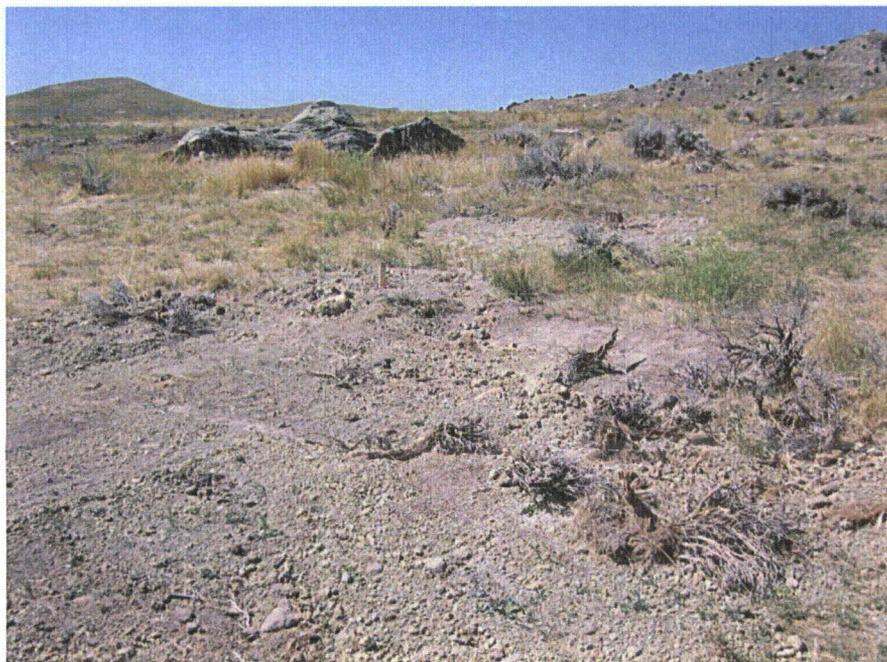
Photo No. 6
Looking west at Drill Hole 13-692. Some cleanup is needed here as subsoil was left on the surface covering topsoil at some distance from the mudpit area.

There were only a few areas where some remedial work was requested. One was Drill Hole No. 13-692 where a quantity of subsoil had been left covering topsoil at some distance from the location (Photo No. 6). Another was near Drill Hole 13-596's location for some bentonite, either drilling mud or chips, had been left exposed at the surface, possibly from abandonment of an old hole left over from historic drilling operations (Photo No. 14). Cameco was requested to remove the bentonite and bury it properly.

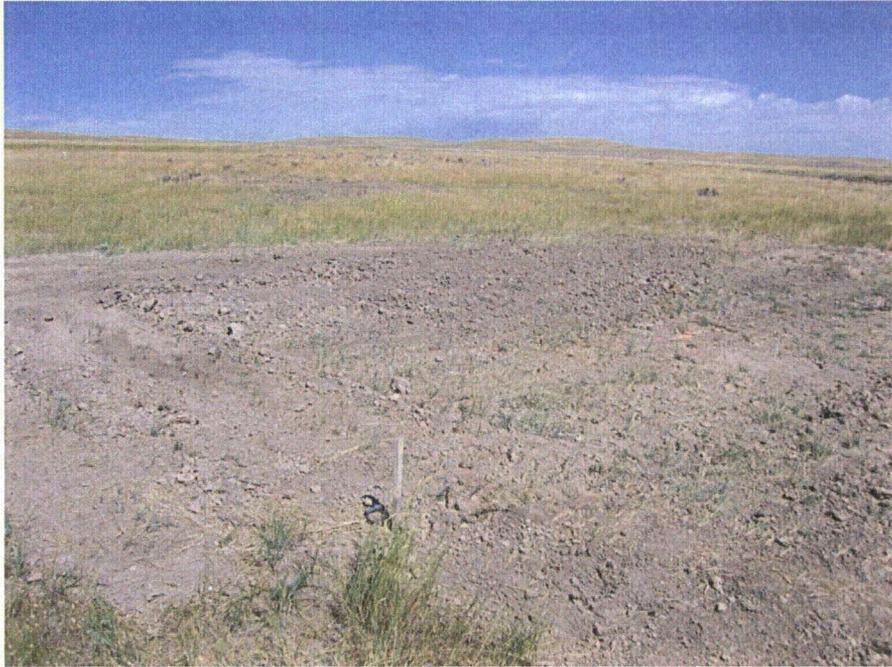
Photo No. 7
Looking north at location of Drill Hole No. 18-242. There has been good, even topsoil redistribution over this location.

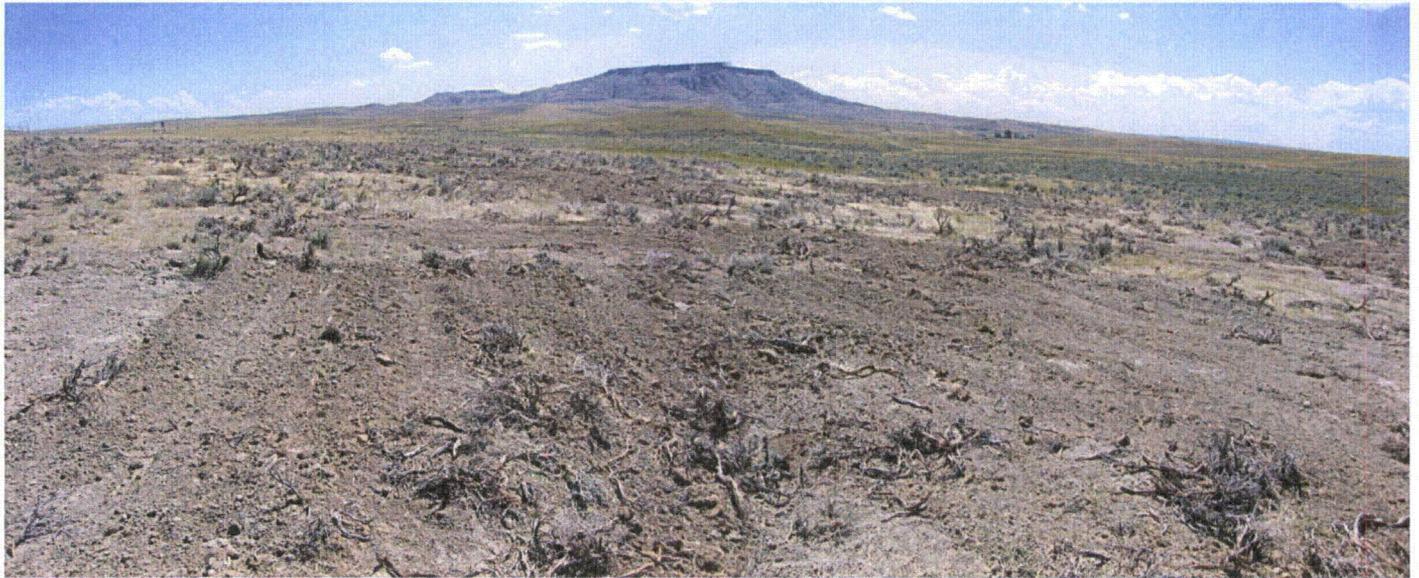
Photo No. 8 Looking south to southwest across locations of several drill holes including 19-459 in foreground. Topsoil replacement on drill hole locations in this area was generally good.

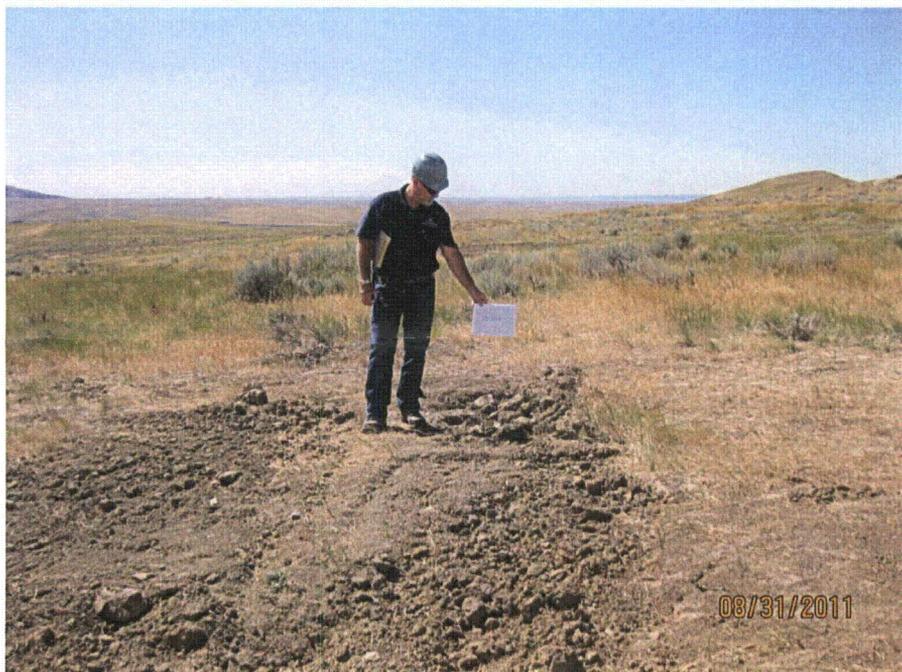
Photo No. 9
Looking south at location of Drill Hole No. 13-646 with good topsoil replacement.

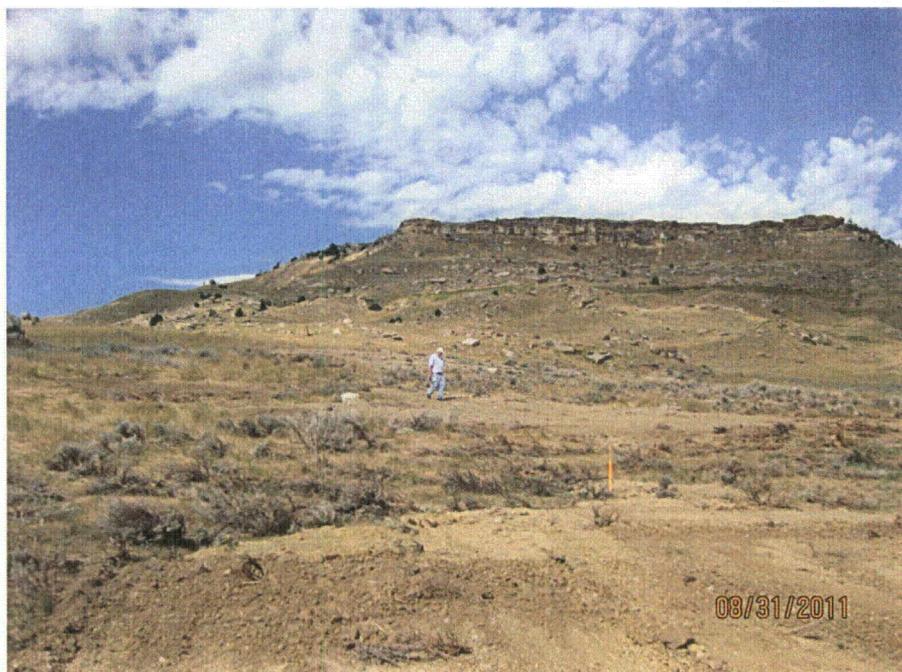
Photo No. 11
Looking northwest at location of Drill Hole 13-639 which shows uneven distribution of topsoil over location with much subsoil remaining exposed.

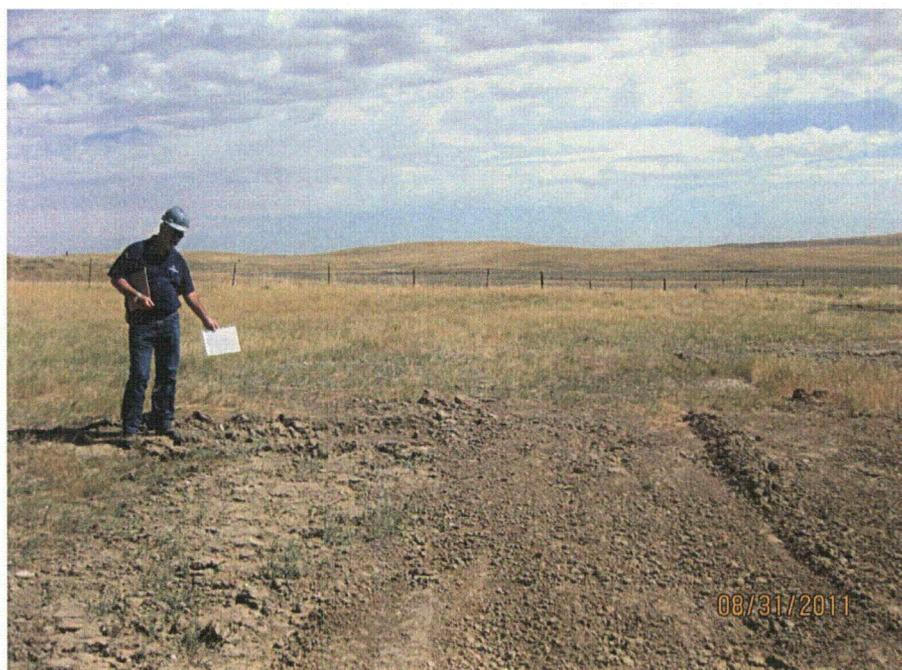
Photo No. 12
Location of Drill Hole No. 13-649 showing good topsoil replacement.

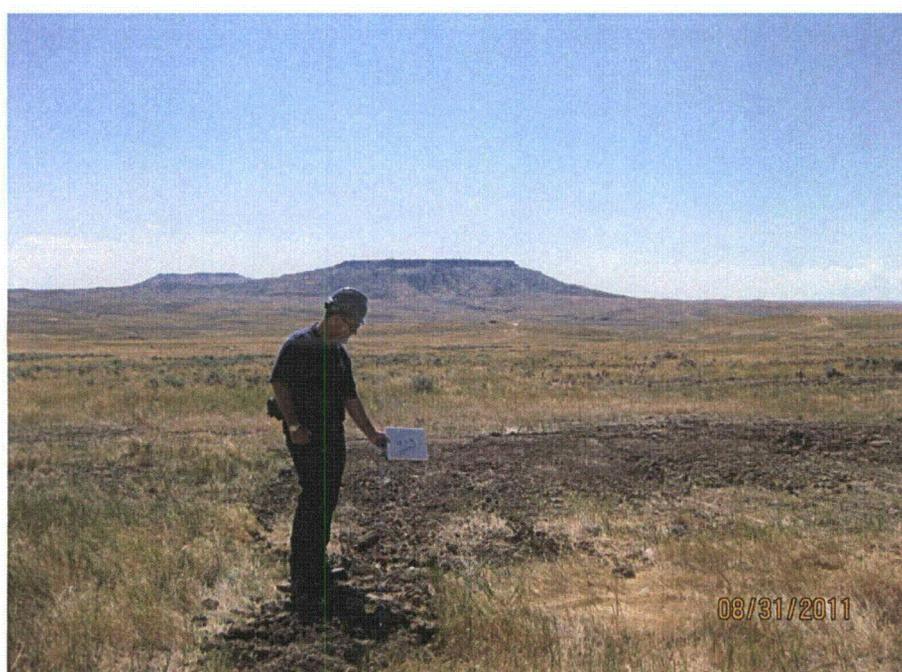
Photo No. 13
Looking south-southeast at location of Drill Hole No. 13-634 where grading and topsoil replacement are good.

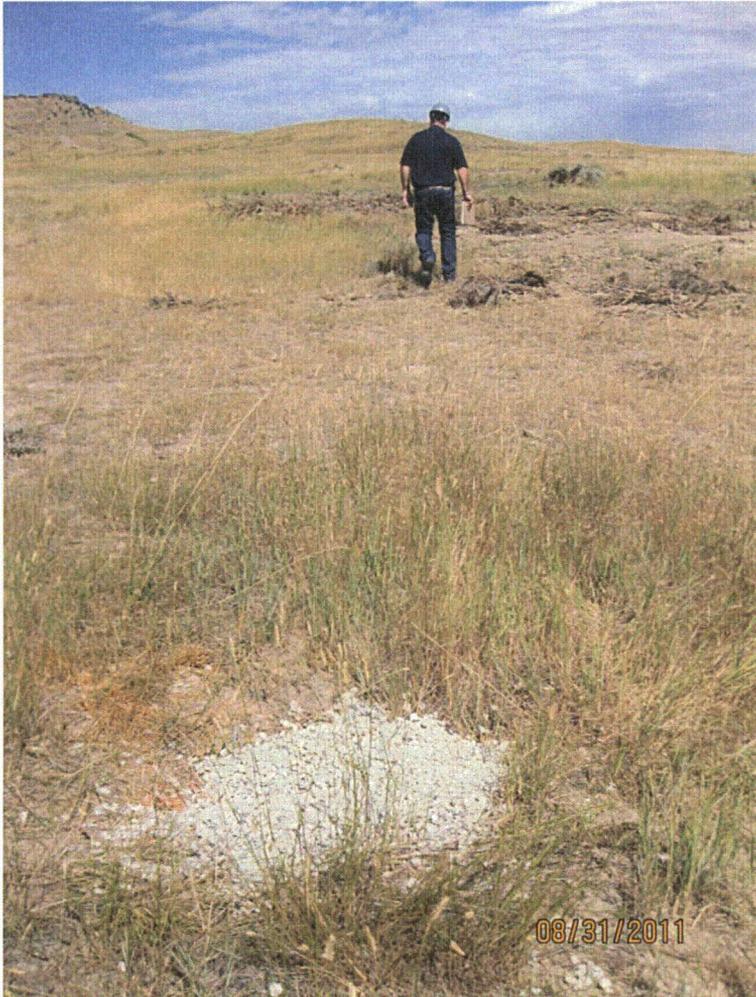
Photo No. 14

Looking north at bentonite left on surface near location of Drill Hole 13-596. PRI has agreed to clean up area which may be related to filling of an earlier abandoned drill hole.

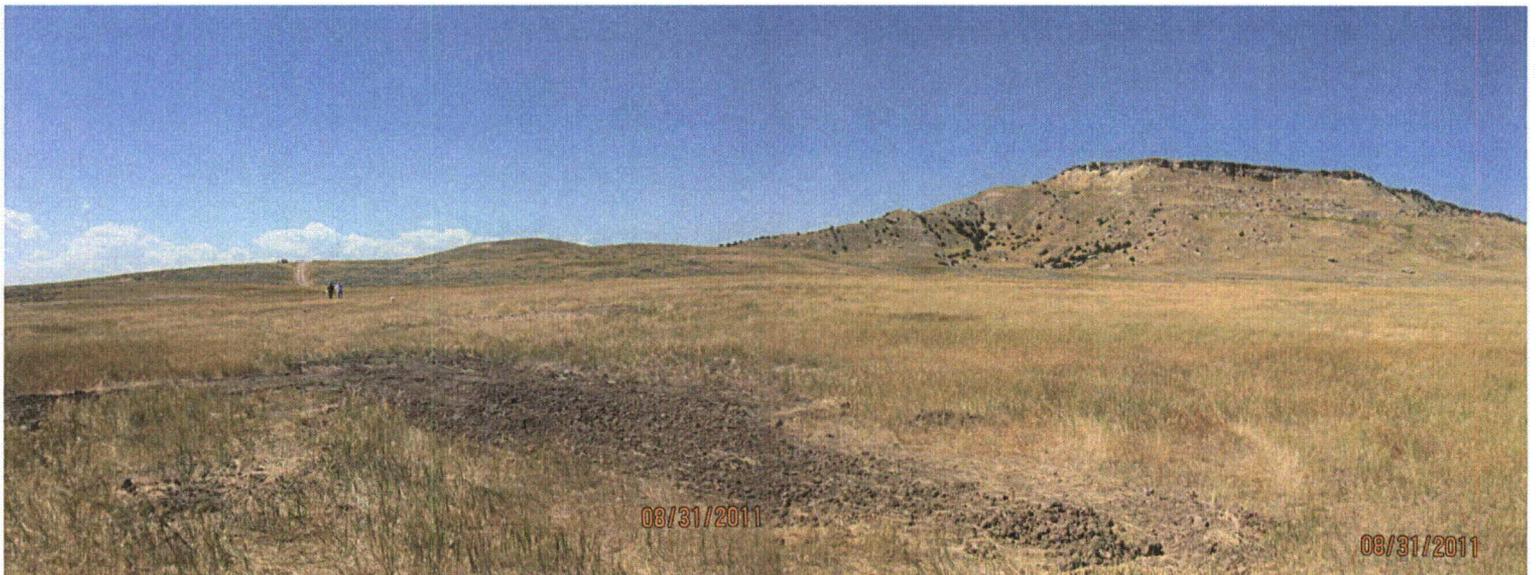
Photo No. 15

Looking west to northwest at Location of Drill Hole 13-485 where topsoil replacement is good.
