**Wenck Associates, Inc., "Engineering Evaluation of Hesco Barriers Performance at
Fargo, ND 2009," May 2009**

**DOS K12 CRASH TEST AND EVALUATION OF THE
HESCO C-3315 FLOOD BARRIER**

Contract No.: P2005003
Project/Test No.: 400001-HBL2
Test Date: 12-17-2004

April 2005

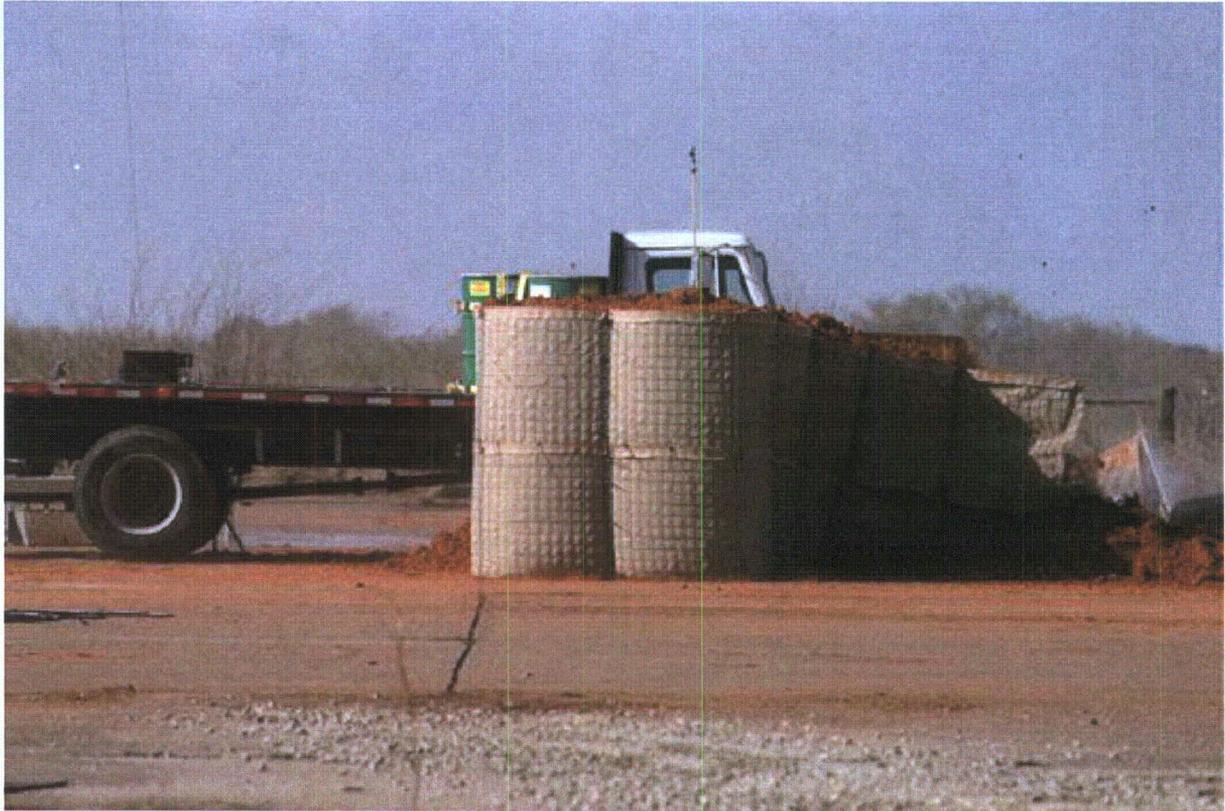
Figure 6. Vehicle trajectory path after test 400001-HBL2.

The wire mesh ruptured and the center rows were damaged. Three rows of box units on each side were intact. The ends of the barrier were pulled inward, 150 mm (5.9 inches) on the right side and 140 mm (5.5 inches) on the left side. Soil was scattered over an area to the inside of the barrier, 12.2 m (40 ft) long and 9.1 m (30 ft) wide. Damage to the installation is shown in figures 6 and 7.

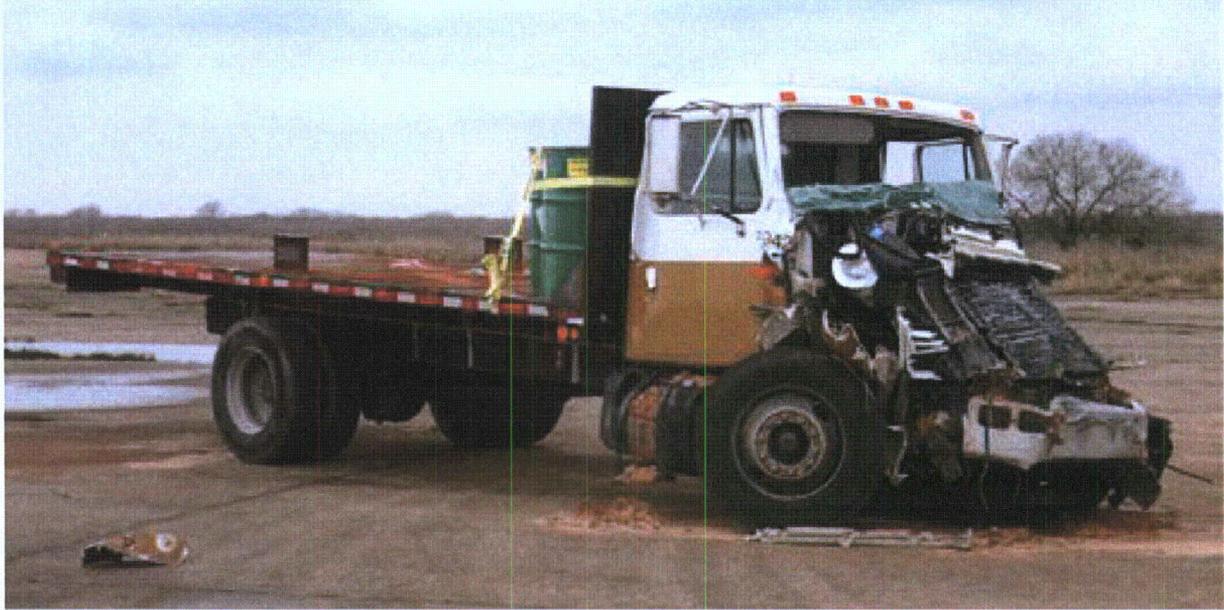
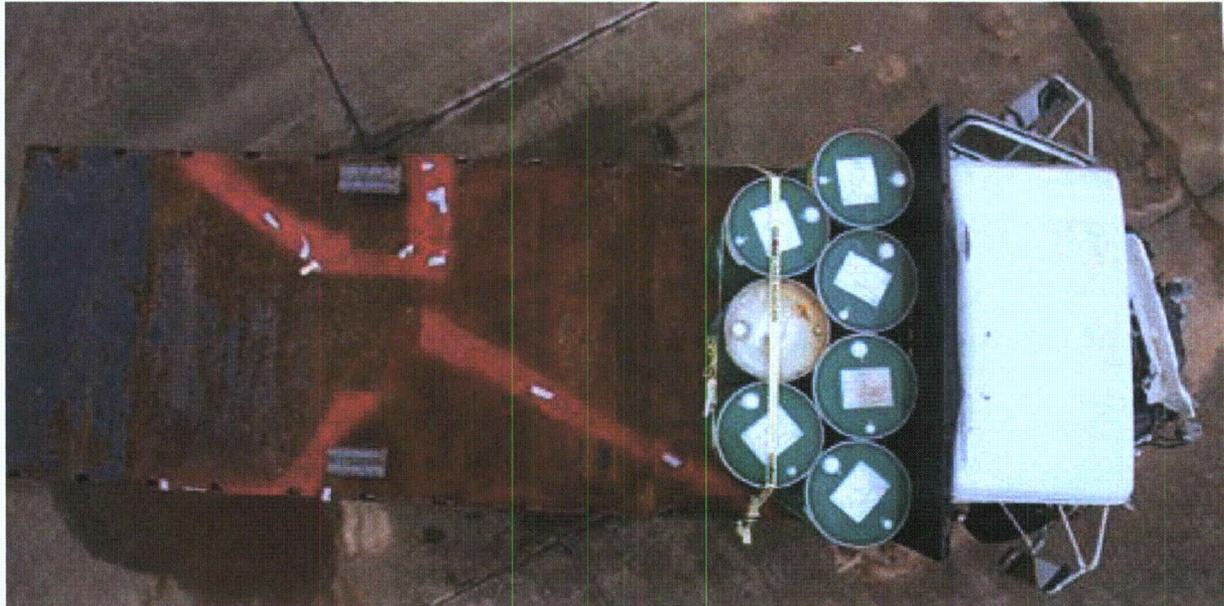
Figure 8. Vehicle after test 400001-HBL2.

Damage to the vehicle is shown in figure 8 and 9. The front of the cargo bed did not penetrate the inside edge of the barrier, and came to rest 0.85 m (2.8 ft) from the inside edge of the barrier.

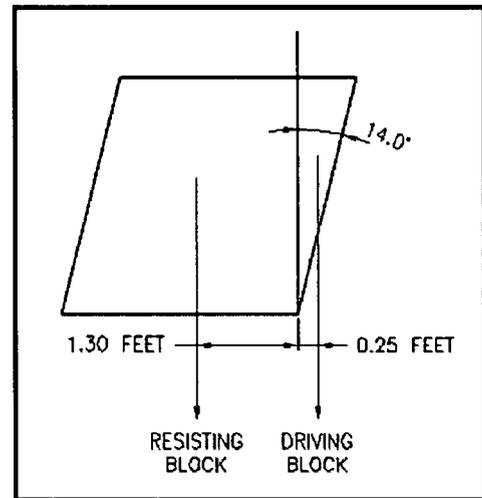
As discussed earlier in this report, some of the units were experiencing some tilt, with angles nearing 6 or 7 degrees. Based on information obtained during the field work, it is believed that the units showing some tilt were either installed that way, or settlement of the units into the base soils occurred.

For a single layer system, a tilt of less than 14 degrees is a reasonable maximum value. The reason for this is because the system tends to operate as a block. Therefore, at an angle of 14 degrees or less, there is at least 7 times the mass holding back the container from tipping. When considering this angle, the resisting mass and the associated moment arm of the units, based on the resisting and driving forces, a calculated system factor of safety against overturning is greater than 30. This is shown by Equation 2 below.
