MONTICELLO NUCLEAR GENERATING PLANT
Docket No. 50-263 License No. DPR-22

Supplemental Report
Fabrication Flaws Discovered in HPCI Line Welds

LICENSEE EVENT REPORT (LER)

TITLE (4) **Fabrication Flaws Discovered in HPIC Line Welds**

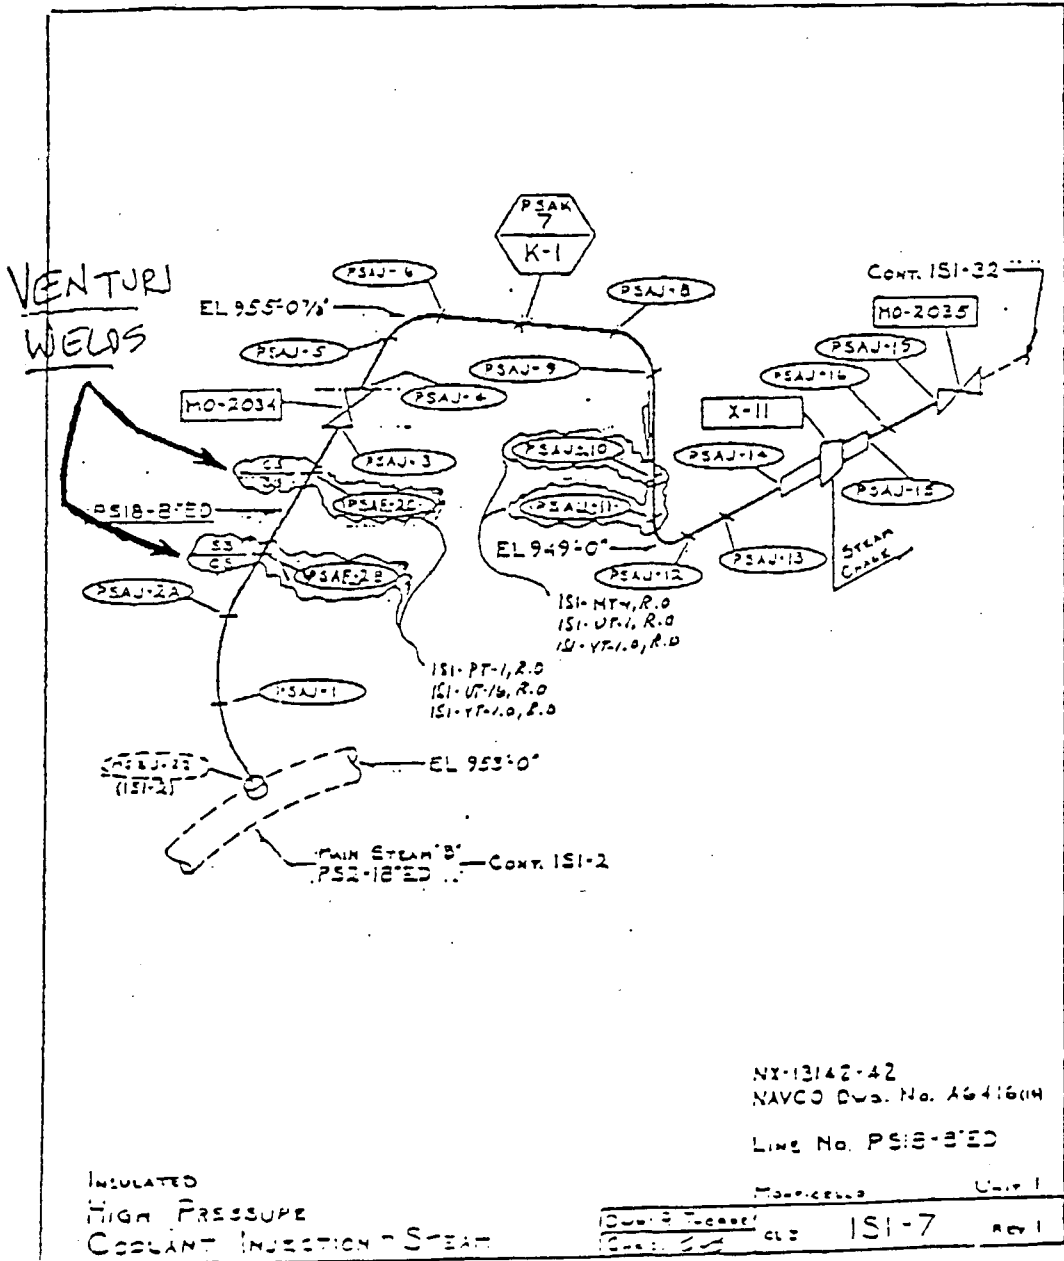
During a scheduled ISI examination of welds in the HPCI (BJ) steam supply line, rejectable flaws were found in two welds. The plant was shutdown for refueling at the time. The flaws were discovered by radiographic testing on 9/7/89. The flawed welds (PSAF 2b and 2c) on line PS 18-8"ED are shown on the attached figure. The welds are dissimilar metal welds joining a stainless steel venturi (PSP) in the carbon steel line.

The flaws appear to be slag and lack of fusion weld defects from fabrication. Radiography was not performed during fabrication of spool piece as it was not required by the design and fabrication Code, ANSI B31.1-1967. The liquid penetrant testing done during fabrication would not have detected the flaws found.

This event does not involve equipment failure. The flaws were not found previously because joint configuration masked indications when examined using ultrasonic testing (UT). Recognizing difficulties with UT examination, radiography was attempted to further evaluate previous inspection results. Radiography revealed rejectable flaws. Acceptance criteria are defined by ASME Boiler and Pressure Vessel Code, Section IX 1977 edition including summer 1978 addenda.

ASME Boiler and Pressure Vessel Code Section XI and fracture mechanics analyses have been completed to see if these flaws could have resulted in a significant safety problem. The analyses indicate that the weld would not have failed as a result of stresses from normal operation or accident conditions.

The spool piece including the flow venturi and pup pieces was replaced soon after detection of the flaw. A replacement spool piece was ordered before the outage in anticipation of possible stress corrosion cracking in the venturi welds. Design of the new component facilitates inspection. Radiography and baseline ultrasonic examination results of welds on the new component are acceptable. The new flow element and dissimilar welds conform to NUREG 0313 Rev 2 for "Category A Weldments."
