REGULATORY INFORMATION DISTRIBUTION SYSTEM (RIDS)

SUBJECT: LER 89-040-01: on 891219, failure to meet secondary containment performance requirements due to design defects.

MONTICELLO NUCLEAR GENERATING PLANT
Docket No. 50-263 License No. DPR-22

Failure to Meet Secondary Containment Performance
Requirements Due to Design Deficiencies

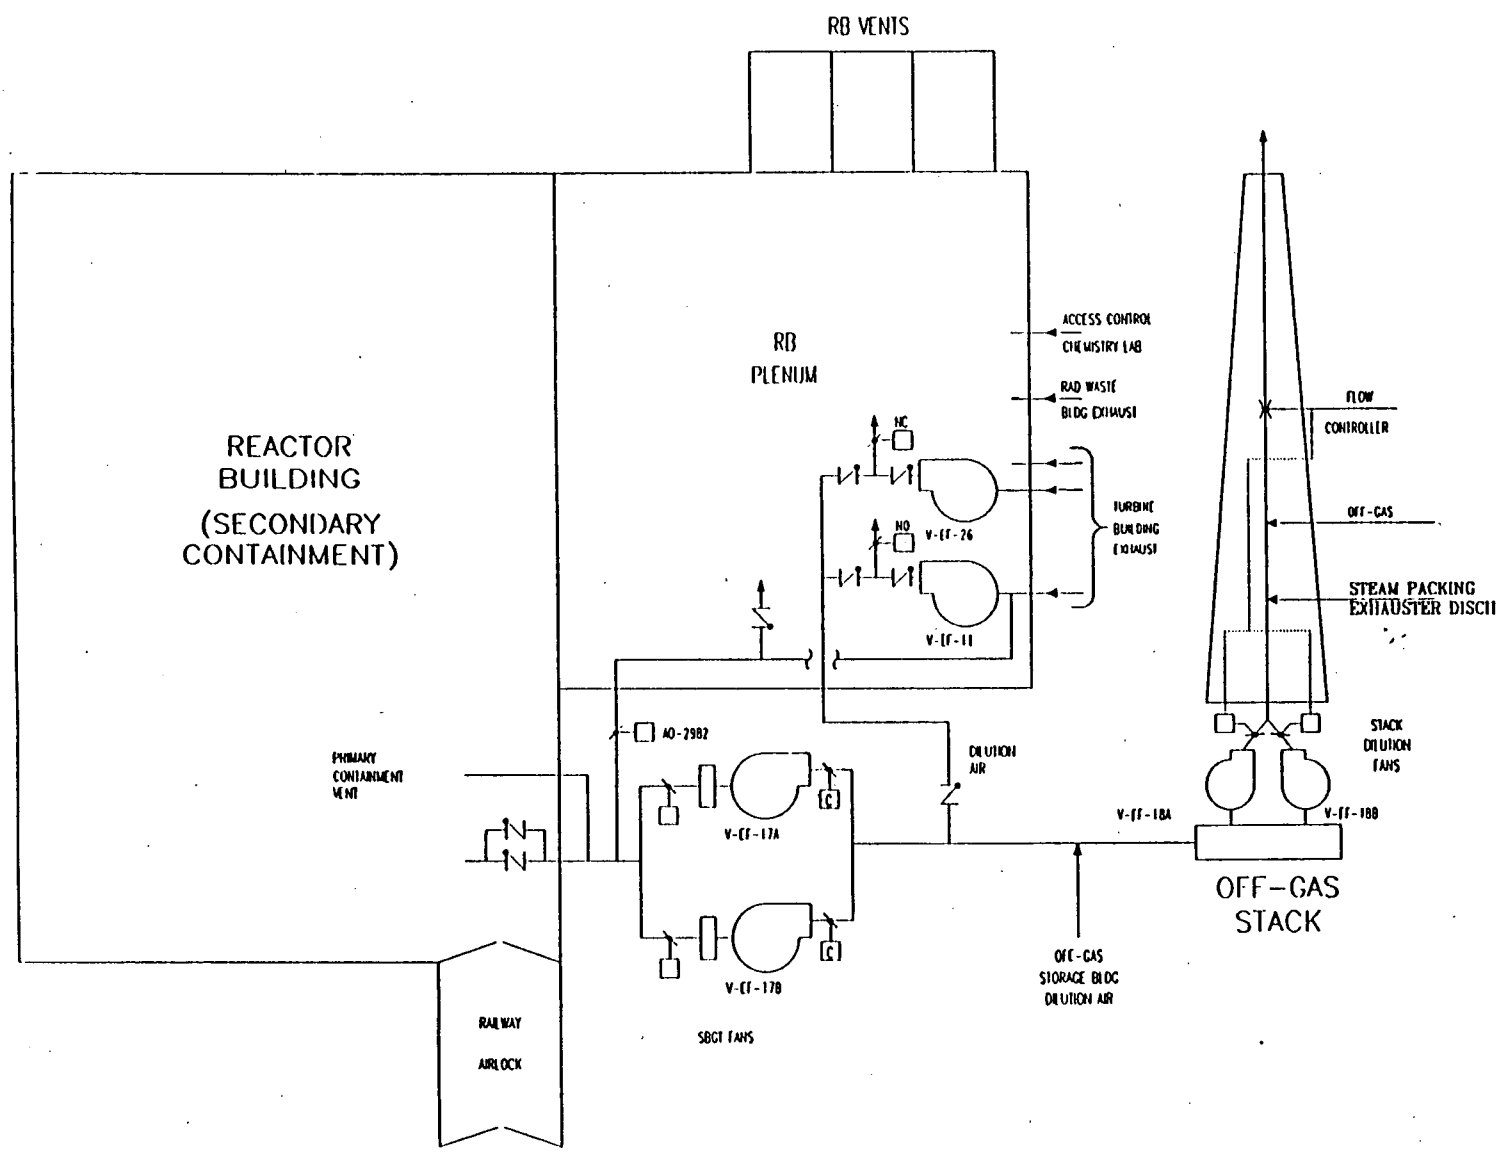
REACTOR BUILDING VENTILATION SYSTEM

The maximum flow through Standby Gas Treatment that could be achieved during the test was 3500 CFM which produced only a 0.22 to 0.23 inches water vacuum within Secondary Containment. Investigation of the operation of Standby Gas Treatment revealed that, during Secondary Containment isolation conditions with the reactor at power and without a loss of offsite power, Standby Gas Treatment system flow was being limited by flow to the Offgas Stack from the Steam Packing Exhauster discharge (See Figure 1.) Steam Packing Exhauster flow injects into the Offgas Stack after the discharge of the Offgas Dilution Fans (V-EF-18A, V-EF-18B) (EIIS Component Code: FAN) and before the flow sensors (SPS 8000-H1, SPS 8000-H2) (EIIS Component Code: TC) which are used to control the flow through the dilution fans. This causes a reduction in flow through the Dilution Fans and Standby Gas Treatment Fans (V-EF-17A, V-EF-17B) (EIIS Component Code: FAN). This condition may then prevent the achievement of the 0.25 inches water vacuum required within Secondary Containment.

It was determined that a failure of either of two discharge dampers (EIIS Component Code: DMP) for the Turbine Building exhaust fans (V-EF-11 or V-EF-26) (EIIS Component Code: FAN) could lead to higher back pressure in the Standby Gas Treatment discharge line and likewise prevent Standby Gas Treatment from achieving full rated flow. These fans run in parallel to supply 50% of the dilution flow during normal operation. During a Secondary Containment isolation, dampers on the discharge of these fans open to release their discharge to the Reactor Building Plenum Room. However, either of the discharge dampers could stick in a closed position and the respective fan would continue to discharge to the dilution fans. This flow could create a back pressure on the running Standby Gas Treatment fan and limit its flow.

It was also determined that failure of Primary Containment Exhaust to Plenum isolation valve (AO-2982) (EIIIS Component Code: ISV) in the open position during a Secondary Containment Isolation would allow the Standby Gas Treatment fans to draw on the Reactor Building Exhaust Plenum Room instead of the Reactor Building. Therefore, Standby Gas Treatment would not be able to maintain the required vacuum within Secondary Containment.

1. An administrative hold was placed on AO-2982 to secure it in the closed position when Standby Gas Treatment is required to be operable.
2. Operating procedures were revised to require tripping the Turbine Building Exhaust Fans and tripping the Steam Packing Exhauster blowers after an initiation of Standby Gas Treatment and isolation of Secondary Containment which was caused by a radioactive release from within Secondary Containment.
