MONTICELLO NUCLEAR GENERATING PLANT
Docket No. 50-263 License No. DPR-22

Potential Emergency Filter Train System Inoperability
Due to Interaction with Non-Safety Related Equipment

TITLE (4) Potential Emergency Filter Train System Inoperability Due to Interaction with Non-Safety Related Equipment

FACILITY NAME (1)	DOCKET NUMBER (2)	LER NUMBER (8)			PAGE (3)		
		YEAR	SEQUENTIAL NUMBER	REVISION NUMBER			
		90	001	03	02	OF	09

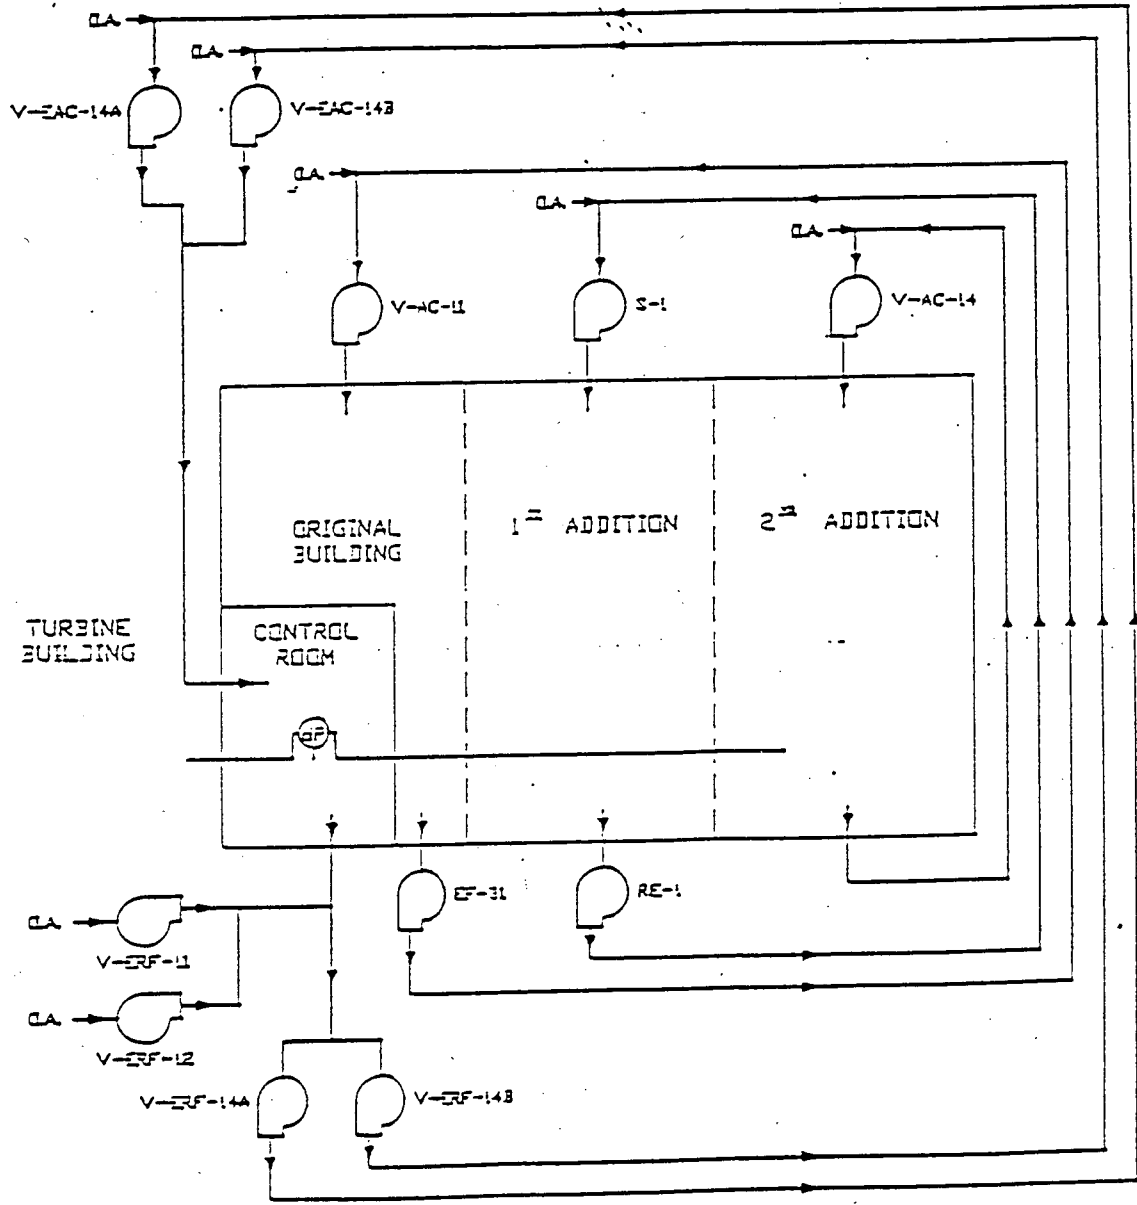
FIGURE 1 SIMPLIFIED ADMINISTRATION BUILDING VENTILATION

On March 30, 1990 during subsequent investigation of the Emergency Filter Train system design, engineers determined that administration building ventilation supply units V-AC-11 and S-1 (see Figure 1, Simplified Administration Building Ventilation system drawing), may not trip in the event of an Emergency Filter Train High Radiation Mode automatic initiation. The signal for these ventilation units is initiated by a single Non-Safety Related relay and associated Non-Safety Related switchgear. This is contrary to the design basis for the Emergency Filter Train system which requires all equipment related to Control Room habitability to be single failure proof and Safety Grade. Failure of these ventilation units to trip during a High Radiation event could potentially pressurize the Administration Building and degrade the Emergency Filter Train's ability to maintain a positive differential pressure between the Control Room and the Administration Building. The ventilation units were immediately tripped and secured to ensure Emergency Filter Train operability.

The Emergency Filter Train was installed in response to the Three Mile Island Action Plan. The system was designed to enhance Control Room habitability following a Loss of Coolant event. During the final stages of the Emergency Filter Train construction, a second addition to the plant Administration Building was constructed (see Figure 1). The potential for the second Administration Building addition's Non-Safety Related ventilation system (V-AC-14) to interact with the Emergency Filter Train system was never considered in the design of V-AC-14. No direct Safety Related trips from the Emergency Filter Train were included in the design of V-AC-14.

The design of ventilation systems for the original Administration Building and its first addition took into account the need to provide a level of protection for the facilities during a High Radiation Event. With this in mind, Administration Building ventilation units were provided with an automatic trip upon initiation of the Emergency Filter Train High Radiation Mode. Since the ventilation systems serving these areas are not required to be single failure proof, the automatic trips and associated ductwork were designed and installed utilizing Non-Safety Related components. Also, redundant isolation between safety and non-Safety Related portions of the ductwork was never installed. The design did not take into account the potential interactions with the Safety Related Emergency Filter Train system, and the Non-Safety Related ventilation systems and non-Safety-Related ductwork.

1. The breakers for all ventilation units which could potentially degrade the Emergency Filter Train due to a Safety Related/Non-Safety Related interaction were immediately secured opened.

An analysis (using the Commercial Grade Dedication process) was completed to show that the Administration Building ventilation unit (V-AC-11, V-AC-14, and S-1) breakers, motor contractors, and relay trip logic would be able to perform their intended functions in the event of an accident. Analysis of the Turbine Building ventilation unit (V-AH-1, V-AH-2, V-MZ-1, V-MZ-4, V-MZ-5, V-MZ-6) breakers was also completed, showing that the breakers are able to perform their intended functions in the event of an accident. In the most limiting case, the ventilation units are required to trip in a Design Basis Loss of Coolant Accident (Analysis does not have to be made for a simultaneous seismic event per Generic Letter 87-02).
