# Union of Concerned Scientists

November 4, 2011

## SUBJECT: Conditional Allegation – Shield Building Design at Davis-Besse

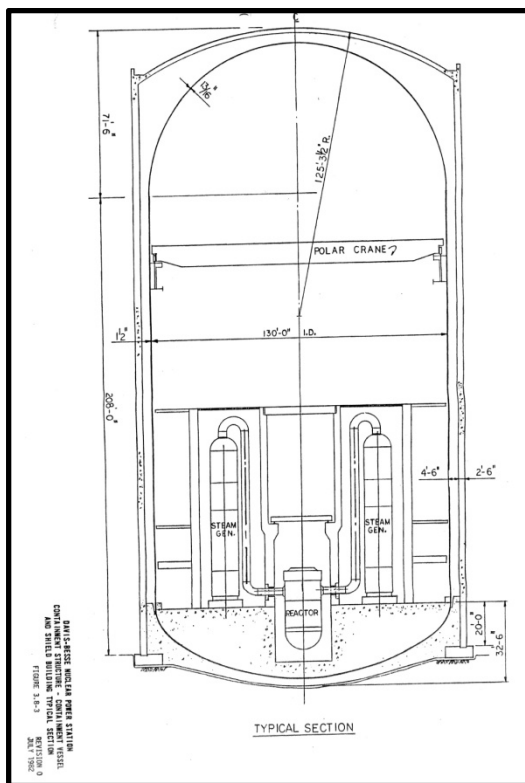
Updated Final Safety Analysis Report (UFSAR) section 3.8.2.2 summarizes the design and associated analyses for the shield building. UFSAR section 3.8.2.2.2 states that dead loads were considered in the shield building design. UFSAR section 3.8.2.2.4 states that the dead loads included concrete (143 pounds per square foot) and steel reinforcing (489 pounds per square foot). UFSAR section 3.8.2.3.7 states that "Cement for all concrete except the Shield Building is Type II low alkali cement ... The Shield Building has Type I cement above grade." UFSAR Figure 3.8-3 (left) illustrates a typical section of the containment vessel and shield building.

1. The “non-structural, architectural concrete” elements do not appear in UFSAR Figure 3.8-3. The plan diagram indicates these elements are connected to the shield building wall. Are the dead loads from these concrete elements properly considered in the design analyses of the shield building?
2. The UFSAR does not explicitly describe these “non-structural, architectural concrete” elements. Thus, it is not clear if these elements have Type II concrete or Type I cement as explained in UFSAR section 3.8.2.3.7. What type of cement was used in the “non-structural, architectural concrete?”
3. If the concrete/cement in the shield building is the same as that in the “non-structural, architectural concrete” elements and all have the same age and environmental exposure history, would numerous cracks identified in one suggest comparable conditions in the other? If not, why not?

UCS realizes that UFSAR Figure 3.8-3 is a simplified drawing and the design analysts hopefully used the more detailed civil/structural arrangement drawings, but it is prudent to check to verify

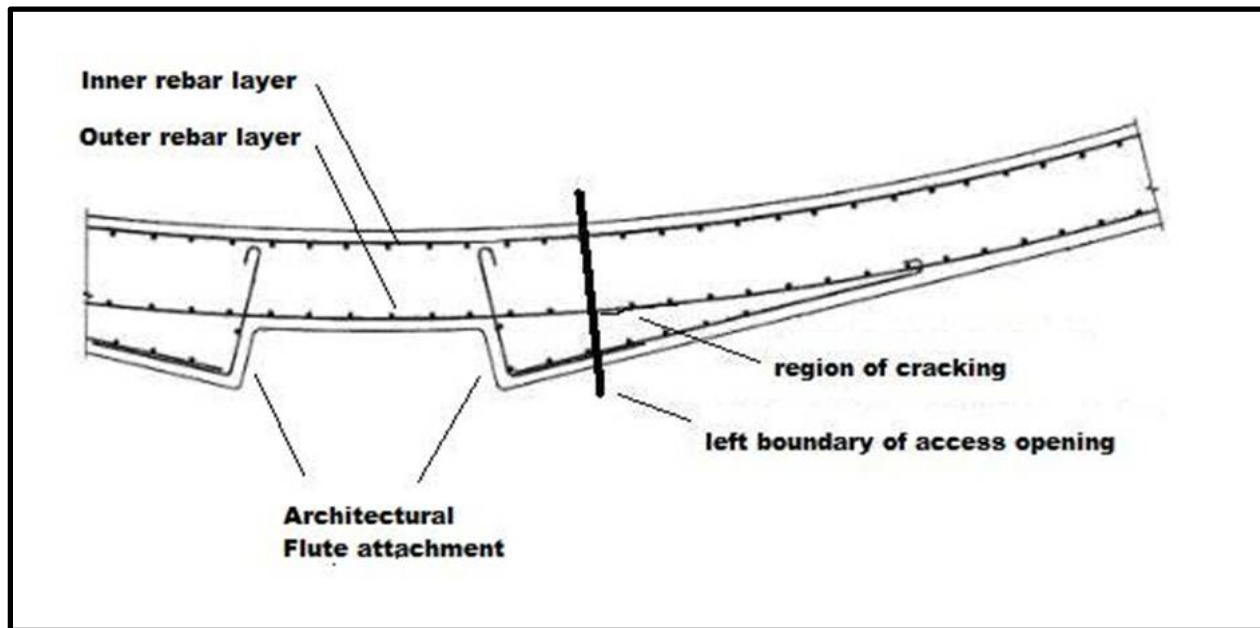
This plan diagram (overhead view) of a section of the shield building wall shows the “non-structural, architectural concrete” referred to in the NRC’s PNO. As indicated by the two fish-hook shaped devices in the drawing, the attachments are anchored to the shield building wall.

The media has reported that numerous cracks in the “non-structural, architectural concrete” have been identified. The NRC PNO stated “If there are any challenges identified to the design function of the shield building they will have to be resolved before the plant restarts.”

UCS also understands that the numerous cracks, even if also within the shield building's walls, do not in themselves demonstrate that the design function has been compromised. But there's little reason that numerous cracking found in the "non-structural, architectural concrete" would not also be found in the shield building concrete unless (a) a different type of concrete was used, or (b) no one looked at the shield building concrete.

1. The design evaluation and analysis for the shield building did not properly consider the dead load from the "non-structural, architectural concrete" attached to it.
2. The shield building wall was not sufficiently examined for indication of cracking.
